PB90-916301
NTSB/RAR-90/01

RAILROAD ACCIDENT REPORT

**REAR-END COLLISION OF TWO
NEW YORK CITY TRANSIT AUTHORITY TRAINS
103RD STREET STATION
NEW YORK, NEW YORK
MARCH 10, 1989**

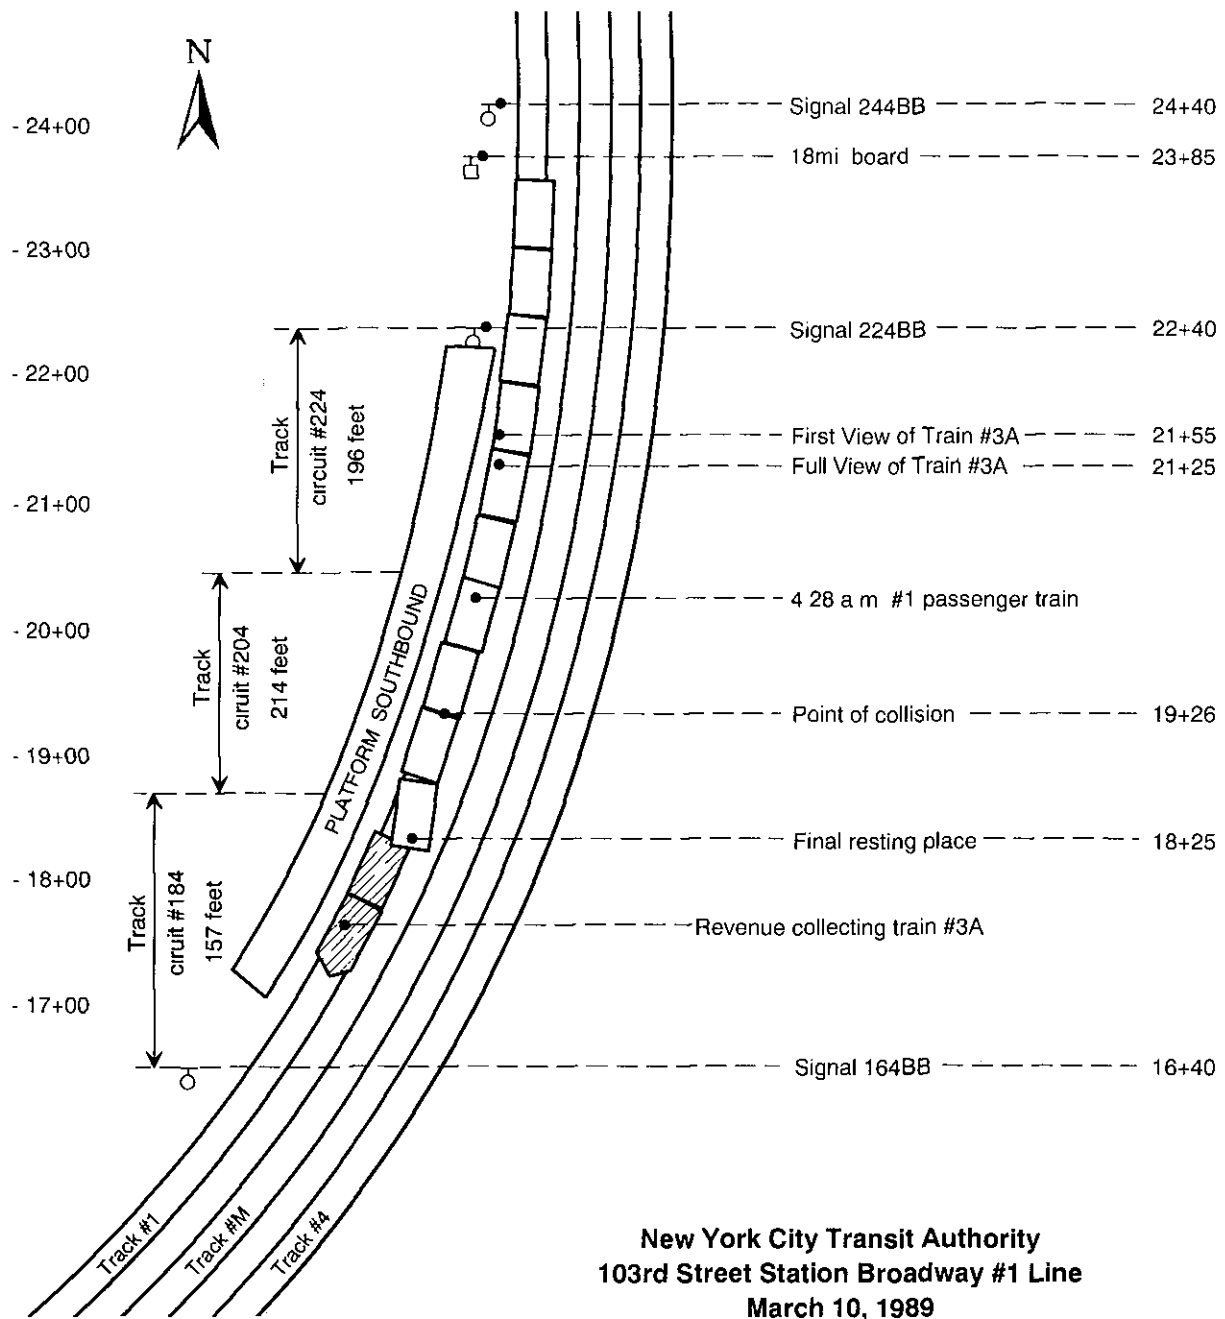
Figure 2.--Accident Site.

watching for a repeater signal on the left side of the track structure as the train moved along the station platform. Then, as the train rounded the 4-degree curve to the right, he saw a standing train 2 car lengths ahead (about 130 feet) and he put the train brakes in emergency using the brake valve handle. However, before he could stop the train it collided with the standing train (see figure 2).

Of the 10 cars of train 428, only the lead car sustained major structural damage. The end door was buckled, sheet metal was torn, and the door was pushed inward 6 inches. The left front of the car was deformed rearward 14 inches and the roof panel was separated from the left front corner. The sheet metal on the left corner was separated from the side, a vertical frame member was deformed and the left front window was displaced rearward 2 inches.

Damage to train 3A was confined to the rear end of the last car. The damage occurred to the undercarriage and floor near the center and extended from the rear end of the car inward 51 inches.

Seven load bearing columns in the station located adjacent to the track structure were heavily damaged. The columns are constructed of I-beams, measuring 10 inches in width and secured to concrete bases at the bottom. It was necessary for NYCTA to make temporary repairs, timbers measuring 12 inches by 12 inches were set in place adjacent to each side of the damaged columns, to support the street above. Subsequently, two columns were replaced and five repaired.

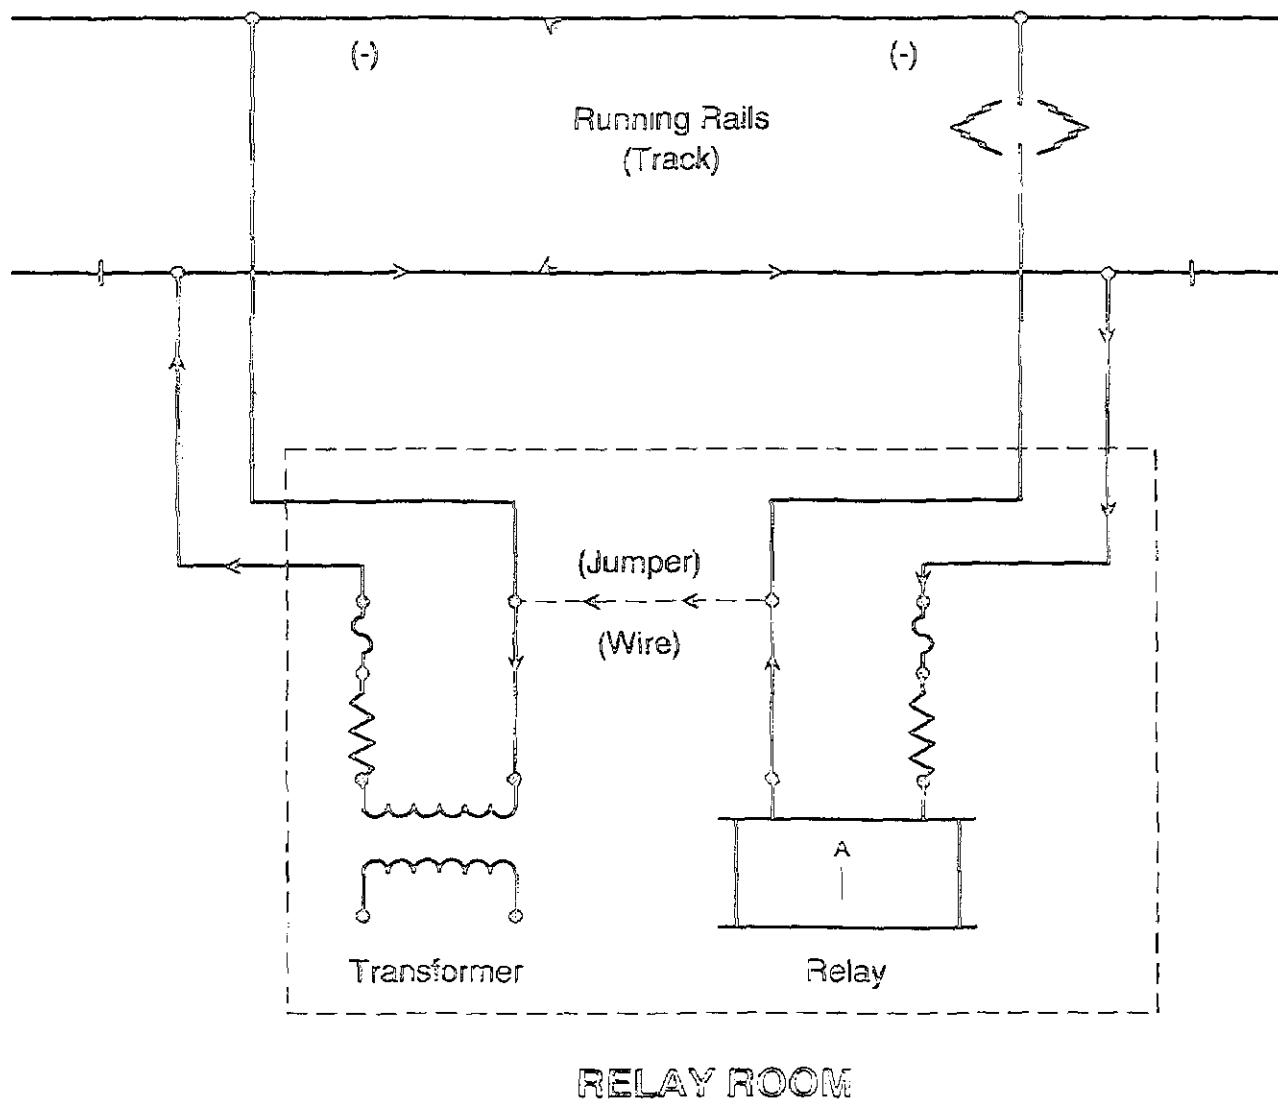
Figure 7 --Signal System Displays Clear With Jumper Wire Applied.

Inspection of the signal system at the 103rd street station following the accident revealed that a jumper wire had been installed between the transformer and the relay and tucked away (out of easy sight) in the circuit rack of the 204 circuit (the track circuit at which the train 3A was located at the time of the collision). With either of the negative relay or feed wires broken, current flow through the negative rail would be eliminated causing the relay to deenergize and the signal system to display a stop indication. However, with the jumper wire in place, current would still flow through the relay and the signal system would indicate clear when no train is

present (see Figure 7). Also, with the jumper wire in place, train wheels would still shunt the circuit removing the current to the relay, the relay would be deenergized and the signals would display a stop indication.

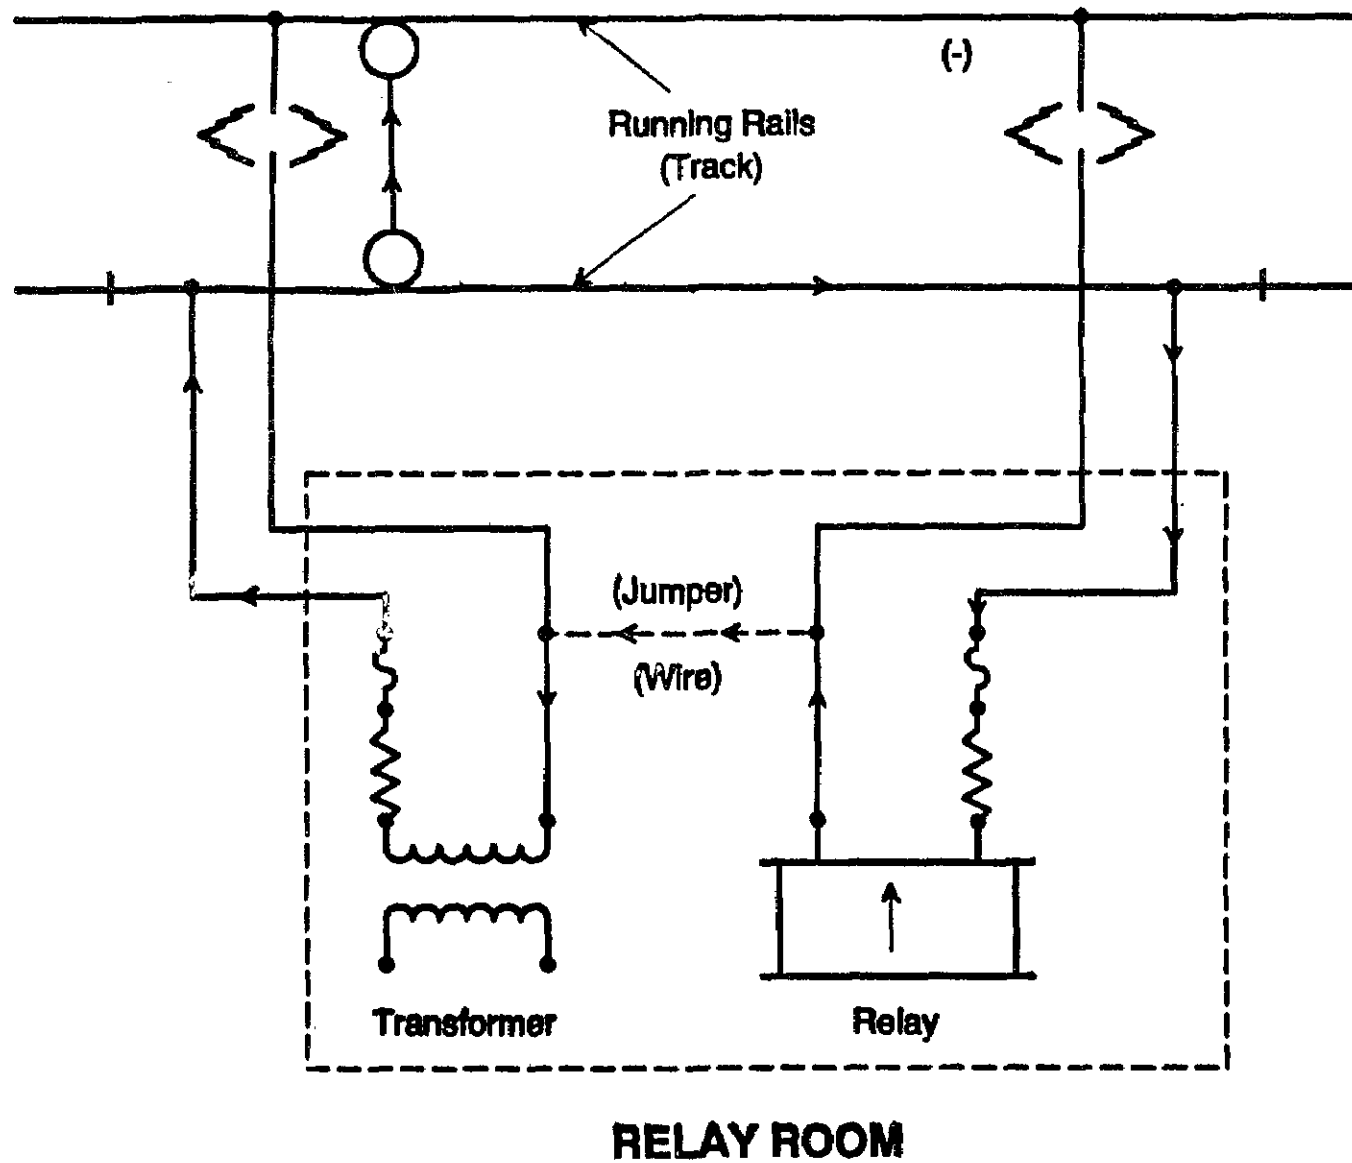
Figure 8.--Jumper Wire Applied, Train Wheel Not Shunting Signal System.

Further inspection revealed that both the negative feed wire and the negative relay wire were broken in the 204 track circuit, eliminating the connections between the relay and the negative rail and the transformer and the negative rail (see figure 8).

However, with both negative wires broken, any connection to the negative rail is eliminated and the current is directed through the jumper wire energizing the relay. Thus, with both negative rail wires broken and a jumper wire in place the wheels of a train would not shunt the current flow to the relay, the relay would remain energized, and the signals would display a clear indication (see figure 8). Following the accident a second jumper wire applied in the same manner as the one on circuit 204, was found on the next track circuit 224. Additionally another jumper wire, installed in the same manner, was found at the 116th Street station on track circuit 534. All three of these jumper wires were in the same signal maintenance district.

3. Improper repairs of signal circuit 204 had been made using a jumper wire because of expediency; with the jumper cable in place and two broken circuit wires, the signal at the entrance to 103rd Street Station displayed a false clear signal indication to the operator of train 428 entering the station when train 3A was occupying the circuit.
