REPORT OF THE DIRECTOR
BUREAU OF SAFETY

ACCIDENT ON THE
NEW YORK CHICAGO & SAINT LOUIS RAILROAD

BLOOMINGTON, ILL.

INVESTIGATION NO. 2130

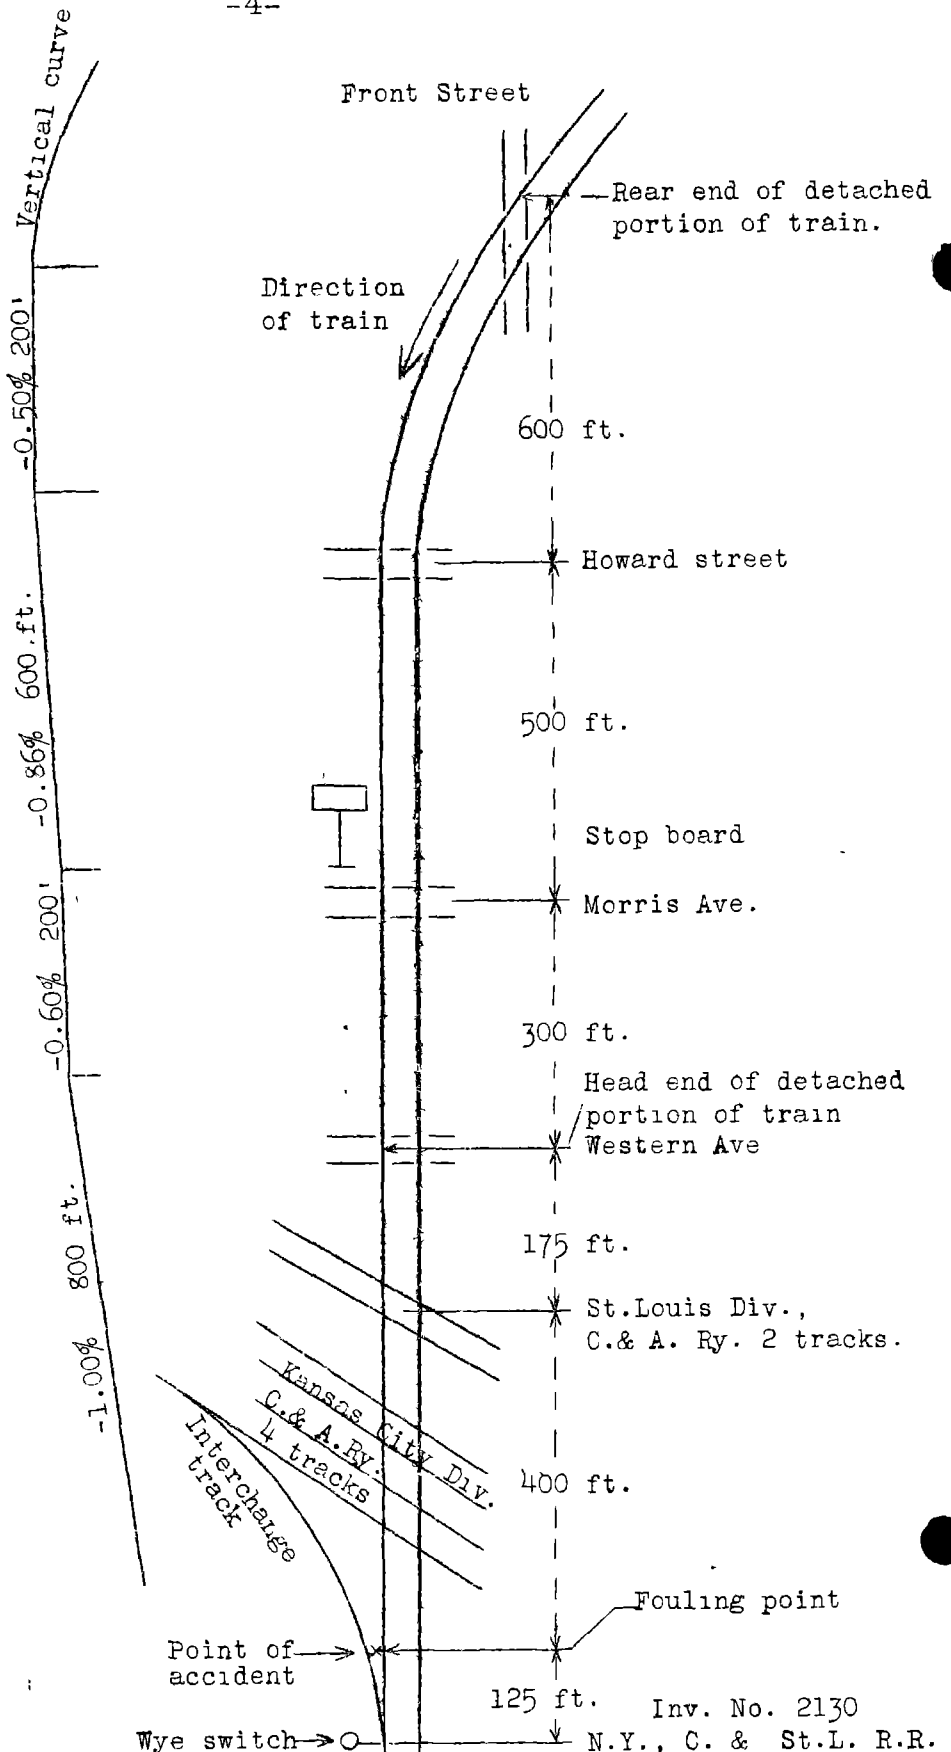
Inv. No. 2130
N.Y., C. & St.L. R.R.
Bloomington, Illinois,
Dec. 31, 1936

The tracks of the New York, Chicago & St. Louis Railroad, hereinafter referred to as the N.Y.C. & St.L., cross those of the Chicago & Alton Railway, hereinafter called the C. & A., at Alton Junction, approximately one mile west of Bloomington passenger station; 279 feet west of the center of the most westerly C. & A. track of this crossing, a trailing point switch, used as an interchange between the two railroads, leads off the N.Y.C. & St.L. west-bound track to the north. The collision occurred at the fouling point between this interchange track and the N.Y.C. & St.L. main track. Approaching this point from the east there is a compound curve to the left, 800 feet long, having a maximum curvature of 5 degrees, 57 minutes, followed by a tangent approximately 1500 feet long; the collision occurred at a point 1475 feet west of the receiving end of this tangent. The gradient is 1.00 percent descending for west-bound trains for a distance of 850 feet immediately preceding the point of accident.

The railroad crossing is not protected by interlocking and a time table rule requires all trains to come to a full stop before moving over it, regardless of the position of the governing signal. A stop board is located at a point approximately 500 feet east of the crossing, and 1,000 feet east of the point of accident. Four city street crossings intersect the N.Y.C. & St.L. tracks east of the railroad crossing, within a distance of 1,500 feet.

This accident was caused by failure to set brakes on the detached portion of a train left standing on a grade.

A rule requiring the use of hand brakes for the purpose of holding detached portions of trains on grades should be put into effect.
