INVESTIGATION NO. 2573

THE NEW YORK, CHICAGO & ST. LOUIS RAILROAD COMPANY

REPORT IN RE ACCIDENT

AT EDWARDSVILLE, ILL., ON

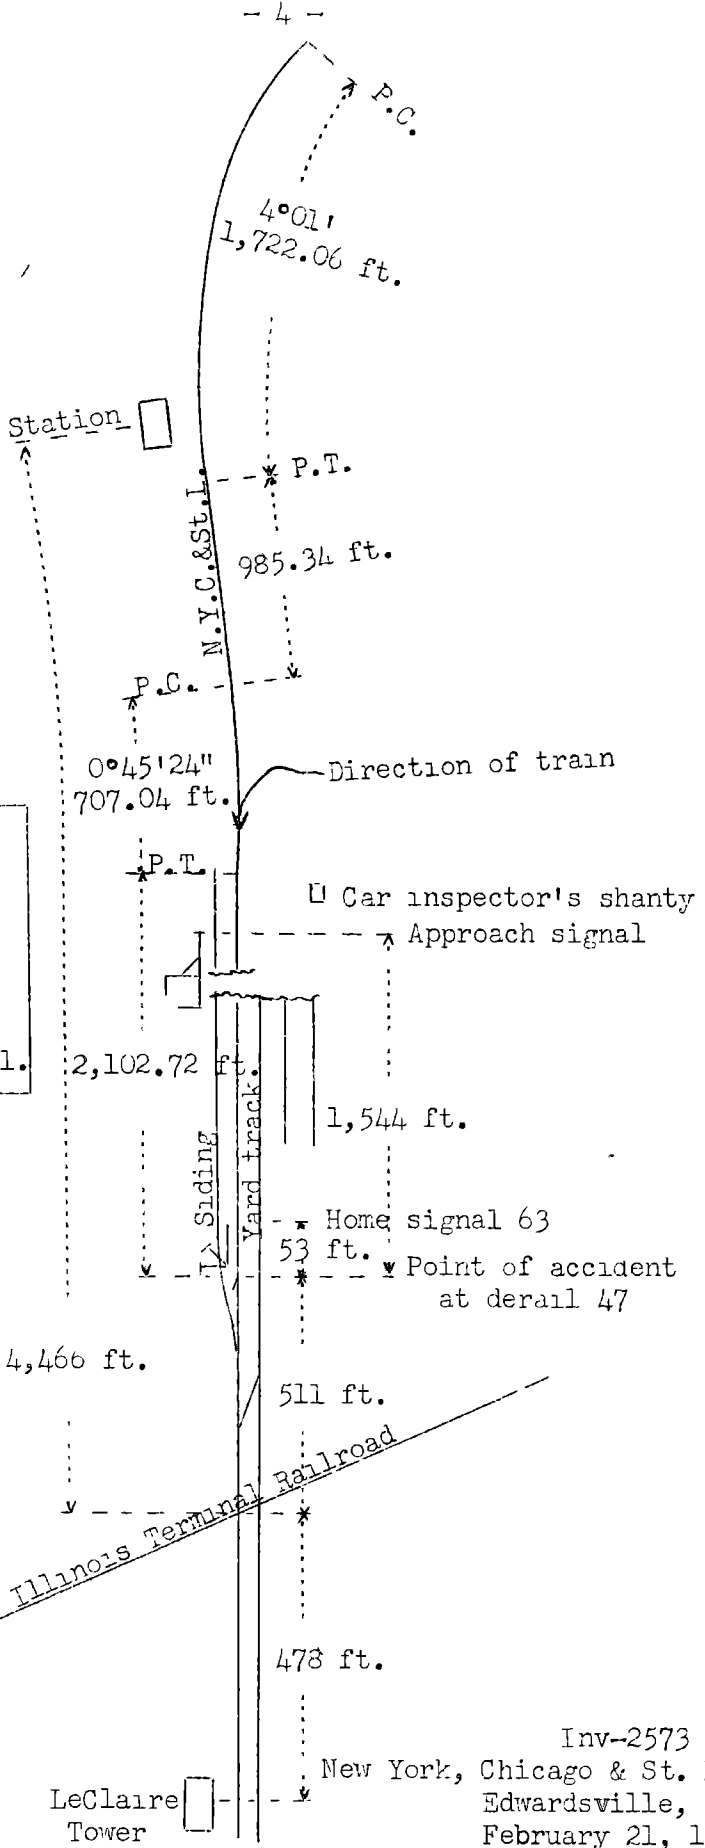
Inv-2573
 New York, Chicago & St. Louis Railroad
 Edwardsville, Ill.
 February 21, 1942

Location of Accident and Method of Operation

Only the engine-truck wheels were derailed at the derail. The No. 1 pair of driving wheels bent the derail switch point and riser rail in such manner that no further derailment occurred at that point, but when the engine-truck wheels encountered the frog of a trailing-point switch 430 feet farther west, the general derailment occurred.

The engine was derailed to the north and stopped, badly damaged, on its left side and at an angle of 45 degrees to the track. The tender was torn loose from the engine and stopped on its left side, south of the track at a point about 200 feet west of the engine. The first three cars were derailed but remained upright and in line with the track. The front truck of the fourth car was derailed.
