INVESTIGATION NO. 2462  
THE NEW YORK, CHICAGO & ST. LOUIS RAILROAD  
COMPANY

REPORT IN RE ACCIDENT  
AT PANAMA, ILL., ON  
NOVEMBER 14, 1940

Accident near Panama, Ill., on November 14, 1940, caused by  
broken rail, as a result of presence of transverse  
fissures.

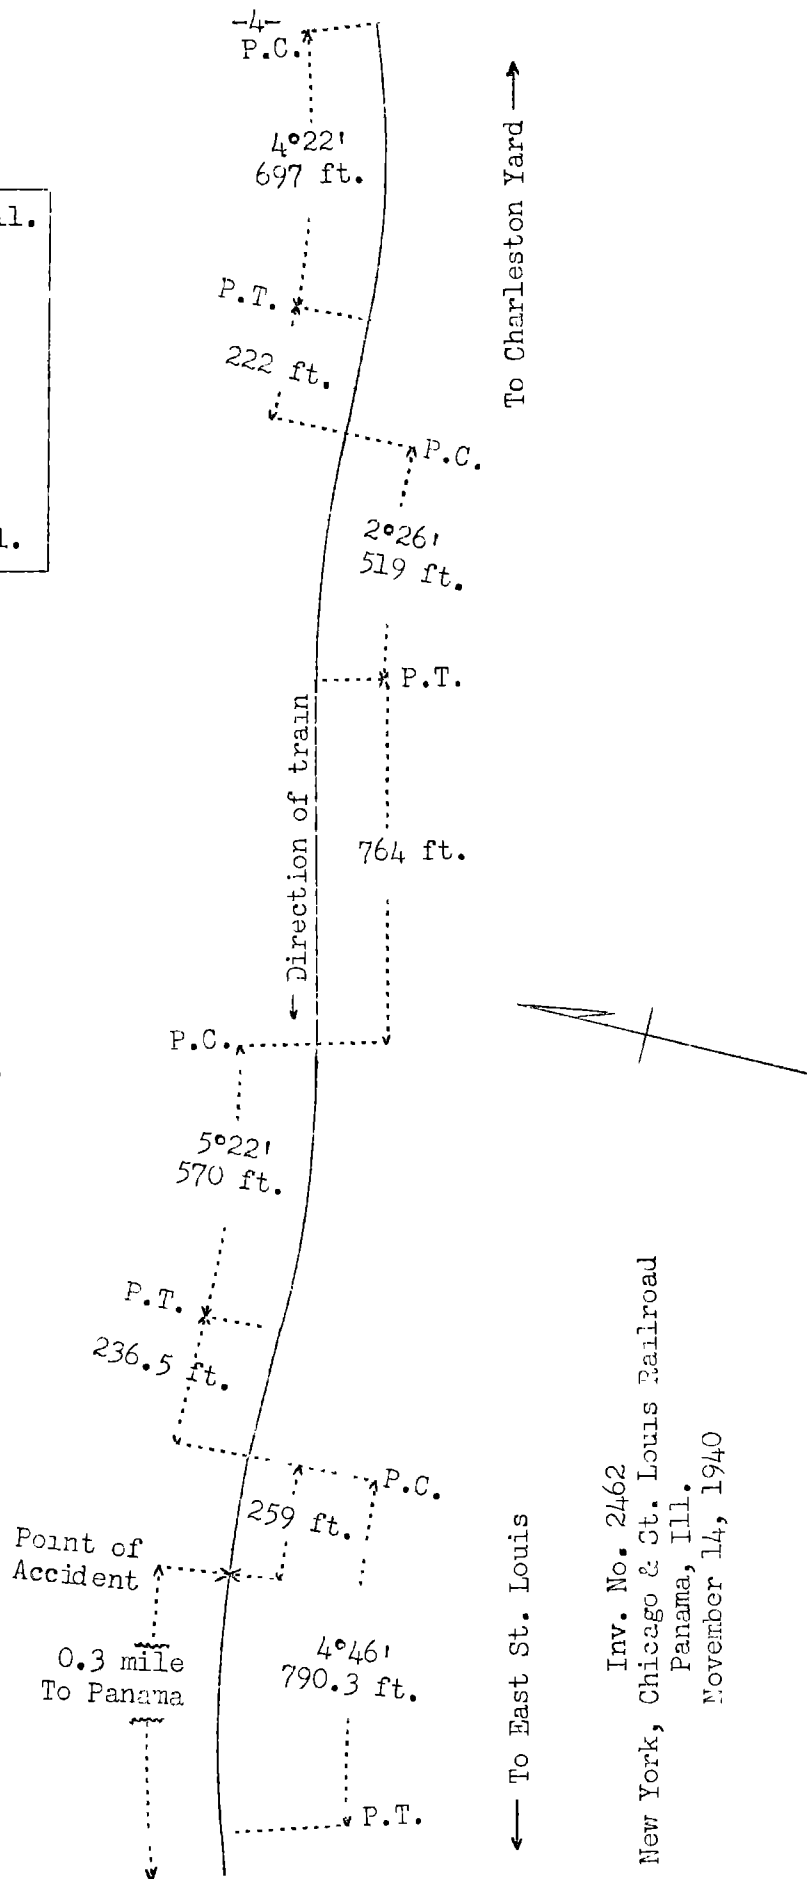
- BROKEN RAIL  
NORTH SIDE OF TRACK

Rail broke into 22 pieces  
shaded portion indicates  
missing fragments

Leaving or  
west end

Seventeen pieces of the broken rail were assembled; the broken pieces varied in length from 11 to 77 inches. Transverse fissures were evident at 11 of these fractures. At the most easterly break the transverse fissure reached the running surface and the gage side of the rail. The fracture showed two distinct elliptical areas, an inner area and an outer area. The inner area was smooth, and the outer area was smooth at some places. The fissure was discolored and the entire break was darkened to some extent.

The rail involved, which was on the north side of the curve, was broken into 23 pieces and at 11 of these fractures transverse fissures were found. The most easterly fracture occurred 25 inches west of the eastern end of the rail, 3-1/2 inches west of the angle bar and 2 inches west of a tie. This fracture showed a transverse fissure, 1 inch high and 2 inches wide, which covered 62 percent of the cross-sectional area of the head of the rail and extended to the running surface and to the gage side of the rail. The discoloration of the fissure indicated that it had existed for some time.
