INTERSTATE COMMERCE COMMISSION

REPORT OF THE DIRECTOR

NEW YORK, CHICAGO & ST. LOUIS RAILROAD

INVESTIGATION NO. 2089

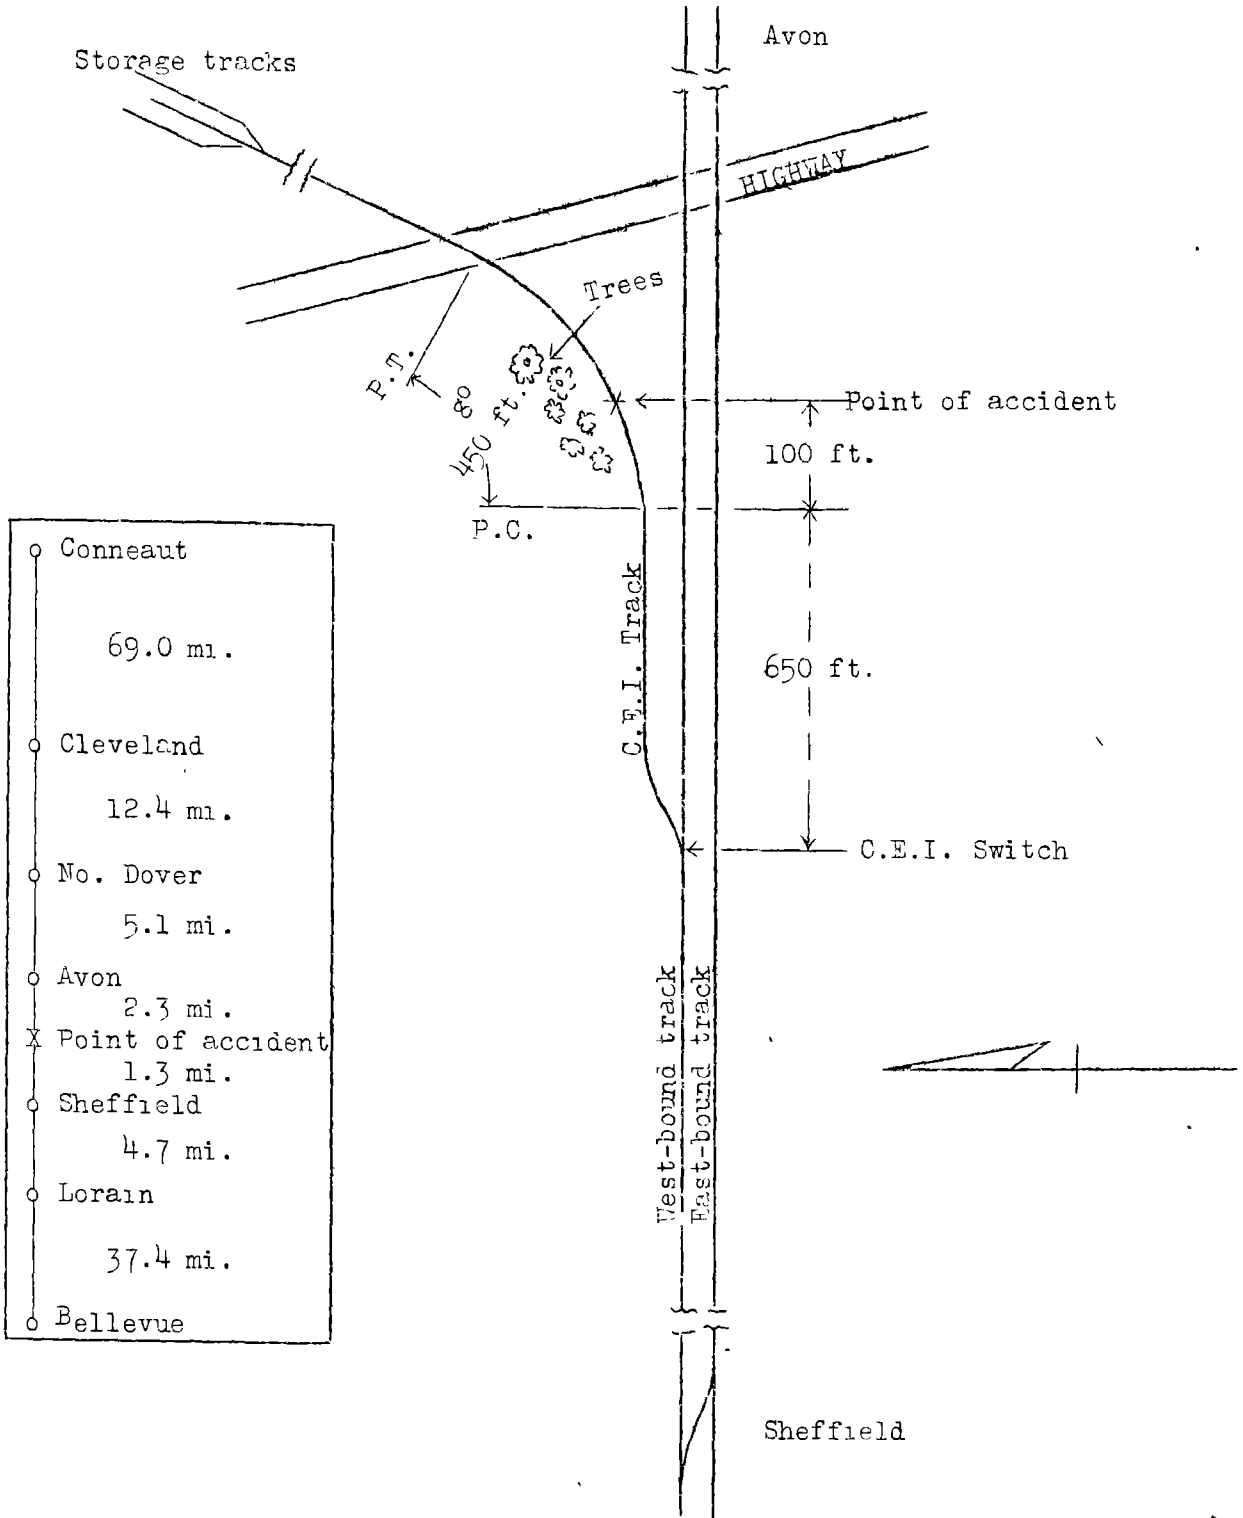
Inv. No. 2089  
N.Y.C. & St.L.R.R.  
Sheffield, Ohio  
August 7, 1936

This accident occurred on the Cleveland Division, which extends between Conneaut and Bellevue, Ohio, a distance of 132.2 miles. In the vicinity of the point of accident this is a double-track line over which trains are operated by timetable, train orders, and an automatic block-signal system; extra trains require running orders and work trains require work orders. The accident occurred on a side-track leading off the west-bound main track to the north, through a trailing point switch located about 19.8 miles west of Cleveland, or 2.3 miles west of Avon and 1.3 miles east of Sheffield. This track, known as the C.E.I. track, joins two storage tracks serving the Cleveland Electric Illumination power plant at Avon Lake, the storage tracks being located about 2,000 feet from the main track switch. The C.E.I. track parallels the main track on a tangent for a distance of about 650 feet then curves to the left on an 8° curve for a distance of 450 feet to the center of a highway crossing and is then tangent for a distance of 900 feet to the storage tracks. Due to trees on the inside of the curve, the view of the track ahead is restricted to a distance of approximately 350 feet from either direction; the grade is slightly descending eastward and is about 0.33 percent at the point of accident, which occurred at a point 750 feet from the main-track switch and 100 feet east of the west end of the curve.
