INTERSTATE COMMERCE COMMISSION

ACCIDENT ON THE

NEW YORK, CHICAGO & ST. LOUIS

ST. MARYS, OHIO

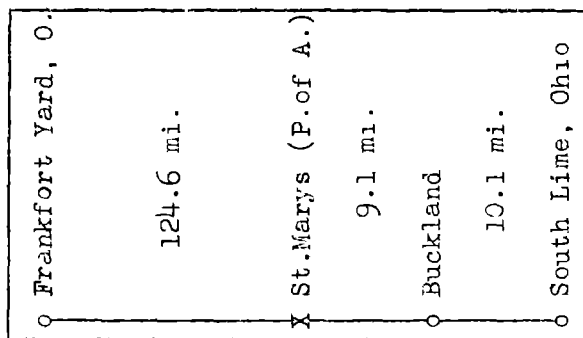
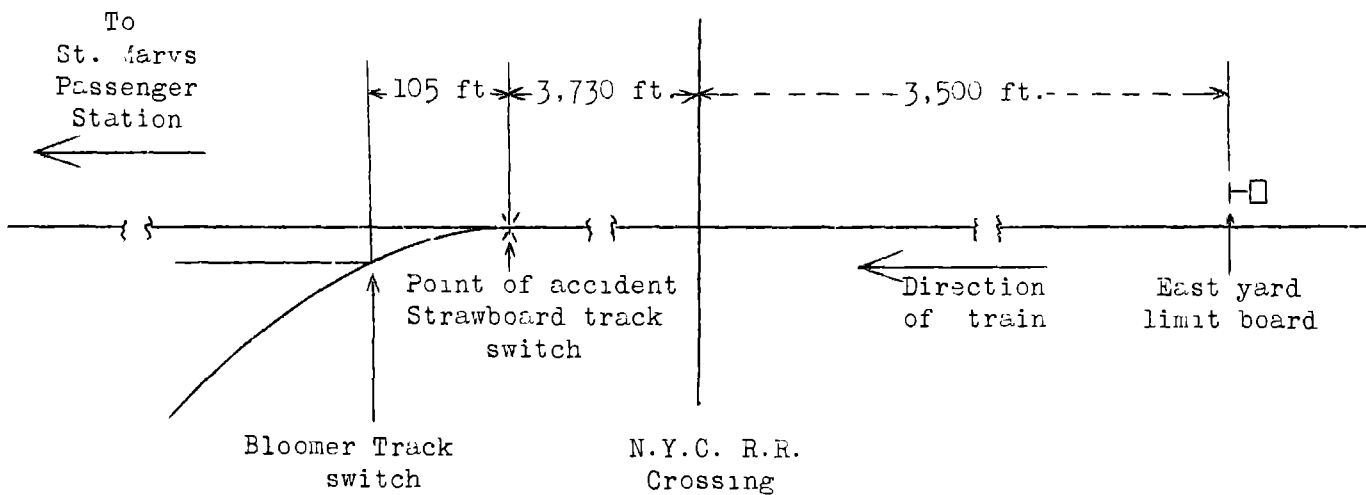
Inv. No. 2155
New York, Chicago & St. Louis RR
St. Marys, Ohio
March 6, 1937

The Strawboard track has a facing point switch with a No. 11 turnout, and diverges to the left in a southwesterly direction. The switch stand, which is of the standard intermediate type, is located south of the main track and is 8 feet, 8½ inches high; it is equipped with targets set at right angles to each other; when the switch is closed a white diagonal target is displayed to an approaching train; when it is lined for a movement to the Strawboard track the red target is displayed. The red target consists of two 11½ inch circular discs, one on each side of the spindle, each being perforated by a 3½ inch hole; the centers of these discs are 7 feet 8 inches above the head block ties. Another industrial track, known as the Bloomer Track, diverges to the north from the Strawboard track and parallels the main track on the south. The switch stand to this track is of the low type and is located 105 feet west of the Strawboard main track switch. At the time of the accident a number of box cars were standing on the Bloomer track. The maximum speed authorized for freight trains, between South Lima and Frankfort, is 50 miles per hour.
