INVESTIGATION NO. 2567
THE NEW YORK, CHICAGO & ST. LOUIS
RAILROAD COMPANY
REPORT IN RE ACCIDENT
AT WEST STEECA, N. Y., ON
FEBRUARY 6, 1942

Accident at West Seneca, N. Y., on February 6, 1942,
caused by runaway cars fouling main track.

Inv. No. 2567
 New York, Chicago & St. Louis Railroad
 West Seneca, N. Y.
 February 6, 1942

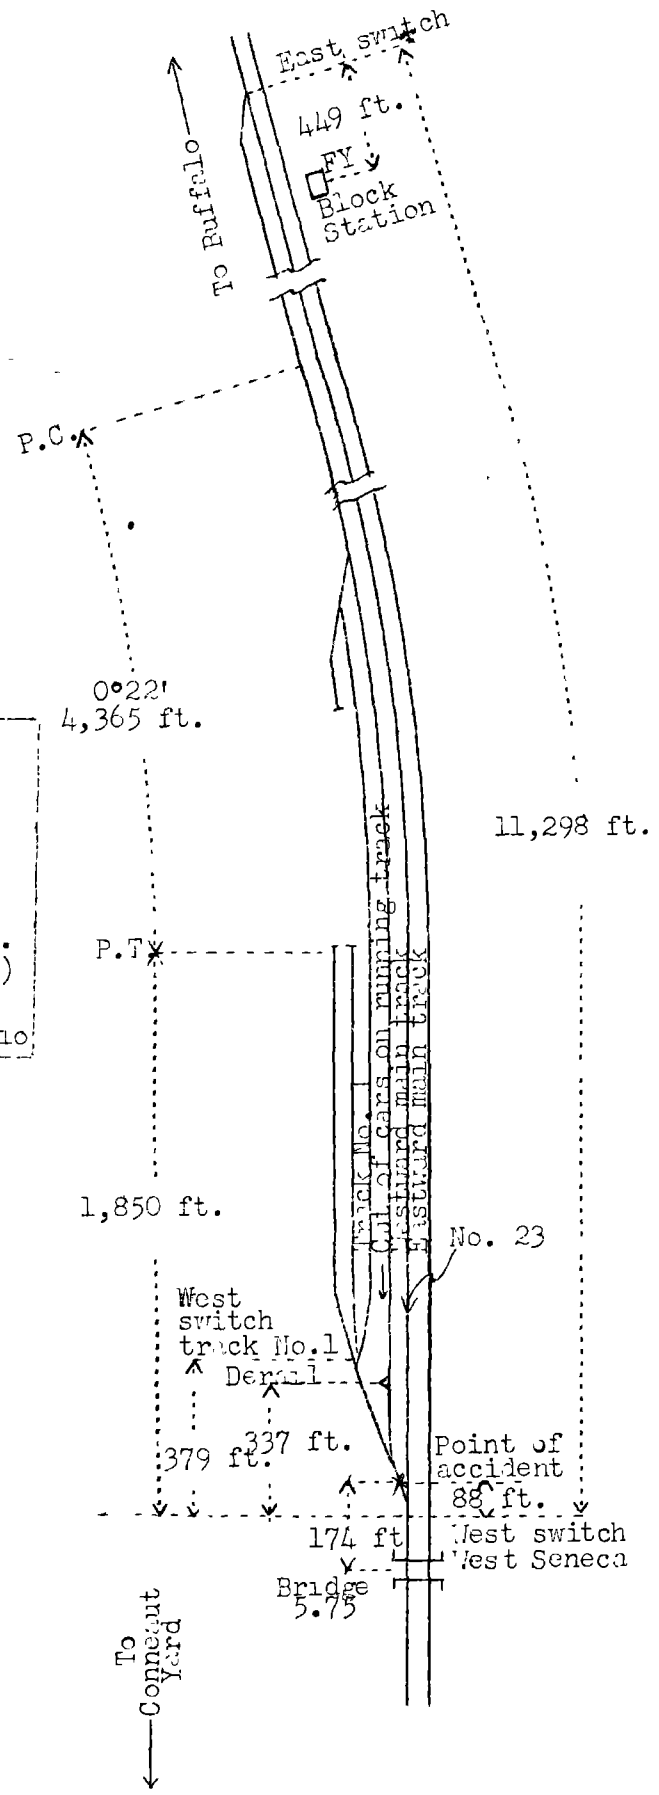
- o Buffalo, N. Y. 2.4 mi.
- o Tift Yard 0.6 mi.
- o FY Block Station 2.1 mi.
- x West Seneca, N. Y. (Point of accident) 110.3 mi.
- o Conneaut Yard, Ohio
