RAILROAD ACCIDENT INVESTIGATION

Report No. 4113

THE NEW YORK, NEW HAVEN AND HARTFORD RAILROAD COMPANY

DECEMBER 10, 1966

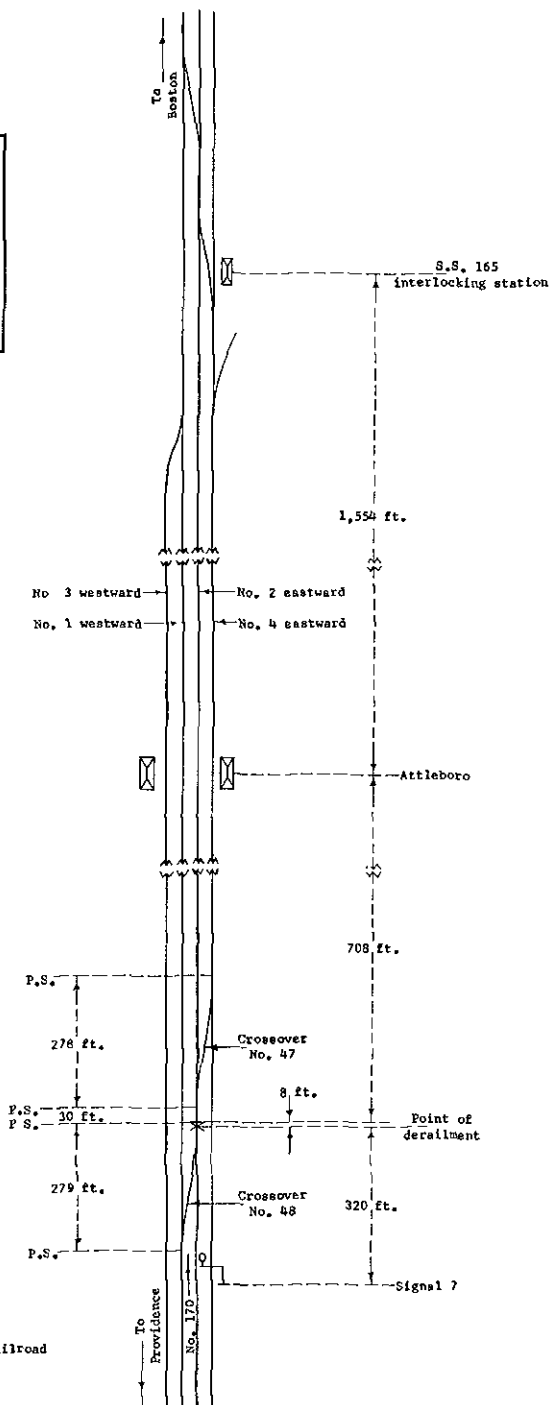
The New York, New Haven and Hartford Railroad
 Attleboro, Mass.
 December 10, 1966

The initial derailment occurred on track No. 2 within interlocking limits, about 8 feet west of the east switch of crossover No. 48 and 716 feet west of Attleboro station. The general derailment occurred on track No. 2, at the frog of the west turnout of crossover No. 47.

The first mark of derailment was a wheel mark on a pipe connection to a gas heater for the east switch of crossover No. 48. It appeared at a point $7\frac{1}{2}$ inches south of the field side of the south rail and about 8 feet west of the east switch of crossover No. 48. It indicated that a pair of wheels, apparently the rear wheels of the front truck of the 2nd car, had derailed to the south at this point. Four feet 2 inches farther eastward, a wheel mark appeared on a switch rod for the east switch of crossover No. 48, 11 inches south of the gage side of the north rail. Eight inches farther eastward, a pair of wheel marks appeared on switch plates, 11 inches from the gage side of the north rail and 11 inches from the field side of the south rail. Wheel marks on the field side of the south rail extended eastward on the ties to the west turnout of crossover No. 47. At a point about 60 feet east of the switch of this turnout, a scrape mark appeared on the field side of the head of the south rail of the turnout. It extended about 50 feet eastward to the frog of the turnout, indicating that the derailed pair of wheels had been diverted southward at the turnout and had struck the frog, causing the general derailment. Eastward from the frog, the structure of track No. 2 was destroyed or heavily damaged throughout a considerable distance.
