INTERSTATE COMMERCE COMMISSION

REPORT OF THE DIRECTOR OF THE BUREAU OF SAFETY CONCERNING AN
ACCIDENT ON THE NEW YORK, NEW HAVEN & HARTFORD RAILROAD
AT ATLANTIC, MASS., ON NOVEMBER 29, 1933.

February 14, 1934.

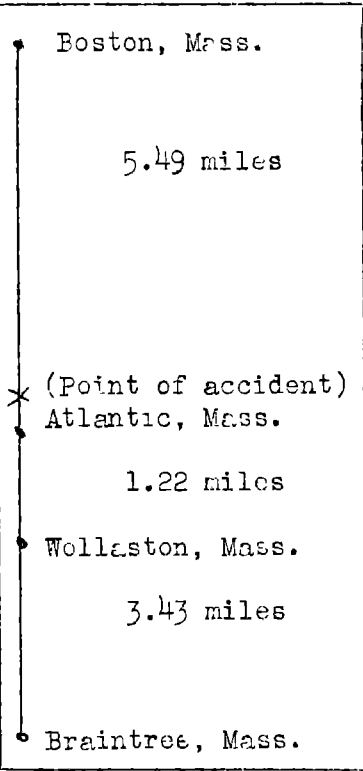
Inv. No. 1369

Interlocking station U-436 is located in the bridge cabin on drawbridge 509; the interlocking is an electric plant with 36 working levers and 5 spare levers. The signals involved in the accident, named in order from drawbridge 509 southward, are

Point of accident

as follows: drawbridge home signal 36L, home signal 38L, route signal 30L, semiautomatic signal 0-6.0, and automatic signal 0-6.4. These signals are located approximately 235 feet, 1,295 feet, 2,385 feet, 4,375 feet, and 7,075 feet, respectively, south of drawbridge 509. Signals 36L and 38L are mounted on bracket posts. When route signal 30L displays a proceed indication it not only indicates that the approaching train is to use track 2 but it also means that that track is unoccupied as far as home signal 38L. The indications displayed are green, for proceed; yellow over green for approach-restricting, requiring that trains approach next signal at restricted speed; yellow over red for approach, requiring that trains reduce speed at once and proceed at restricted speed, not exceeding 25 miles an hour, prepared to stop at the next signal; and red, for stop. In this instance the first train stood on track 2 at drawbridge signal 36L, with its rear end just north of signal 38L, and the following signal indications should have been displayed for the second train; signal 0-6.4, approach-restricting; signal 0-6.0, approach; route signal 30L, proceed; and signal 38L, stop.
