INTERSTATE COMMERCE COMMISSION

REPORT OF THE DIRECTOR OF THE BUREAU OF SAFETY IN RE
INVESTIGATION OF AN ACCIDENT WHICH OCCURRED ON THE
NEW YORK, NEW HAVEN & HARTFORD RAILROAD AT EAST
TAUNTON, MASS , ON NOVEMBER 11, 1931.

December 8, 1931.

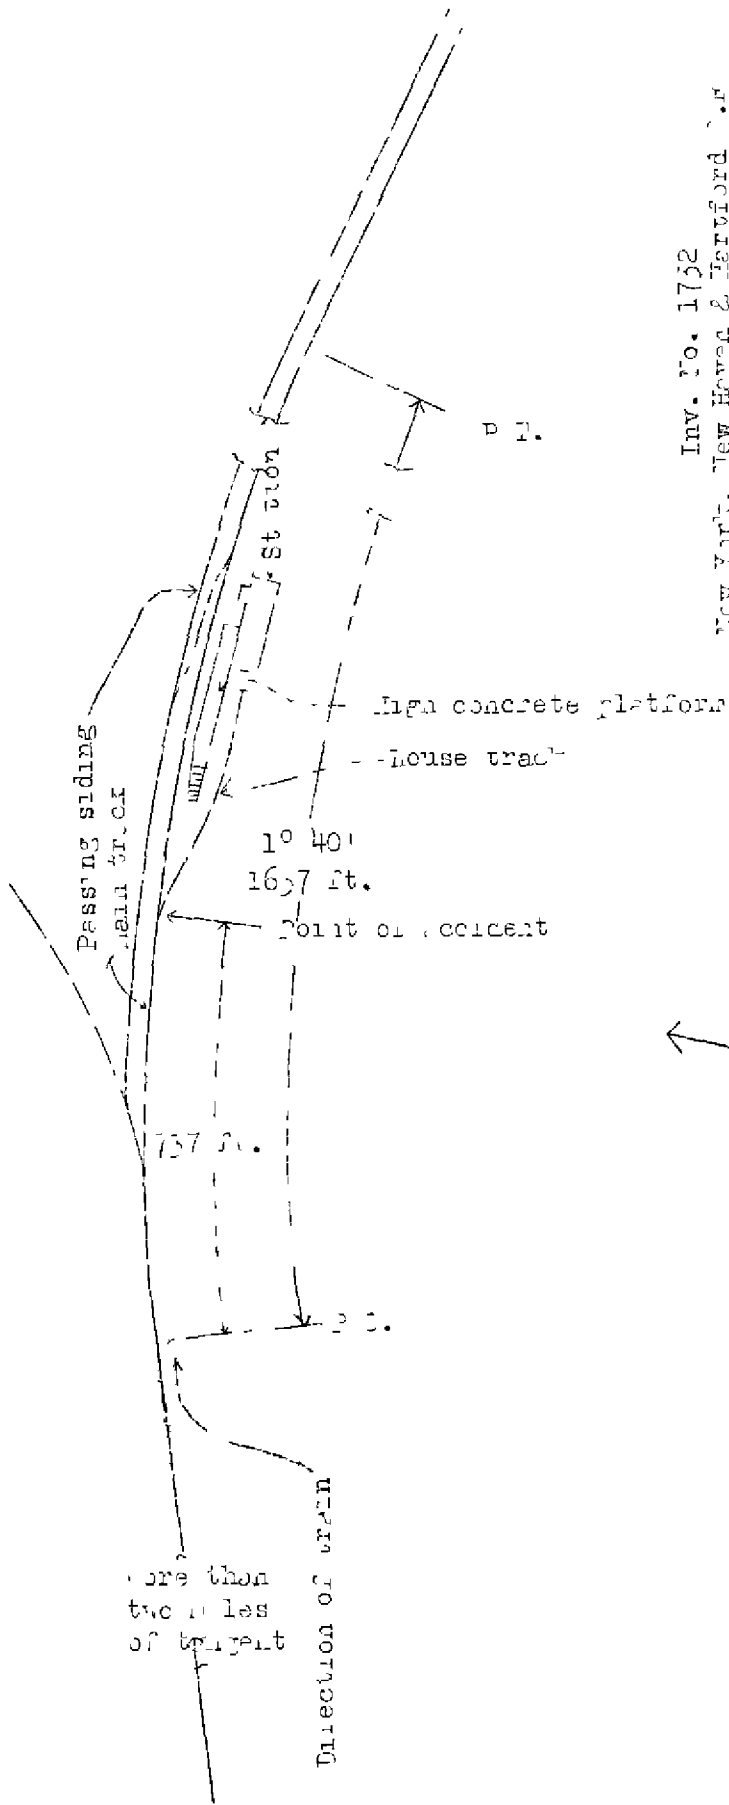
Inv. No. 1752
 New York, New Haven & Hartford R.R.
 East Taunton, Mass.
 Nov. 11, 1931

Engine 3002, its tender, and the first four cars were derailed; the engine struck the end of the high concrete platform at the station, between the main track and house track, and then turned over on its left side on the main track with its head end 227 feet south of the point of switch, while the tender was behind the engine and extended diagonally across from the main track to the house track. The first car came to rest to the right of the house track and opposite the tender, while the other three derailed cars came to rest across the house track in zig-zag fashion, behind the tender. The employees injured were the engineman, fireman and head brakeman.

This accident was caused by a cocked or partly-opened switch, due to malicious tampering.

The indications are that the switch lock was forced open and the switch lever turned, but only enough so that the switch lamp would continue to display a green or proceed indication to the engineman of a southbound train, as though the switch was lined for the main track, but instead the switch points had been actually opened far enough to permit a wheel flange to split the switch and derail the train. No defective condition was found about the track or equipment which would have caused the accident. The last time the switch had been used was on November 7, four days prior to the accident; the section foreman walked by the switch around noon of the day of the accident and at that time he observed that the switch was in proper condition, while the track walker filled the
