INTERSTATE COMMERCE COMMISSION

REPORT OF THE DIRECTOR OF THE BUREAU OF SAFETY CONCERNING AN ACCIDENT ON THE NEW YORK, NEW HAVEN & HARTFORD RAILROAD AT FALL RIVER, MASS., ON JUNE 30, 1934.

August 8, 1934.

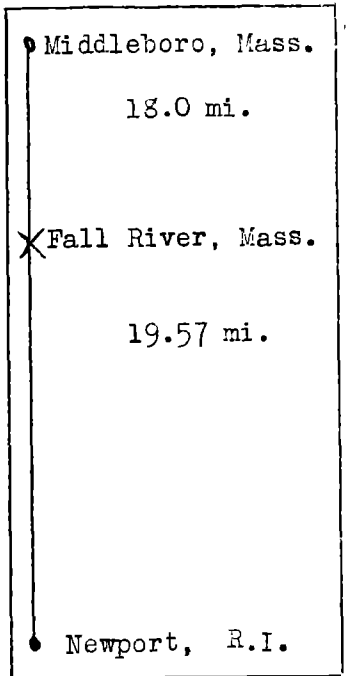
Inv. No. 1918
New York, New Haven & Hartford RR
Fall River, Mass.
June 30, 1934

Point of accident
