REPORT OF THE DIRECTOR

ACCIDENT ON THE

NEW YORK, NEW HAVEN & HARTFORD RAILROAD

INVESTIGATION NO. 2352

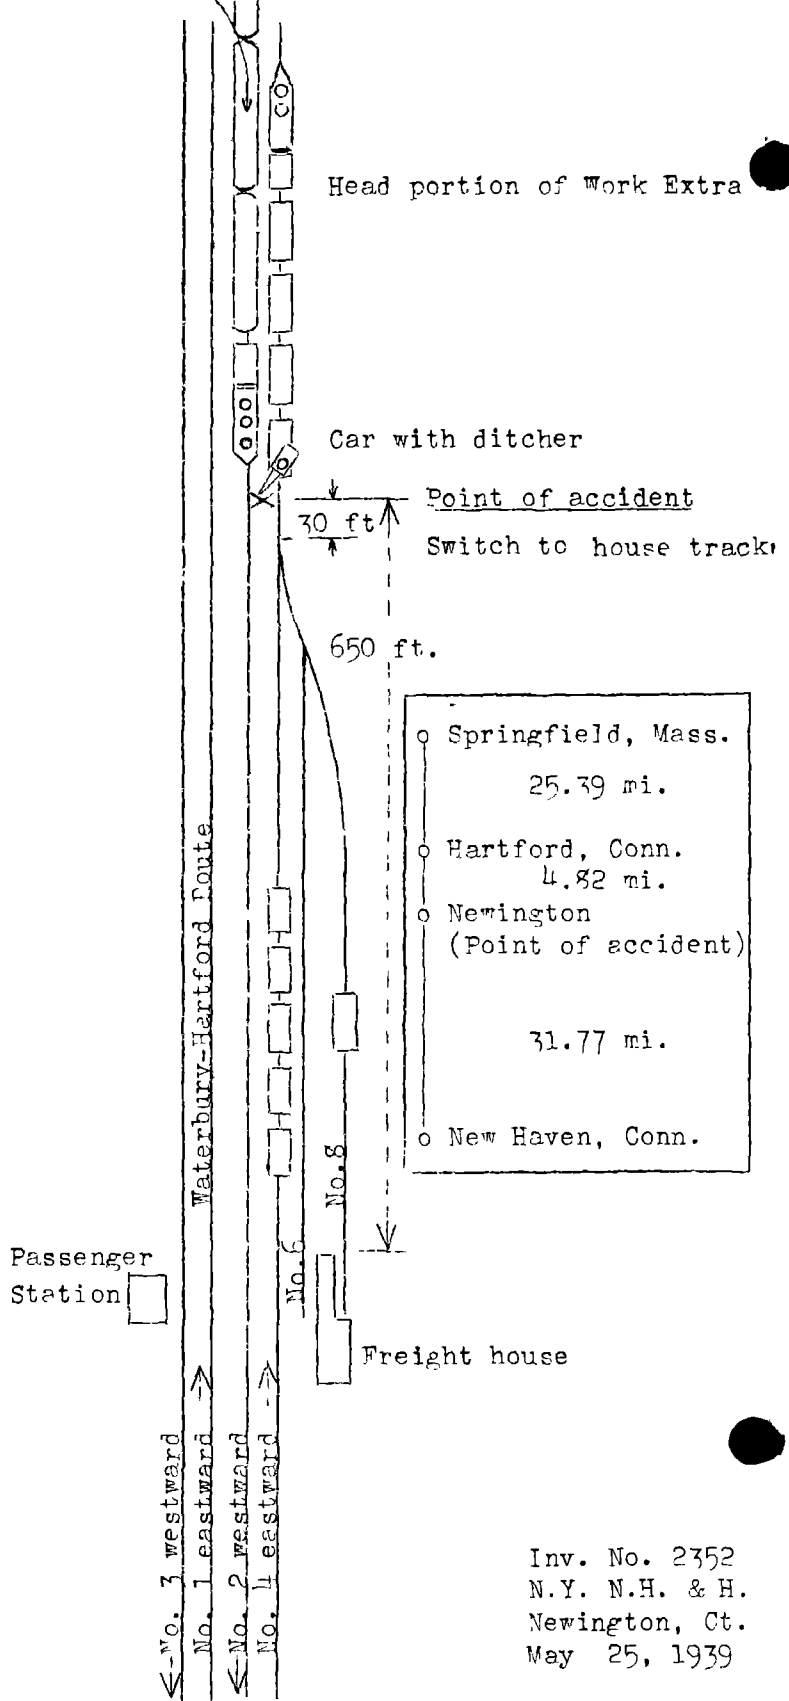
Inv. No. 2352
N.Y. N.H. & H.
Newington, Ct.
May 25, 1939

Approximate movement of cab and boom of ditcher, fouling train No. 159

Direction of No. 169

This accident was caused by the improper manipulation by an inexperienced assistant during the temporary absence of the regular operator of the controlling lever of the ditcher at the time of a switching movement of the work train, permitting the boom to foul the adjacent track and strike the passenger train, and by failure to set the hand brake properly to prevent the lateral movement of the ditcher.

It is recommended that responsible officials of this railroad take immediate action to instruct thoroughly employees assigned to ditching machines.
