INTERSTATE COMMERCE COMMISSION

REPORT OF THE DIRECTOR OF THE BUREAU OF SAFETY IN RE INVESTIGATION OF AN ACCIDENT WHICH OCCURRED ON THE NEW YORK, NEW HAVEN & HARTFORD RAILROAD AT READVILLE, MASS., ON JANUARY 19, 1931.

February 20, 1931.

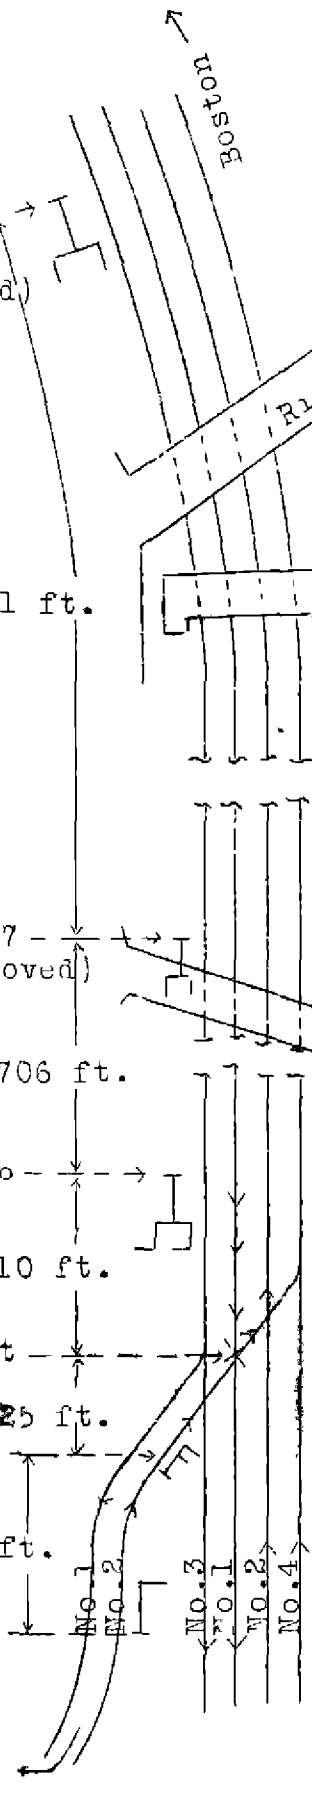
INR. No. 1684,
New Haven & Hartford R.R.
New York, Readville, Mass.
January 19, 1931

Chickering is located 1.98 miles west of Boston and the territory between Chickering and Readville Transfer, a distance of 8.45 miles, is equipped with the controlled-manual block-signal system. Work of replacing the existing distant signals at the block stations with electric distant signals, and relocating them so as to provide additional braking distance between distant and home signals, has been in progress during the past year. The home signal at Readville is located 1,706 feet west of old westbound distant signal 97, while the new distant signal location is 3,751

New Distant Signal
(No blade on mast
for movement involved)

Old Distant Signal 97 -
(Blades had been removed)

Home Signal 96 -

Point of accident -

feet east of the old distant signal. Old distant signal 97 and home signal 96 were of the one-arm, two-position, lower-quadrant type, mechanically operated. About two hours prior to the accident the lever of the interlocking plant in/181 controlling old distant signal 97 was locked so as to hold the arm in the horizontal or caution position, in which position it is required that trains reduce speed at once and proceed at restricted speed, not exceeding 25 miles per hour, prepared to stop at next signal; the intent was to safeguard the relocating of the new distant signal, but a few minutes prior to the accident the blade and lamp of old distant signal 97 were removed, before the installation of the new distant signal was completed.
