INVESTIGATION NO. 2512
THE NEW YORK, NEW HAVEN AND HARTFORD
RAILROAD COMPANY
REPORT IN RE ACCIDENT
NEAR SAUNDERSVILLE, MASS., ON
JULY 22, 1941

Kind of accident: Rear-end collision

Accident near Saundersville, Mass., on July 22, 1941,
caused by authorizing a motor hand-car to occupy
a main track without providing proper protection
for its movement.

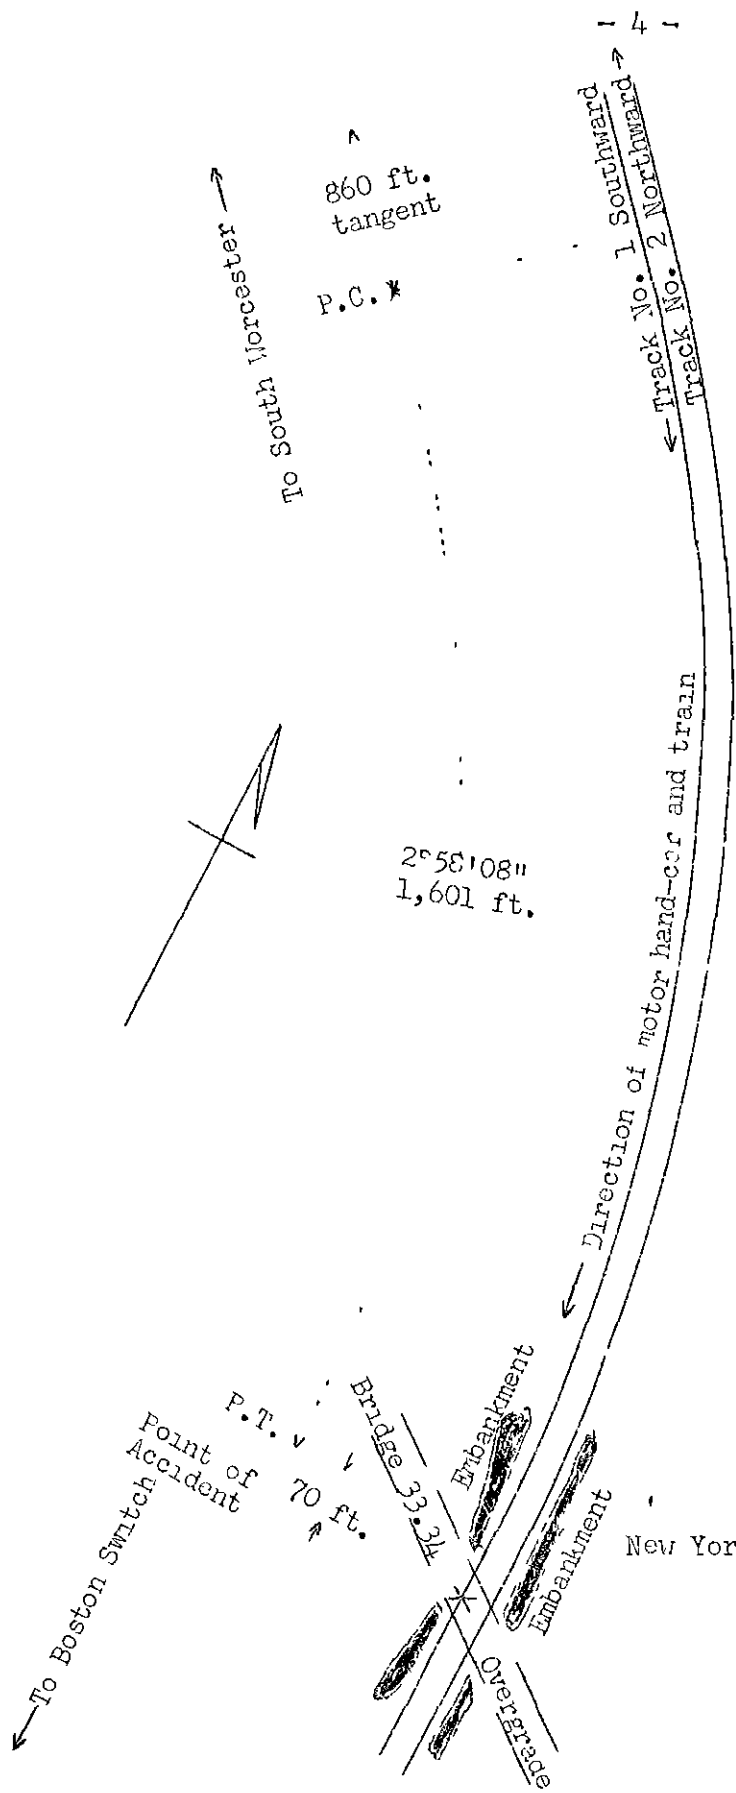
Inv-2512
 New York, New Haven and Hartford Railroad
 Saundersville, Mass.
 July 22, 1941

| X | Point of Accident |

Location of Accident and Method of Operation
