REPORT NO. 2013

Railroad: New York, New Haven & Hartford

Location: Westport, Conn.

Kind of accident: Rear-end collision

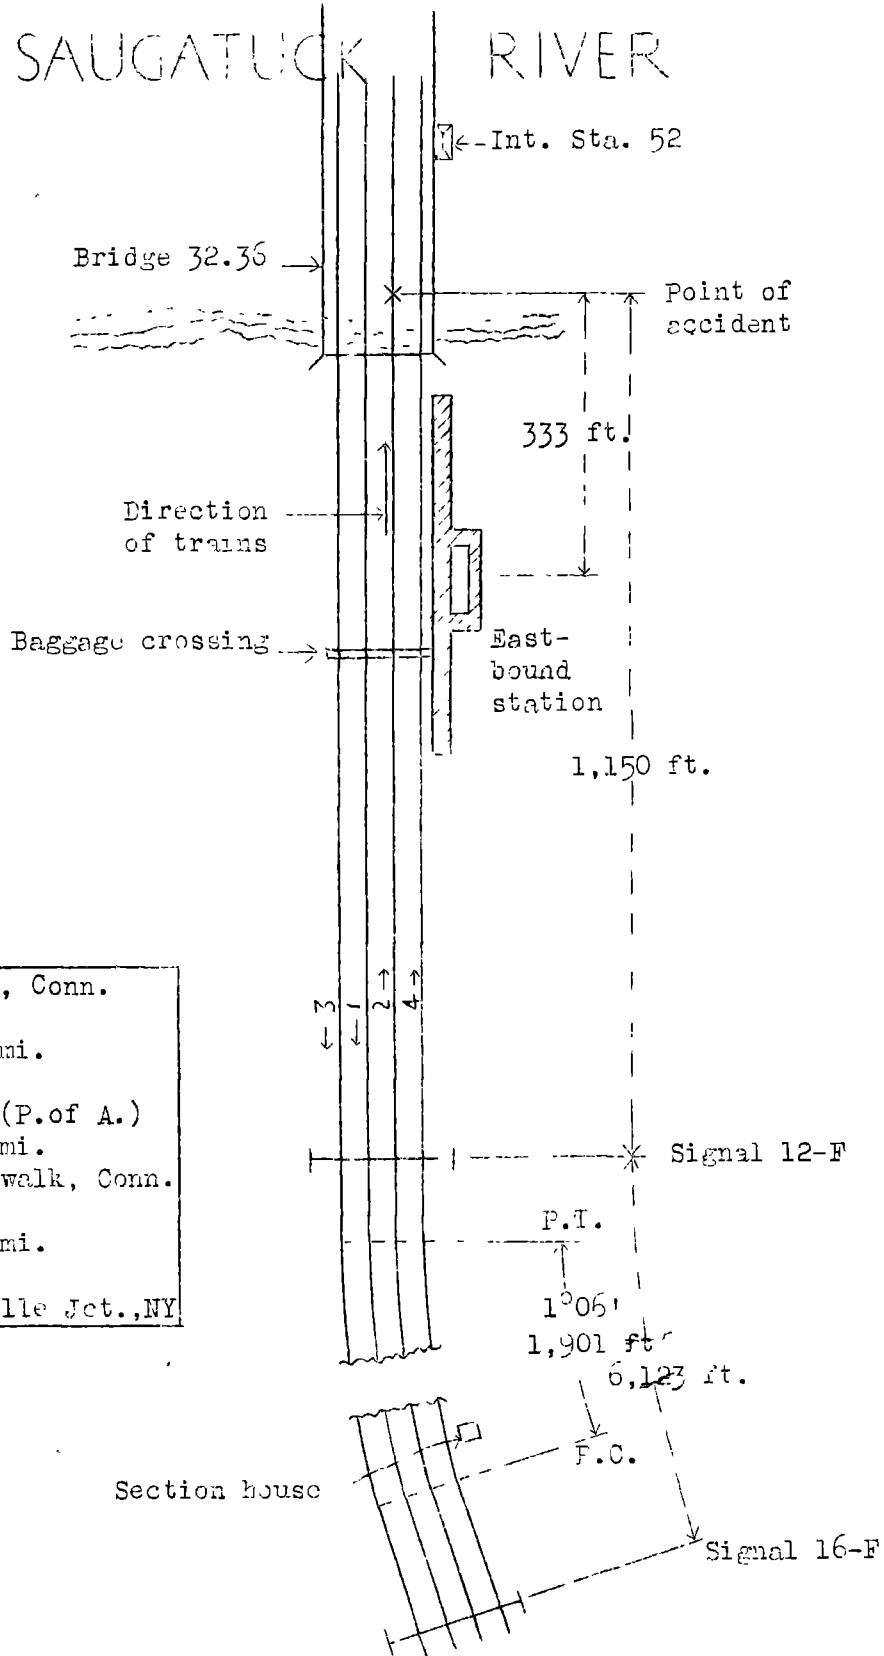
Inv. No. 2013
New York, New Haven & Hartford R.R.
Westport, Conn.
Sept. 27, 1935.

The signals involved in the accident are distant signal 16-F and home signal 12-F, located 7,273 feet and 1,110 feet, respectively, west of the point of accident. They are of the 2-arm, 2-position, semaphore type, with normal-clear color-light indications, illuminated by high-power lamps, and are mounted on signal bridges spanning the tracks. The signal indications displayed were easily discernible. Distant signal 16-F may be seen from the locomotive of an east-bound train approximately 1.75 miles west of the point of accident.

As a result of the accident motor 097, the leading motor of the extra train, plunged off the south side of the drawbridge and into the Saugatuck River; the second motor, 093, was bottom up and hanging over the edge of the bridge, while the third motor, 0108, stood upright, diagonally across track 2, headed south-east. Several cars in the two trains were badly damaged and fire which broke out in the wreckage added materially to the damage. The employee killed was the engineman of Extra 097-093-0108; the employees injured were the fireman and the brakeman of that train, and the flagman of Train Second NE-2.
