ACCIDENT ON THE
NEW YORK, ONTARIO & WESTERN RAILWAY

MIDDLETOWN, N.Y.

SEPTEMBER 28, 1937

INVESTIGATION NO. 2201

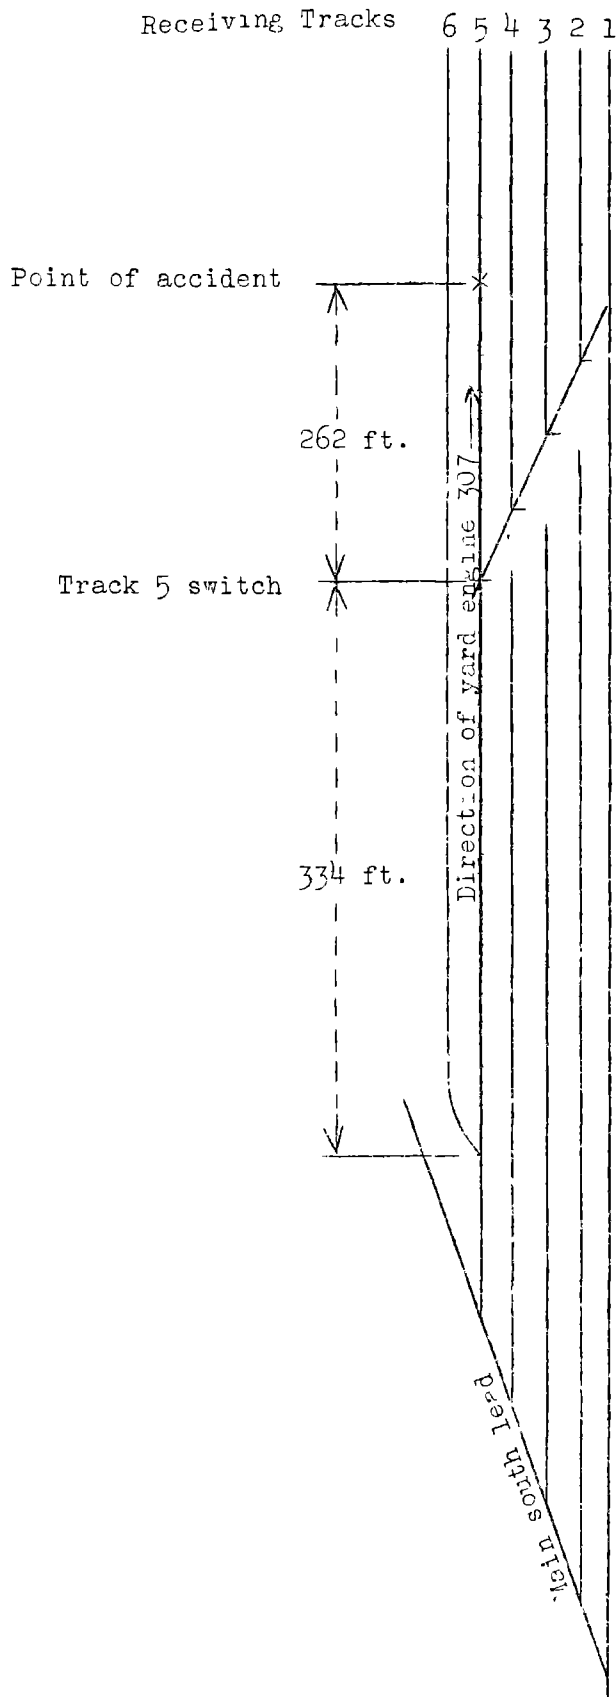
Inv. No. 2201
New York, Ontario & Western Ry.
Middletown, N.Y.
Sept. 28, 1937

At the time of the accident 52 cars, composing the make-up of Train AW-2, were standing on track 5, with the hand brakes set on about 10 of the cars at the south end; track 4 was unoccupied.
