INTERSTATE COMMERCE COMMISSION

REPORT OF THE DIRECTOR OF THE BUREAU OF SAFETY CONCERNING AN ACCIDENT ON THE NICHOLAS, FAYETTE AND GREENBRIER RAILROAD NEAR SAW MILL, W. VA., ON NOVEMBER 15, 1934.

December 29, 1934.

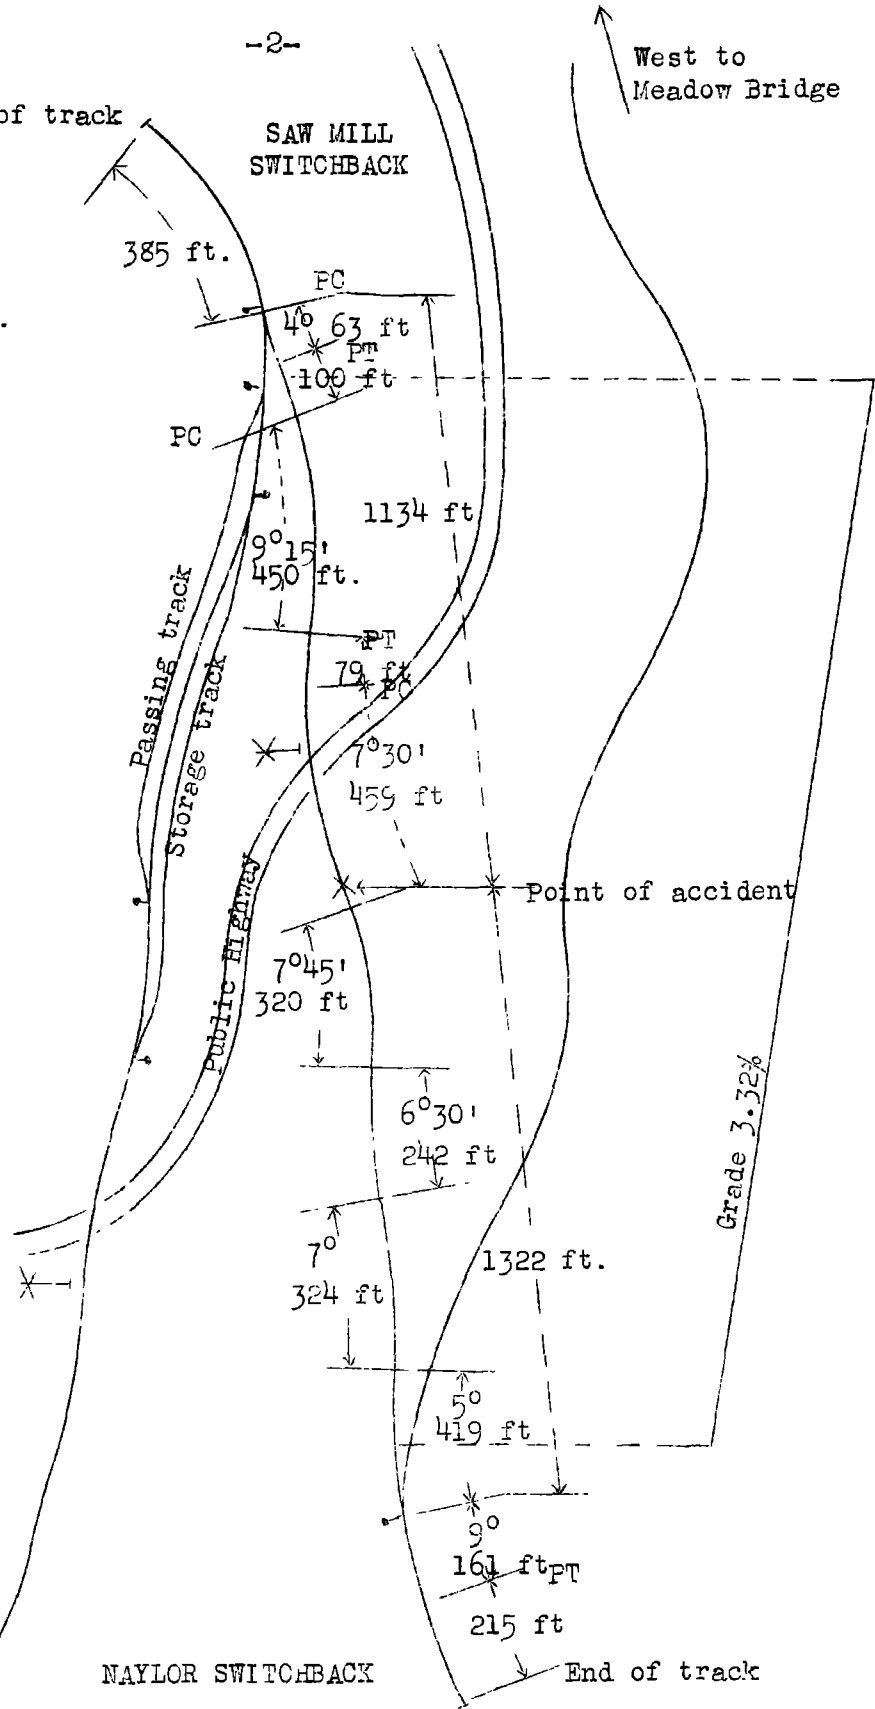
Inv. No. 1944  
 Nicholas, Fayette & Greenbrier RR.,  
 Saw Mill, W. Va.  
 Nov. 15, 1934

Point of accident

curred on the middle leg at a point about half way between Saw Mill and Naylor switchbacks, the distance between these switchbacks being 2,456 feet. This track consists of a series of short curves with only two short tangents near Saw Mill, the curves ranging from 4° to 9°15', and the accident occurred at the eastern end of a 7°30' curve. The grade from Saw Mill to Naylor is 3.32 percent ascending. On the lower leg of the track just east of Saw Mill switchback, the track is paralleled on the south by a passing track and on the north by a storage track 1,015 feet and 1,031 feet in length, respectively.
