INVESTIGATION NO. 2818
THE NORFOLK & PORTSMOUTH BELT LINE
RAILROAD COMPANY
REPORT IN RE ACCIDENT
NEAR BERKLEY, VA., ON
AUGUST 23, 1944

Accident near Berkley, Va., on August 23, 1944, caused
by failure to provide adequate safeguards for
movements approaching drawbridge.

Inv-2818
 Norfolk & Portsmouth Belt Line Railroad
 Berkley, Va.
 August 23, 1944

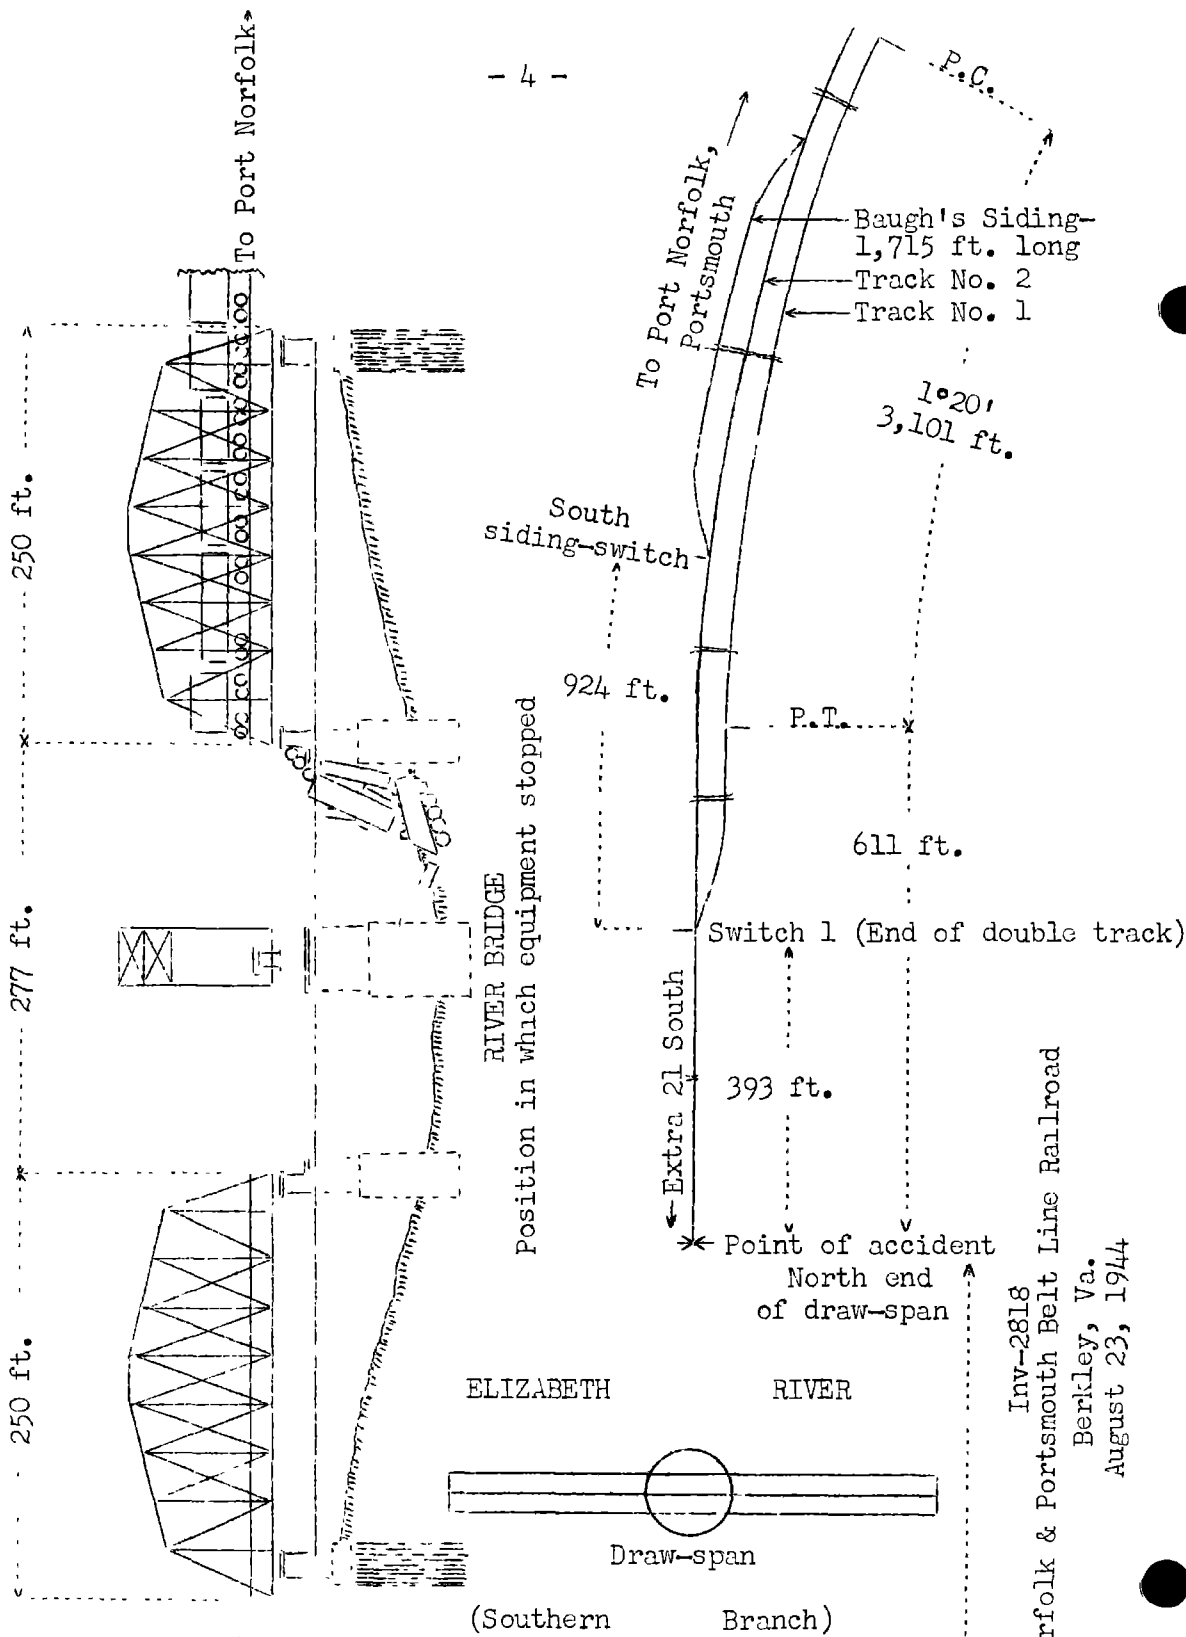
Location of Accident and Method of Operation

This accident occurred on that part of the railroad extending southward from Port Norfolk, Portsmouth, to Berkley, Va., 4.53 miles. Between Port Norfolk and a point approximately 4 miles southward this was a double-track line, and the remainder was a single-track line. The tracks of the double-track line from east to west are hereinafter referred to as tracks No. 1 and No. 2, and the switch at the south end of the double track is hereinafter referred to as switch 1. The entire line was within yard limits and trains were operated by yard rules. The accident occurred on the single-track line 0.46 mile north of Berkley at a draw-span of a bridge, designated as River Bridge, which spanned the Southern Branch of Elizabeth River. From the north there was a 1°20' curve to the left 3,101 feet, which was followed by a tangent 611 feet to the north end of the draw-span and 1,359 feet southward. The grade for south-bound movements was 0.462 percent ascending throughout a distance of 2,200 feet to the north end of the bridge, and was level over the bridge.

The railroad crossed the river at approximately right angles. The draw-span was of the single-track, steel, through-truss, swing type, and was 277 feet in length. The central pier was of concrete construction, and was 26 feet in diameter. At each end of the draw-span there was a steel truss-span 250 feet in length. The mean low level of the water under the draw-span was 20.5 feet below the base of the rails, and the water was approximately 40 feet deep. The draw-span was in the charge of a bridge tender, and was operated from a cabin located on the draw-span near the central pier. The draw-span mechanism was operated by an electric motor. The normal position of the draw-span was for movement on the railroad. At the time of the accident the draw-span was open for river traffic and was at right angles to the track. There was no sign or signal provided to indicate to trains the location or the position of the draw-span.

In the vicinity of the point of accident a siding, 1,715 feet long and designated as Baugh's Siding, paralleled track No. 2 on the west. The south switch of the siding was 924 feet north of switch 1, and 1,317 feet north of the north end of the draw-span.
