RAILROAD ACCIDENT INVESTIGATION

REPORT NO. 4147

NORFOLK AND WESTERN RAILWAY COMPANY

JULY 17, 1968

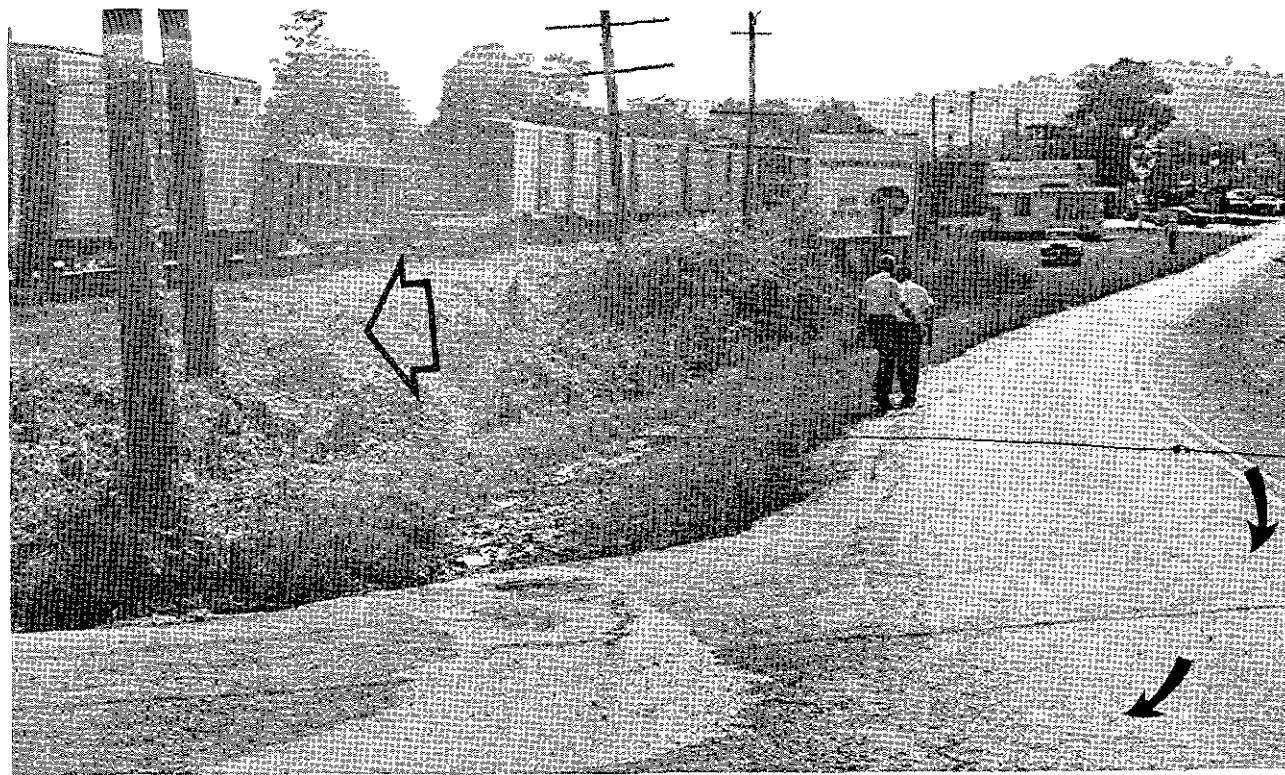
Because of track curvature, and the billboards, shrubbery, trees and structures between West Main Street and the railroad, the view between an eastbound train approaching Haney's Crossing and a southbound highway vehicle nearing the crossing is restricted considerably (see photo). The restricted view at the crossing apparently was an important causal factor in the accident. Since removal of the billboards and

Arrows show directions of train and truck. Note restricted view caused by billboards, structures and trees.

some shrubbery between West Main Street and the railroad would increase sight distance and enhance safety at the crossing, consideration should be given by proper authorities to taking such action

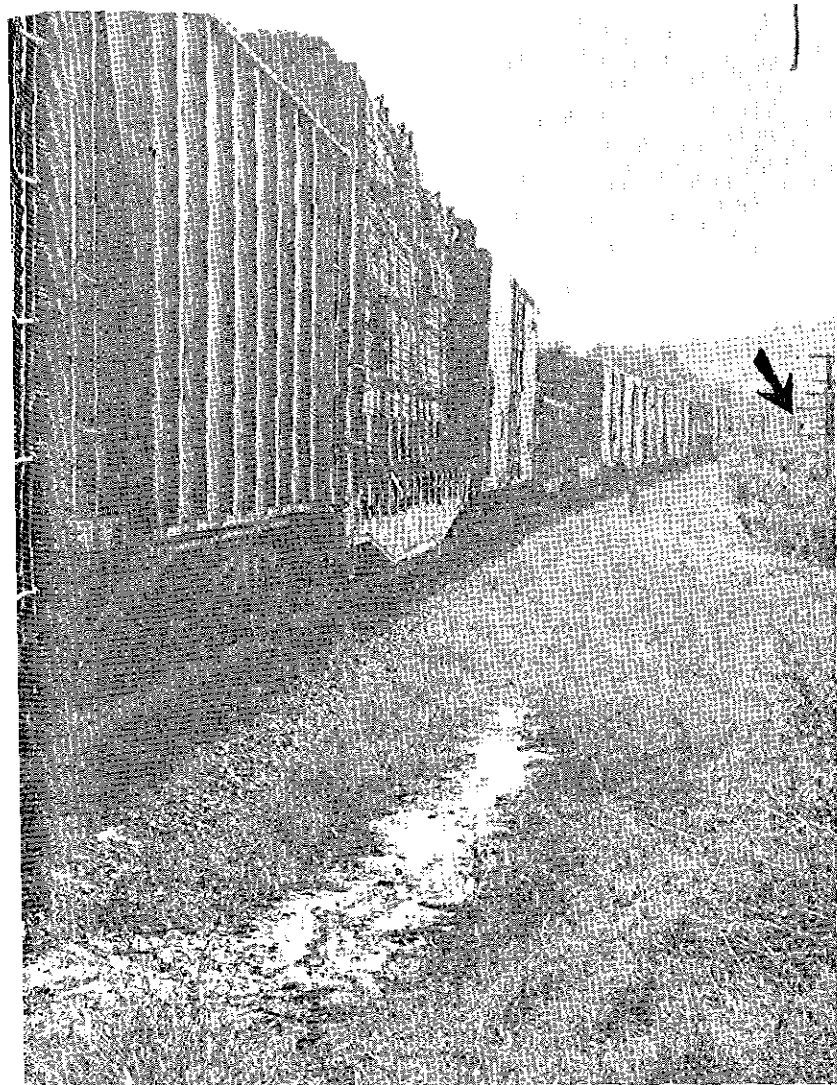
As a highway vehicle moving in either direction on West Main Street turns southward onto Haney's Road, the driver's view of the main track westward is restricted to about 600 feet because of track curvature, two billboards, and the structures, trees and shrubbery between West Main Street and the railroad. The driver's view westward along the track increases as the vehicle nears the automatic crossing signal for southbound traffic. As the vehicle passes the signal, the driver may see any eastbound train approaching the crossing within approximately 1,000 feet.

Truck driver's view in direction from which train approached crossing. Arrow points to approximate location where headlight of approaching train becomes visible.

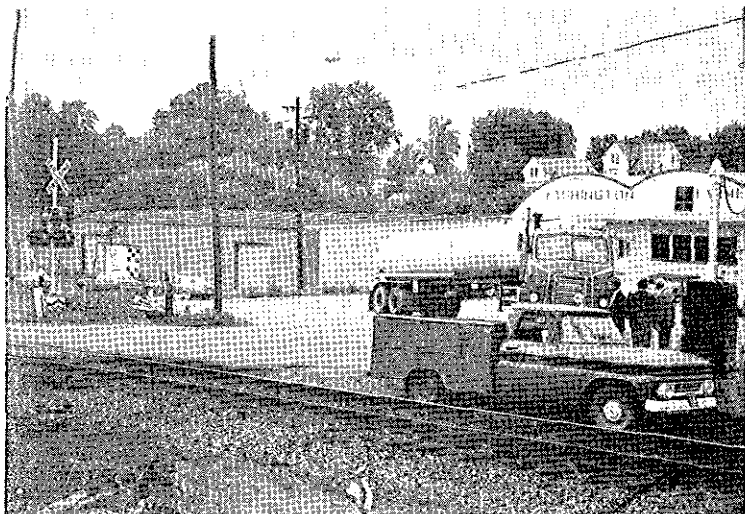
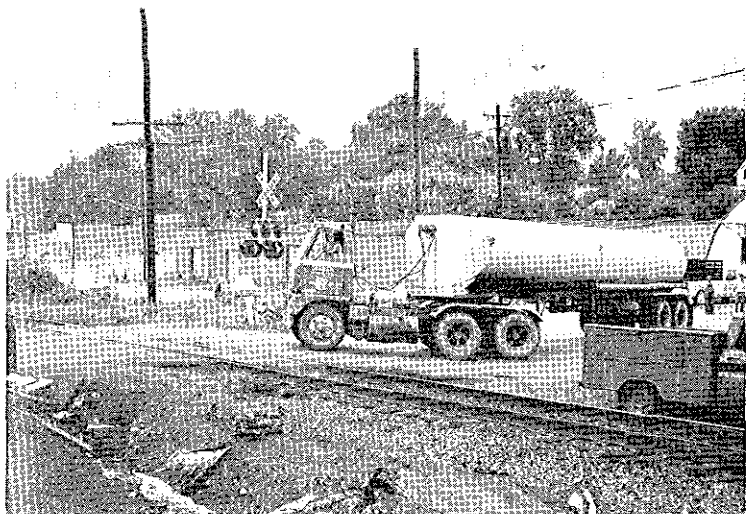
A test was made with a truck similar to the one involved in the accident to determine the characteristics of its movement from the eastward lane of West Main Street onto Haney's Road and to the railroad crossing. It revealed that due to the angle of the intersection of West Main Street and Haney's Road, the truck was required to move over to the westward lane of West Main Street when it reached a point about 60 feet from Haney's Road, so that it would be in a position to negotiate a sharp turn to the right, or south, onto the latter road. The test truck was entirely within the westward lane of West Main Street when it commenced the turn southward. As the vehicle entered Haney's Road and throughout its approach to the track, the tractor and the front portion of the tank semitrailer occupied the northward lane of Haney's Road. The tractor was facing the crossing when it passed the crossing signal for southbound vehicles. Immediately thereafter, it was facing diagonally toward the southward lane of Haney's Road on the other side of the track and slightly toward the track west of the crossing, affording the driver a view of the track westward through the windshield. The tractor continued diagonally toward the southward lane of Haney's Road, entering that lane after traversing the crossing and while the tank semitrailer was moving over the crossing.

In negotiating the turn onto Haney's Road, the driver was required to watch for opposing highway traffic before and after his vehicle entered the westward lane of West Main Street, then watch for opposing traffic on Haney's Road before and after his vehicle entered and occupied the northward lane of that road in approach to the crossing.

Photos showing truck similar to that involved, as it negotiates turn onto Haney's Road and nears crossing.
