RAILROAD ACCIDENT INVESTIGATION

REPORT NO. 4165

NORFOLK AND WESTERN RAILWAY COMPANY

COLBY, OHIO

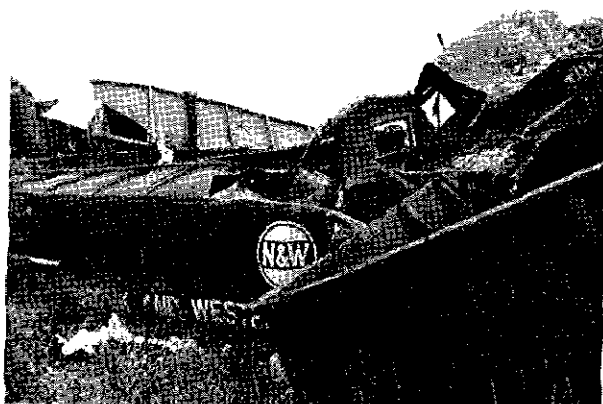
The caboose and the 126th to 129th car, inc , (last four cars) of this train were derailed. The caboose separated from its trucks and stopped upright on the south side of the eastward main track, about 180 feet east of the rear-end collision point. The rear portion of the caboose, including the cupola area was telescoped by the locomotive and derailed equipment of the following train (see following photograph). The caboose and the 128th car were destroyed. The 129th, or last, car was heavily damaged, and the 126th and 127th cars were slightly damaged.

*Caboose of Extra 1381 East*

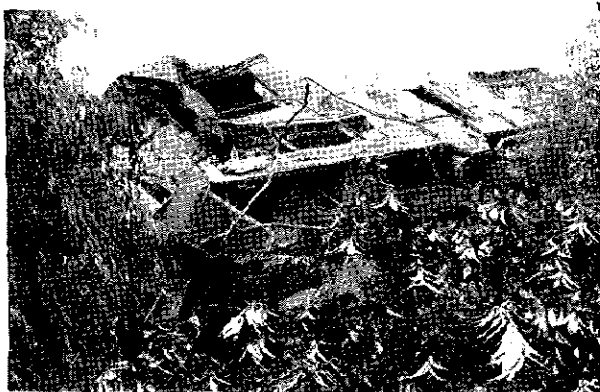
Both locomotive units and the first 10 cars of this train derailed. The first locomotive unit stopped on its right side, and on the south side of the eastward main track, with the front end about 270 feet east of the rear-end collision point (see following photograph). The second unit stopped upright on and in line with the eastward main track structure immediately to the rear of the first unit. The 10 derailed cars stopped in various positions on or near the main track structure, as indicated in Plate No. 2. The two locomotive units were heavily damaged. Of the 10 derailed cars, 7 were destroyed, 2 heavily damaged, and 1 slightly damaged.

*First locomotive unit of Extra 1305 East*
