NATIONAL TRANSPORTATION SAFETY BOARD

RAILROAD ACCIDENT REPORT

SIDE COLLISION AND DERAILMENT OF
NORFOLK & WESTERN RAILWAY
COMPANY TRAINS NOS. 6BS78,
YARD SHIFTER, & 67HNP,
CREWE, VIRGINIA
NOVEMBER 28, 1981

NTSB-RAR-82-3

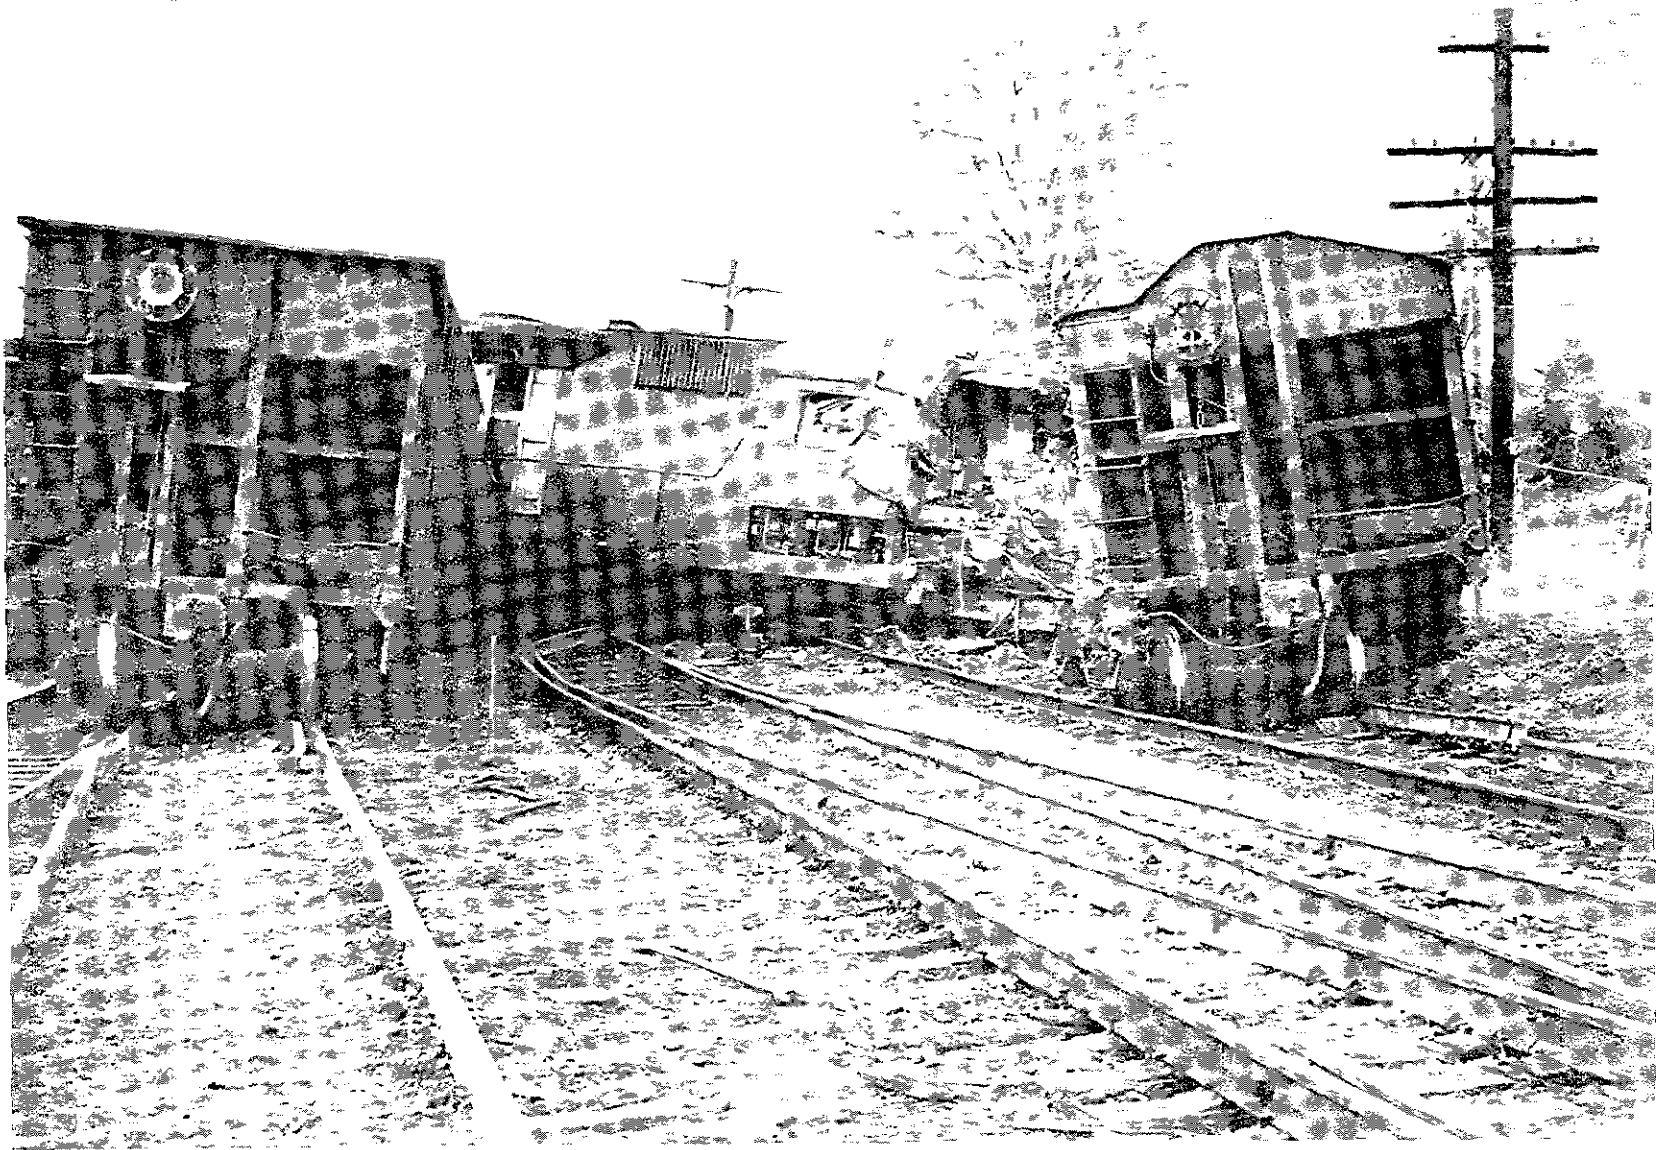
Figure 3.--Lead locomotive 1571.

The lead unit of train No. 6BS78, locomotive No. 1571, was damaged extensively. The short forward hood was demolished and the forward cab wall and the front right side of the cab were severely damaged. (See figure 3.) The front truck and fuel tanks and the underframe appurtenances were torn from the locomotive in the derailment. Locomotive No. 1571 was a model SD-35, 6-axle, 2,500-horsepower diesel-electric locomotive built by the Electro-Motive-Division (EMD) of General Motors. The locomotive unit weighed about 393,000 pounds and was equipped with type 26-L air brakes. The second locomotive unit, No. 1596, was damaged less severely and received only minor damages. Although the fuel tanks of both units were ruptured, there was no fire. The second locomotive unit of train No. 6BS78 was a model SD-40, 6-axle, 3,000-horsepower diesel-electric locomotive, also built by EMD. The unit weighed approximately 392,000 pounds and was equipped with type 26-L air brakes.

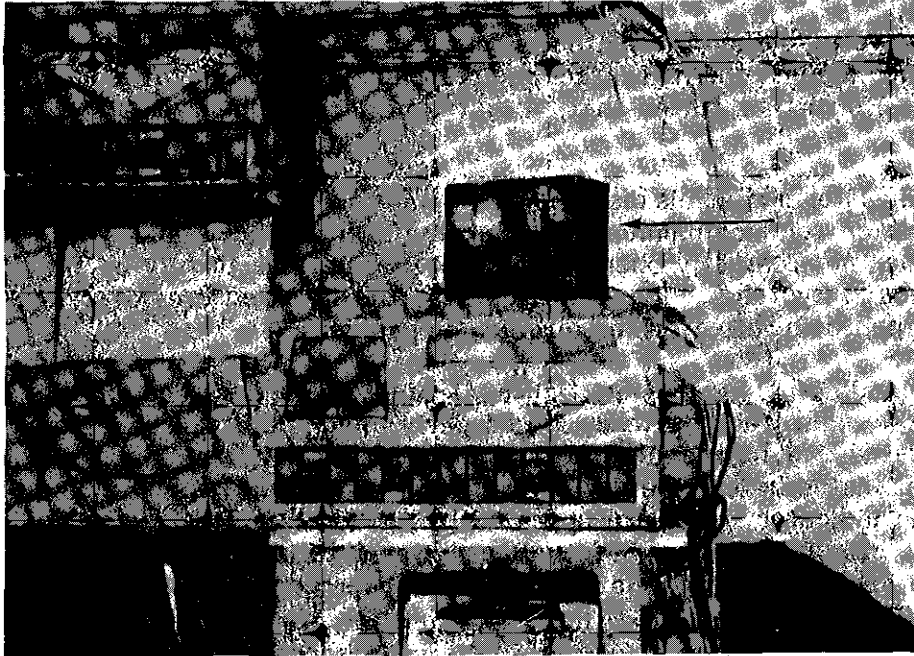
Figure 4.--Indicator lights in yardmaster's office.

The Safety Board believes that the potential false proceed condition existed for more than 3 months. The position indicator lights in the yardmaster's office did not disclose this potential false proceed condition. The indicator lights were connected to and reflected the indication of the automatic block signal. The broken shunt wires prevented the shunt of the misaligned switch from being imposed on the signal circuit.

10. Position indicator lights in the yardmaster's office were not effective in disclosing the false proceed condition.
11. Train No. 6BS78 was operated in accordance with applicable rules and regulations.

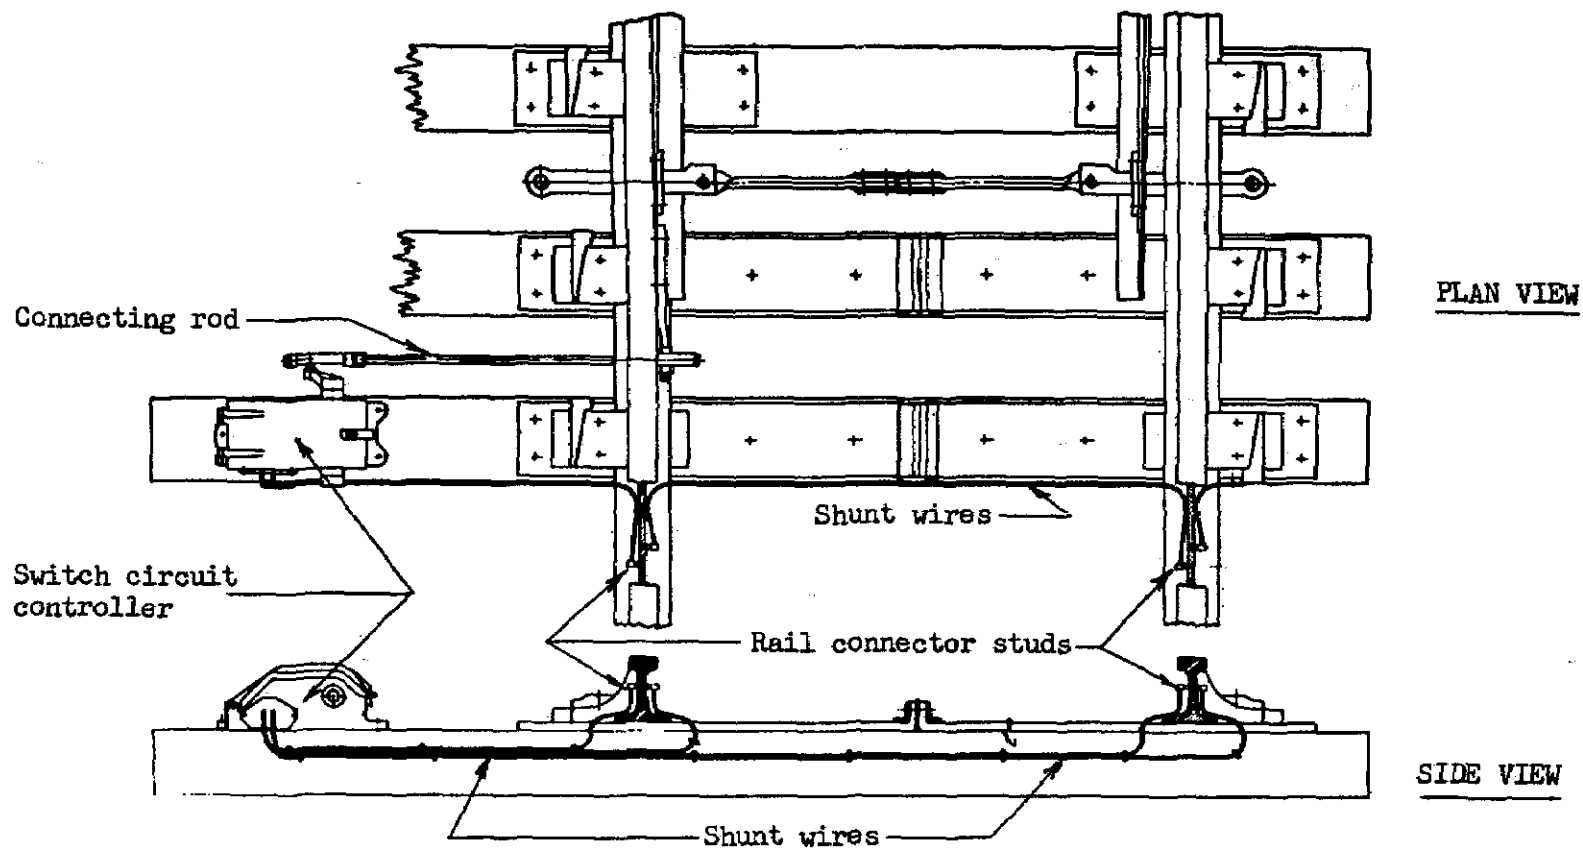
Figure 7.--Switch shunt installation.

The installation of a series break-type circuit, a variation of the shunt circuit which was involved in this accident, would have provided more positive protection. The involved shunt circuit was not designed on the closed-circuit principle and did not have the inherent fail-safe feature of the series break-type circuit. If the involved shunt circuit had been so designed, signal No. 1296 would have displayed a red (stop and proceed) aspect because of the unconnected shunt wires. The display of such a red (stop and proceed) aspect, even with no train occupying the governed signal block, would have indicated a fault within the signal system. The Safety Board believes that had a series break-type circuit been in place at the time of the accident, a red aspect would have been indicated, and the accident could have been avoided.

4. The type of shunt circuit system involved in this accident was not designed on the closed-circuit principle, and did not have an inherent fail-safe feature when the shunt wires were removed or broken from the rails.

Replace, as soon as practicable on a priority basis, track shunt circuit switch protection that does not have series break-type circuits, with series break-type circuits. (Class II, Priority Action) (R-82-43)

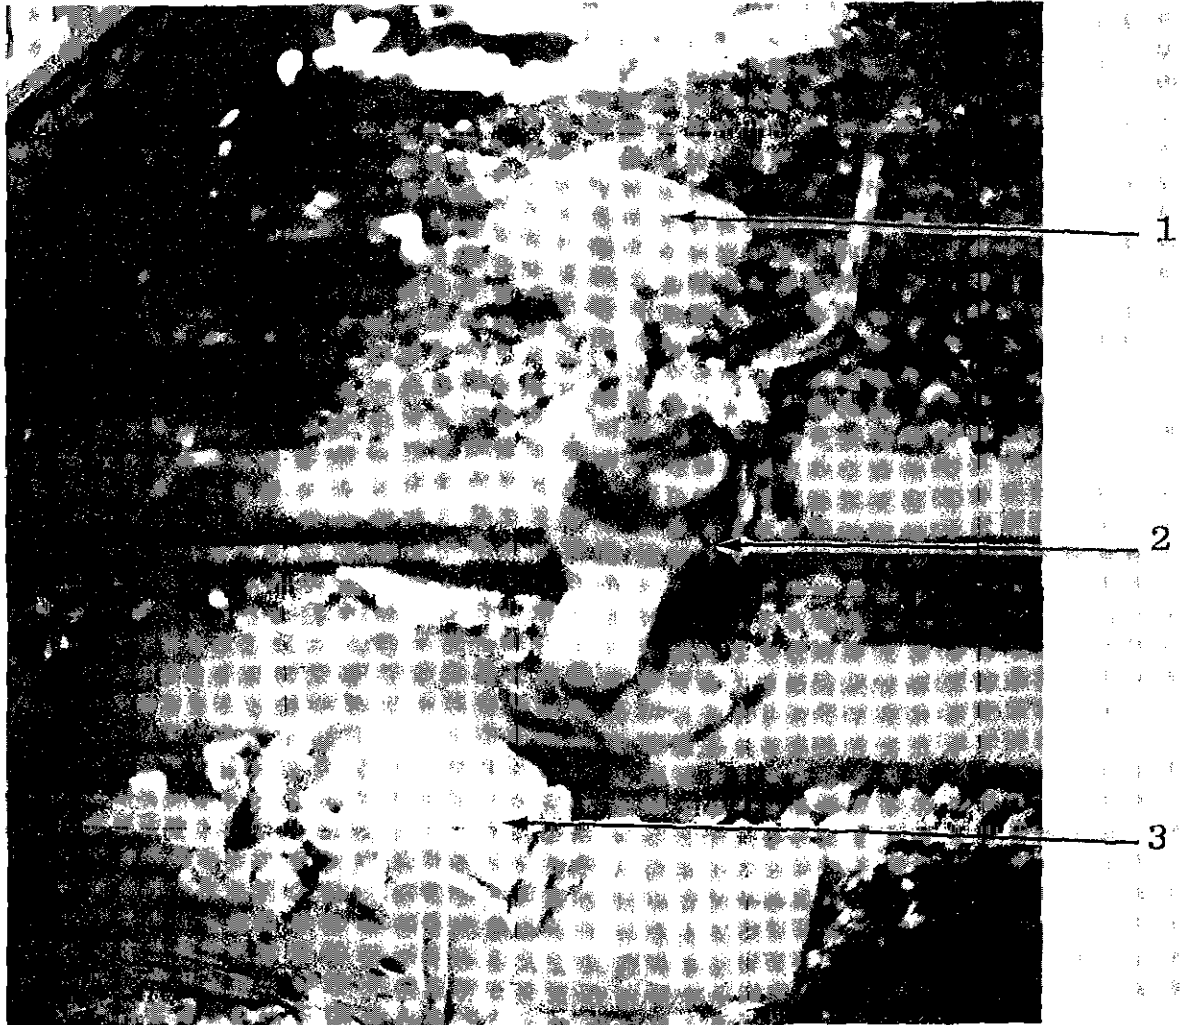
Figure 8.--Switch stand and circuit controller at west switch of crossover.

After the accident, the circuit controller at the west switch of the crossover was opened to determine its condition. There was no external damage to the circuit controller. The contacts were found to be in proper physical correlation with the switch points being in the reversed position. Each of the contacts was found to be clean, and the pressure on each was sufficient to ensure good contact closure. After the damaged track had been replaced and the rail ends bonded, a new set of shunt wires, replacing those which were not connected before the accident, was put into service between the rails and the switch circuit controller. Signal No. 1296 was found to function in the manner in which it was designed to at this time. Officials of N & W's Signal & Communication Department (S & C) stated that signal No. 1296 would display a green (clear) aspect with the west switch of the crossover reversed, given that the shunt wires were not connected to the stock rail and that the east switch of the crossover was lined for the normal movement. The east switch circuit controller and shunt wires were in place. The N & W notified the FRA on November 30, 1981, of this failure of the signal system. (See appendix F.)
