FINNEY, VA.

RAILROAD ACCIDENT INVESTIGATION  
REPORT NO. 4175

NORFOLK AND WESTERN RAILWAY COMPANY  
AUGUST 25, 1970

On August 25, 1970, a head-end collision occurred between a freight train and a helper locomotive on the Norfolk and Western Railway near Finney, Va. It resulted in death to two and in injury to one train-service employees.

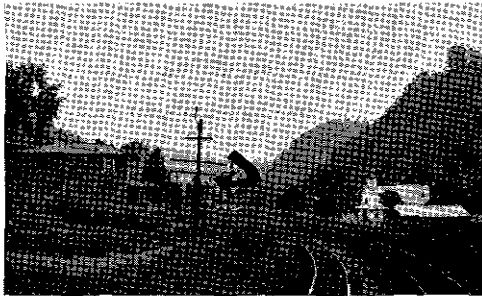
Because of track curvature, a hillside and a house on the hillside, signal 202L cannot be seen from an approaching eastbound train at a distance greater than 1072 feet.

Eastward signal 202L (arrow) from distance of 1072 feet.

7 Assuming that the front brakeman was seated on the left side of the cab of the first locomotive unit, the Stop-and-Stay aspect displayed by signal 202L came into that crew member's view at a distance of 1072 feet The signal aspect came into the engineer's view from the right side of the locomotive cab at a distance of 773 feet Tests revealed that in either case, the train then had sufficient braking distance to stop short of signal 202L as required

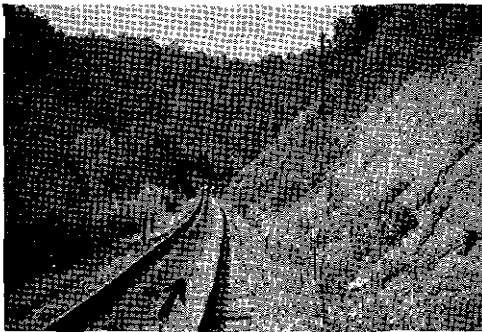
In the immediate vicinity of the collision point, the main track is laid in a hillside cut. Because of the hillside and track curvature, the maximum range of vision between opposing trains approaching the collision point is restricted to a distance of approximately 150 feet.

Collision point (top arrow) from distance of about 1000 feet. Bottom arrow shows direction of westbound helper locomotive involved.

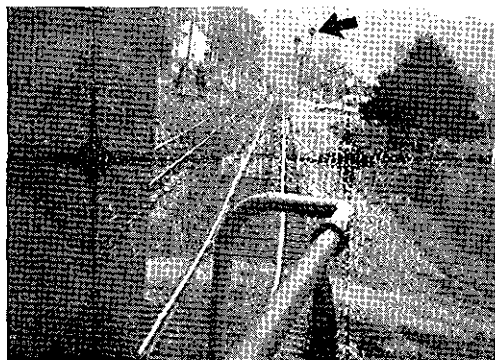
The speed tape, after corrected in accordance with calibrations of the speed-recording device, indicates Extra 1805 East was about three-fourths mile from signal 202L when it began to move eastward at Finney. It further indicates the train increased speed to 10 m p h rather quickly, then slowly increased speed to 12 m p h as it neared signal 202L, which apparently displayed a Stop-and-Stay aspect. The road locomotive was moving on a curve to the left when this signal came into view, at a distance of 1072 feet, from the left or front brakeman's side of the cab of the first unit. Because of track curvature to the left, the short hood compartment in front of the cab, and his position on the right side of the cab, the road engineer was unable to see signal 202L before his locomotive reached a point 773 feet distance (see photo below)

Signal 202L (arrow) from distance of 773 feet.

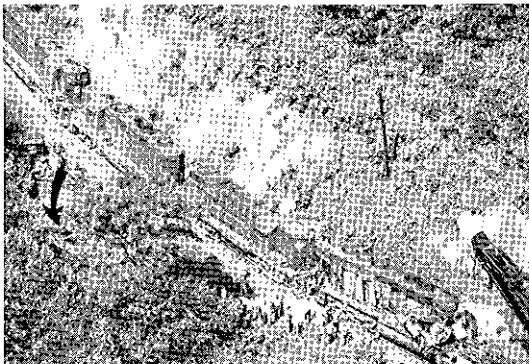
The first and second units of the helper locomotive operating as Extra 924 West were derailed. The first unit overrode the underframe of the leading locomotive unit of Extra 1805 East; struck the short hood compartment and cab of that unit; fell to the south side of the track structure, slid down an embankment, and stopped on one side in a roadway at the foot of the embankment and about opposite the collision point. The second unit stopped upright on and in line with the track structure. The first unit was heavily damaged, the second unit moderately damaged, and the third unit slightly damaged.

This train stopped with the front end 104 feet east of the collision point. All four locomotive units and the first five cars were derailed. The derailed equipment stopped upright on and in line with the track structure. The short hood compartment and cab at the front of the first unit was sheared off and knocked to the ground on the south side of the track structure as a result of being struck by the first unit of the westbound helper locomotive. The first locomotive unit of Extra 1805 East was heavily damaged and the other three units were moderately damaged. The derailed cars were slightly damaged.

According to the carrier's estimate, the monetary cost of damages to the equipment of both trains and track structure was \$181,575 (see photo on the following page).

Locomotive units of Extra 1805 East at center. Arrow points to first unit of helper locomotive operating as Extra 924 West
