# NATIONAL TRANSPORTATION SAFETY BOARD

## RAILROAD ACCIDENT REPORT

HEAD-ON COLLISION OF TWO NORFOLK &  
WESTERN RAILWAY COMPANY FREIGHT TRAINS  
NEW HAVEN, INDIANA  
OCTOBER 19, 1976

REPORT NUMBER: NTSB-RAR-77-6

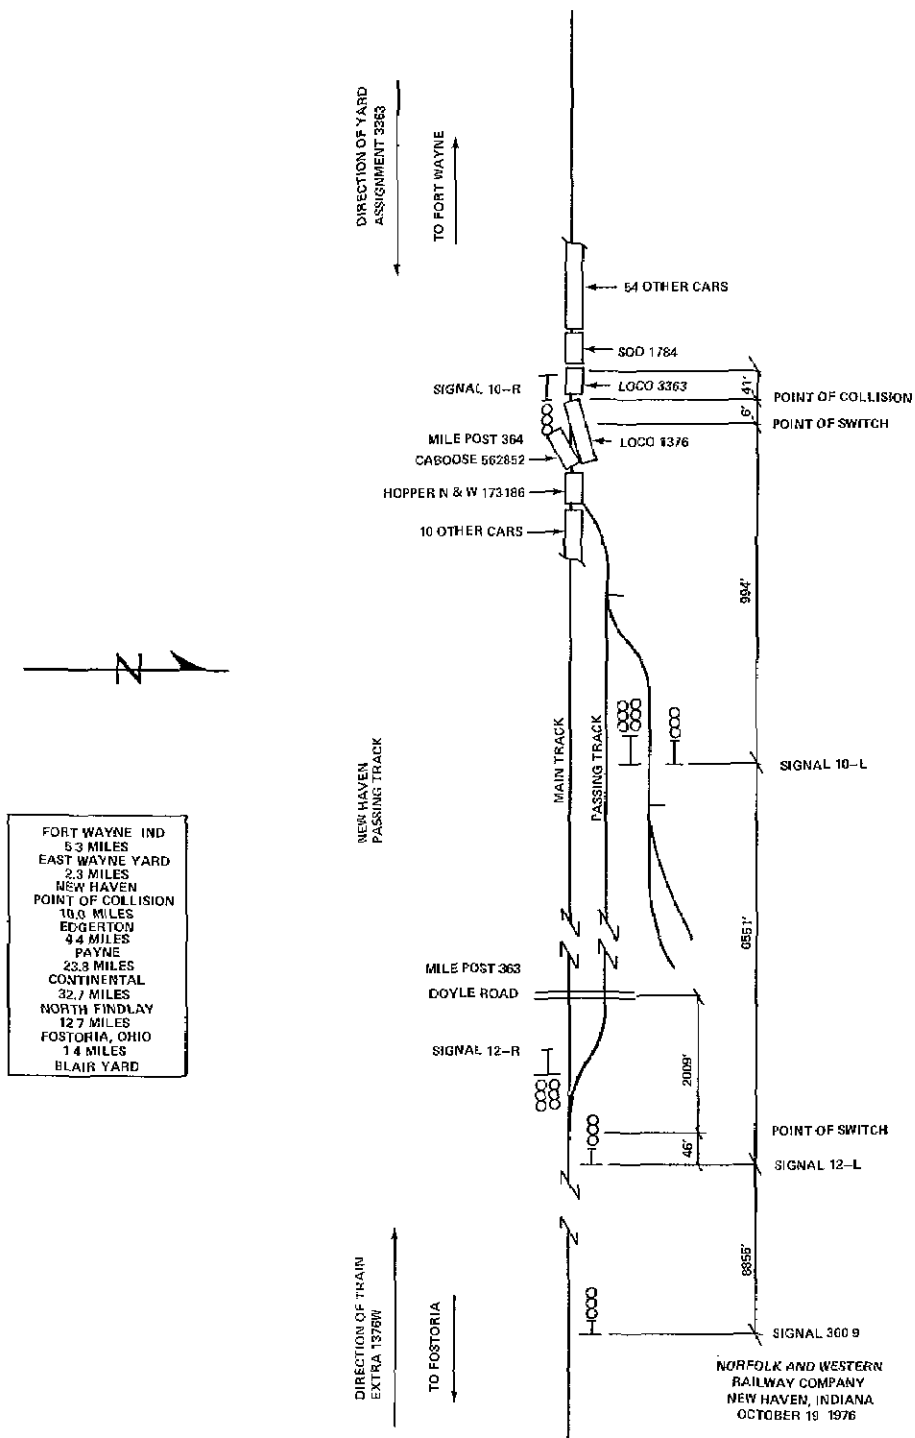
Figure 1. Track layout at and near accident site.

Previously, the East Wayne yardmaster had received authority from the dispatcher to send yard engine 3363 with 55 cars east to the New Haven passing track. At 9:09 p.m., the dispatcher activated the circuit to cause eastbound signal 10R at the west switch of the New Haven passing track to change from a "stop" to a "proceed" aspect and lined the west passing track switch for the passing track. This action caused the westbound signal 10L at the west switch to display "stop," caused westbound signal 12L at the east switch of the passing track to display "approach," and caused the westbound signal 360.9 to display "advance approach." (See figure 1.)

and still moving about 10 mph. Extra 1376 West passed signal 10L, which displayed "stop", and continued west 990 feet where it collided with yard locomotive 3363. The trains collided about 9:15 p.m., 6 feet west of the point of switch at the west end of the New Haven passing track, while both were moving about 10 mph. (See figure 1.)
