**RAILROAD ACCIDENT INVESTIGATION**

Report No. 4107

**NORFOLK AND WESTERN RAILWAY COMPANY**

**JANUARY 13, 1967**

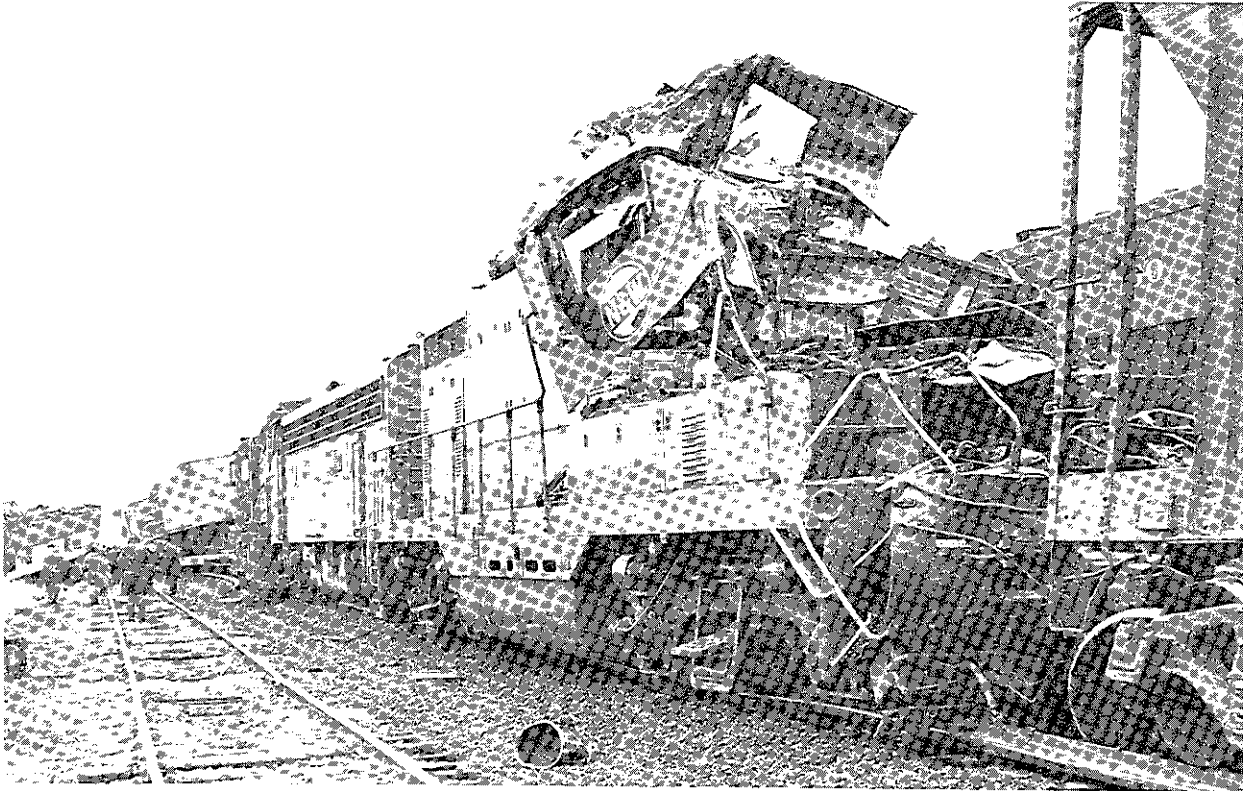
Extra 3482 West stopped with the front of the locomotive 480 feet west of the collision point. The three diesel-electric units and the first five cars were derailed. They stopped upright on and in line with the westward main-track structure. The underframe at the east end of the yard caboose overrode the underframe and platform at the west end of the first diesel-electric unit of Extra 3482 West and demolished the short hood compartment and control compartment of the unit. The first diesel-electric unit was heavily damaged, the other two units were considerably damaged, and the five derailed cars were slightly damaged.

Front end of locomotive of Extra 3482 West. Overturned caboose of yard movement shown at extreme left.
