✓ RAILROAD ACCIDENT INVESTIGATION,

REPORT NO. 4171,

NORFOLK AND WESTERN RAILWAY COMPANY

PEMBROKE, VA

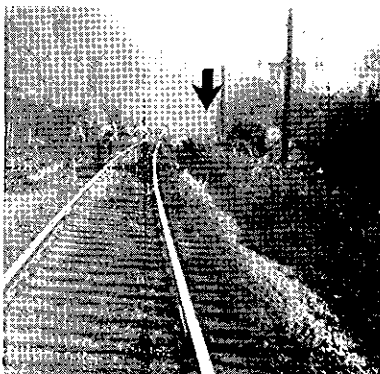
Plate No. 2

westward signal 374L (arrow) from distance of about 1150 feet.

Because of track curvature and trees along the north side of the track structure, signal 374L cannot be seen from an approaching westbound train at a distance greater than about 1150 feet For the same reason, signal 374R

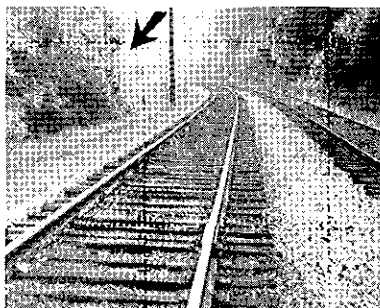
eastward signal 374k (arrow) from distance of about 1175 feet Main track at left Ripplemead siding at right.

cannot be seen from an approaching eastbound train at a distance more than approximately 1175 feet. (See Plate No 2 for views)

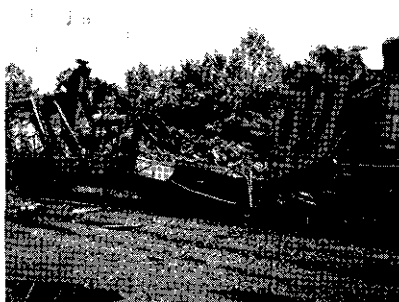
The train stopped with the front end 39 feet west of the collision point. The 1st, 2nd and 4th diesel-electric units, and the 13th to 24th cars, inclusive, were derailed. The 1st and 4th diesel-electric units stopped upright on and in line with the main-track structure, and with the west end of the first unit against the front of the first locomotive unit of Extra 1529 East. The 2nd diesel-electric unit rose from its trucks; overrode the rear, or east, end of the 1st unit, demolishing the control and engine compartments of that unit, (see following photograph); overturned, and stopped about 55 feet north of the main track. Five of the derailed cars stopped upright on and in line with the main-track structure. The other seven derailed cars buckled from the train and stopped in various positions on or near the main-track structure.

The first two diesel-electric units were destroyed; the other three units were slightly damaged. Of the derailed cars, seven were heavily damaged, four were slightly damaged, and one was undamaged.

First locomotive unit of Extra 720 West. Derailed trucks of second unit shown in vertical position between 1st and 3rd units.
