NATIONAL TRANSPORTATION SAFETY BOARD

**SIDE COLLISION OF
NORFOLK AND WESTERN RAILWAY COMPANY'S
TRAIN NO. 86 WITH EXTRA 1589 WEST
NEAR WELCH, WEST VIRGINIA
SEPTEMBER 6, 1980**

NTSB-RAR-81-2

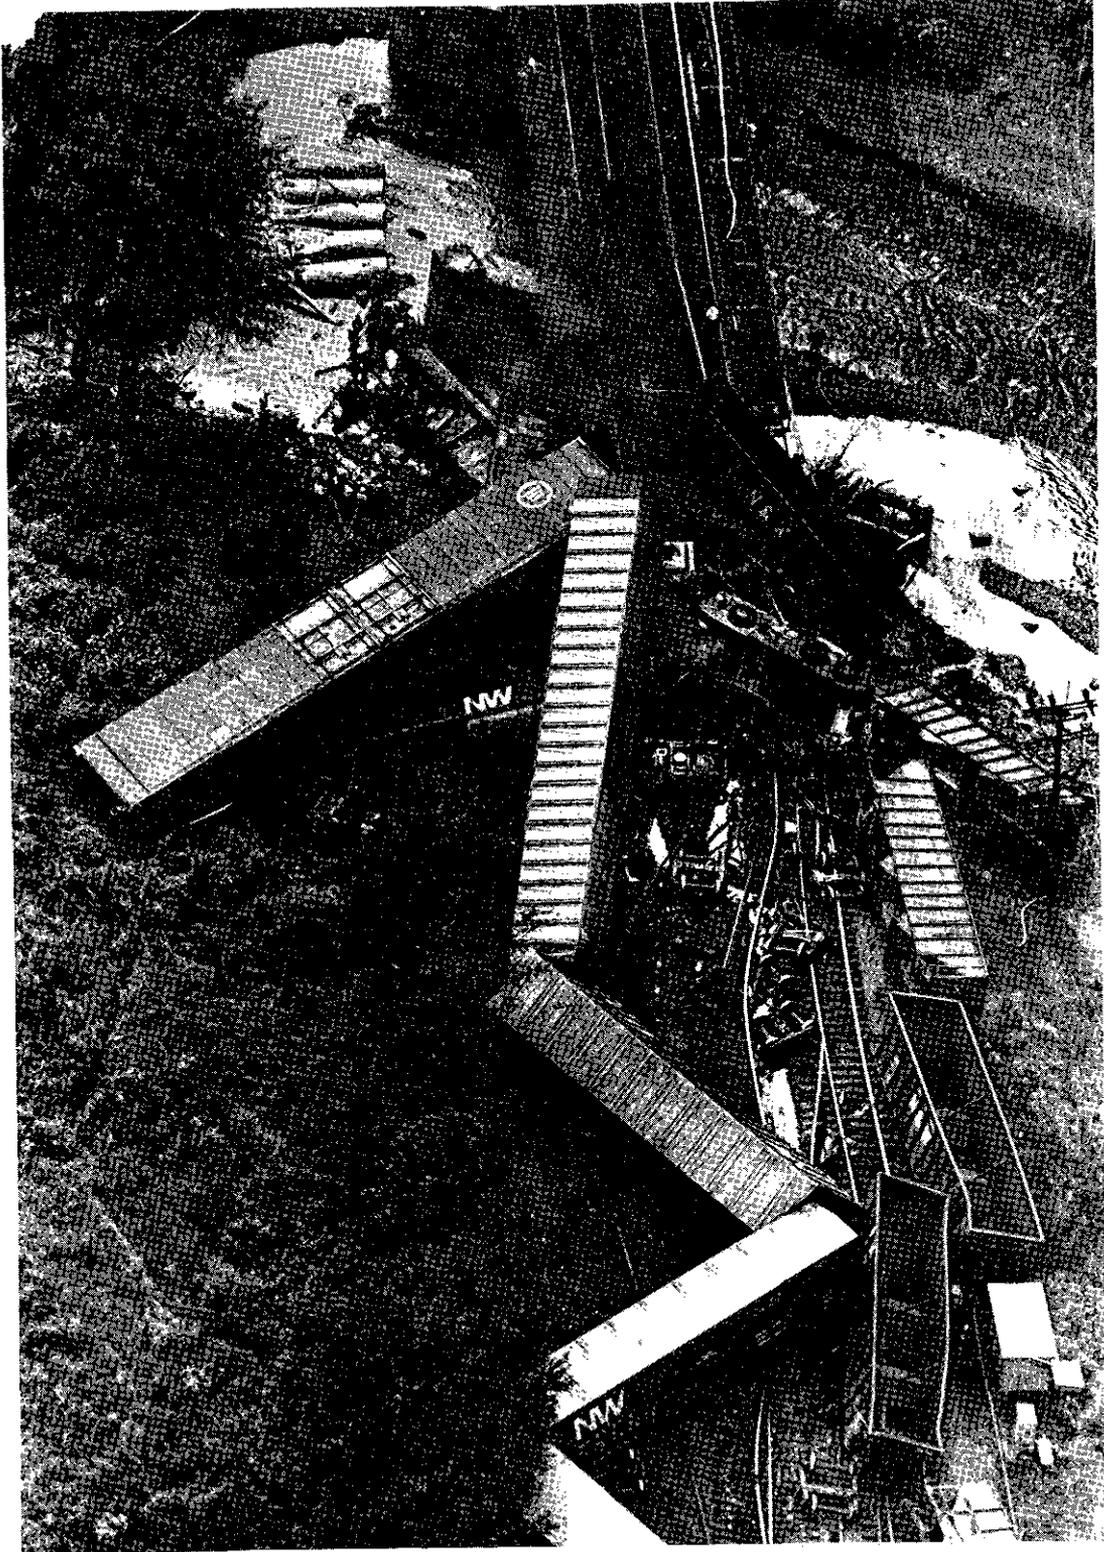
After colliding with Extra 1589 West, the lead unit of train No. 86 collided with a concrete pier supporting a railway trestle over the Tug River Fork and fell into the river between the west bridge abutment and the pier. (See figure 1.) The second unit also collided with the concrete pier and came to rest with the rear end resting on the lead unit and its deformed front end supported by the bridge abutment. (See figure 2.) The third unit came to rest on its side, north of and perpendicular to the track structure; the fourth unit derailed but remained upright. The first six cars of the train derailed. The first car came to rest with the front end resting on the side of the overturned third locomotive unit as did the second car in the train. The second through the fifth cars were derailed in accordion fashion. The sixth car was derailed but remained upright and in line with the track structure. (See figure 2.)

Figure 1.--Side collision of train No. 86
(right) and Extra 1589 West (left).

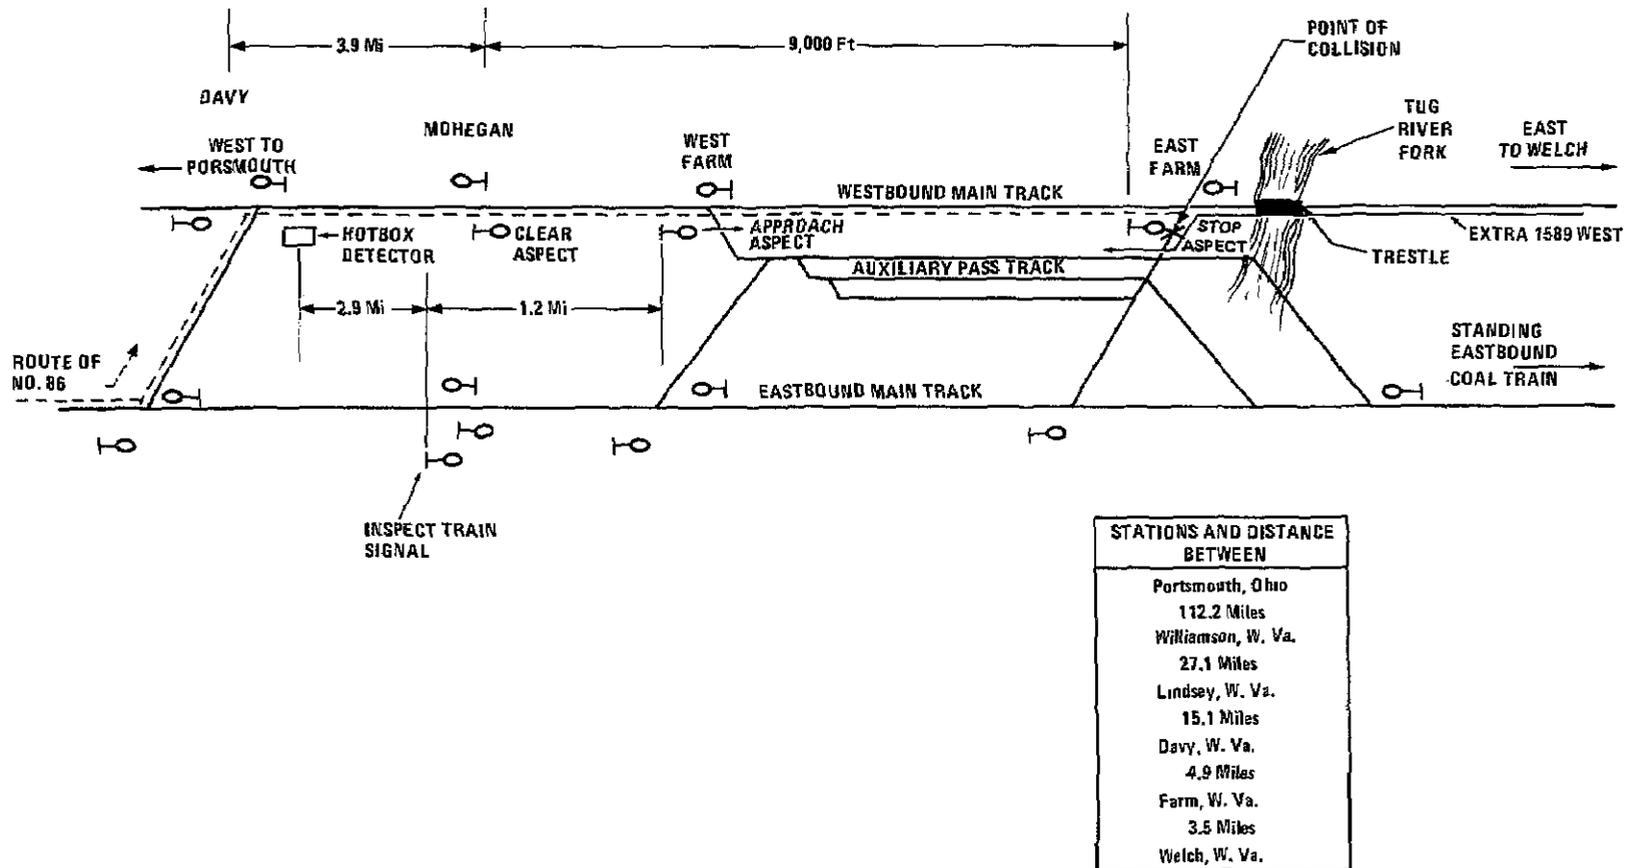
The railroad in the vicinity of the accident follows a water grade route through the Allegheny Mountains, along the Tug River Fork. It is a two-track system extending east and west by timetable direction from the accident site. The north track is designated the westbound main track, and the south track is designated the eastbound main track. The impact occurred in a 4°42' and 5°38' compound curve to the left for train No. 86. The point of impact was at the clearance point in the switch leading from the westbound main track to the auxiliary track at the east end of Farm interlocking. (See figures 3 and 4.)

Figure 3.—Plan view of accident area and route of train No. 86 - not to scale.

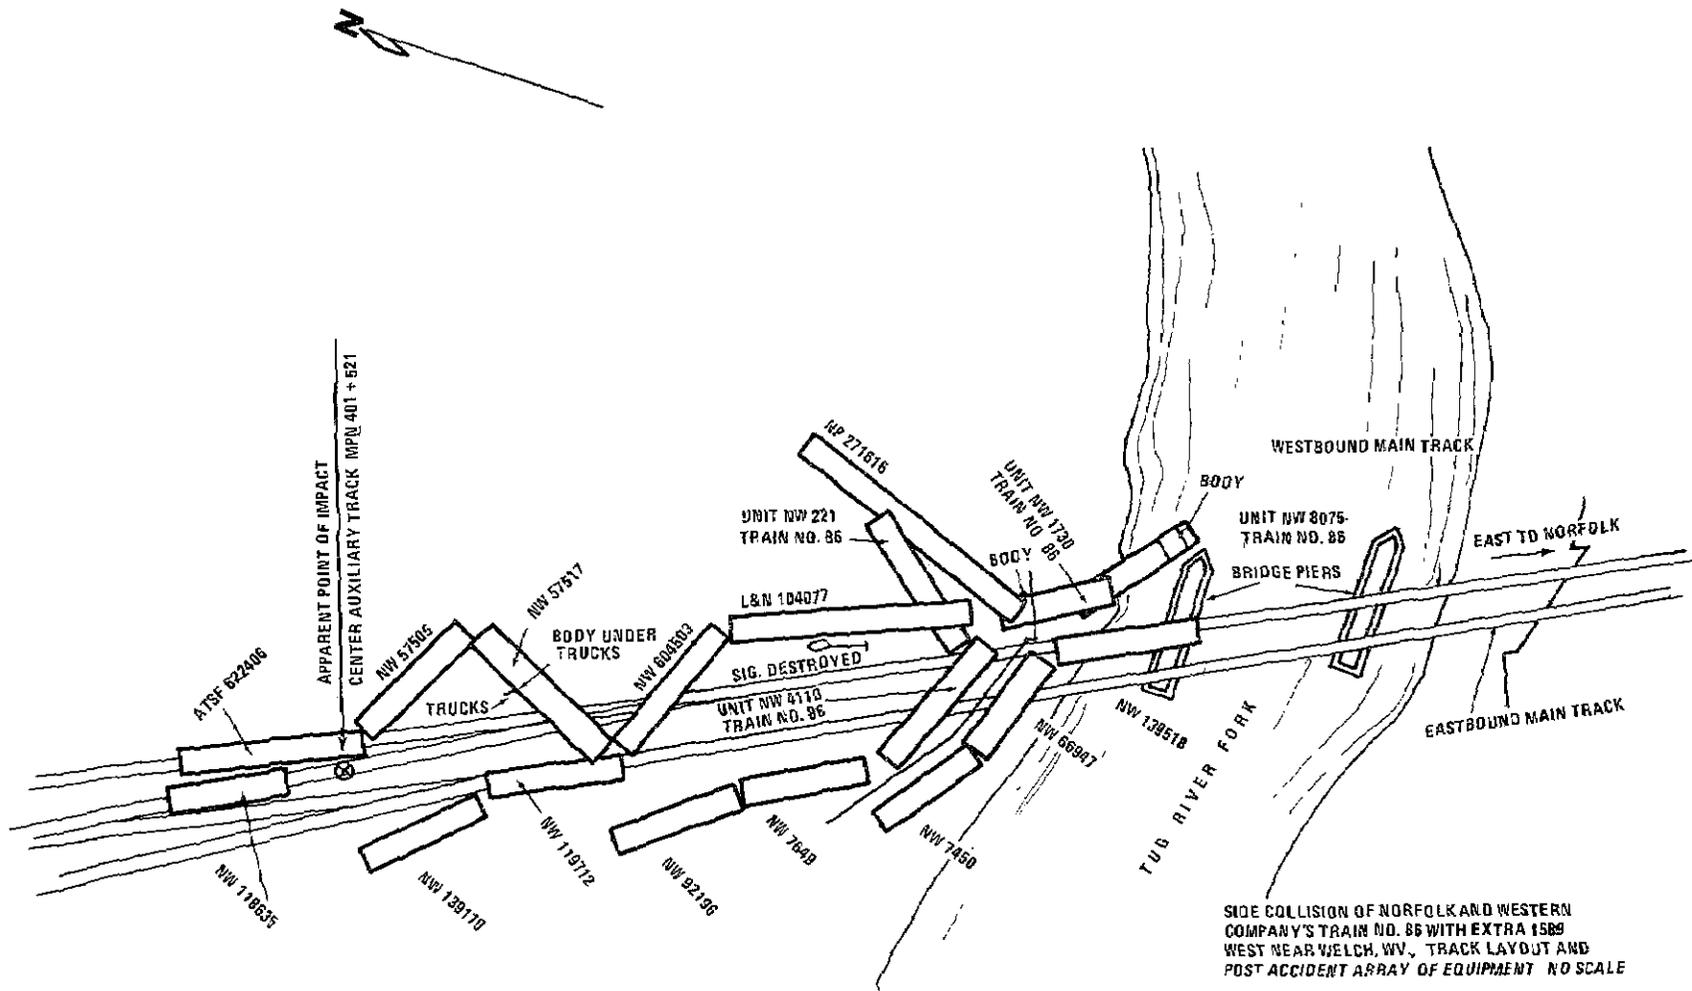
Of the eight empty coal-hopper cars of Extra 1589 West that were derailed, six were lying on or immediately to the south of the track structure. The two easternmost cars were still on the westbound main track and trestle.

Figure 4.--Track layout and postaccident array of equipment.

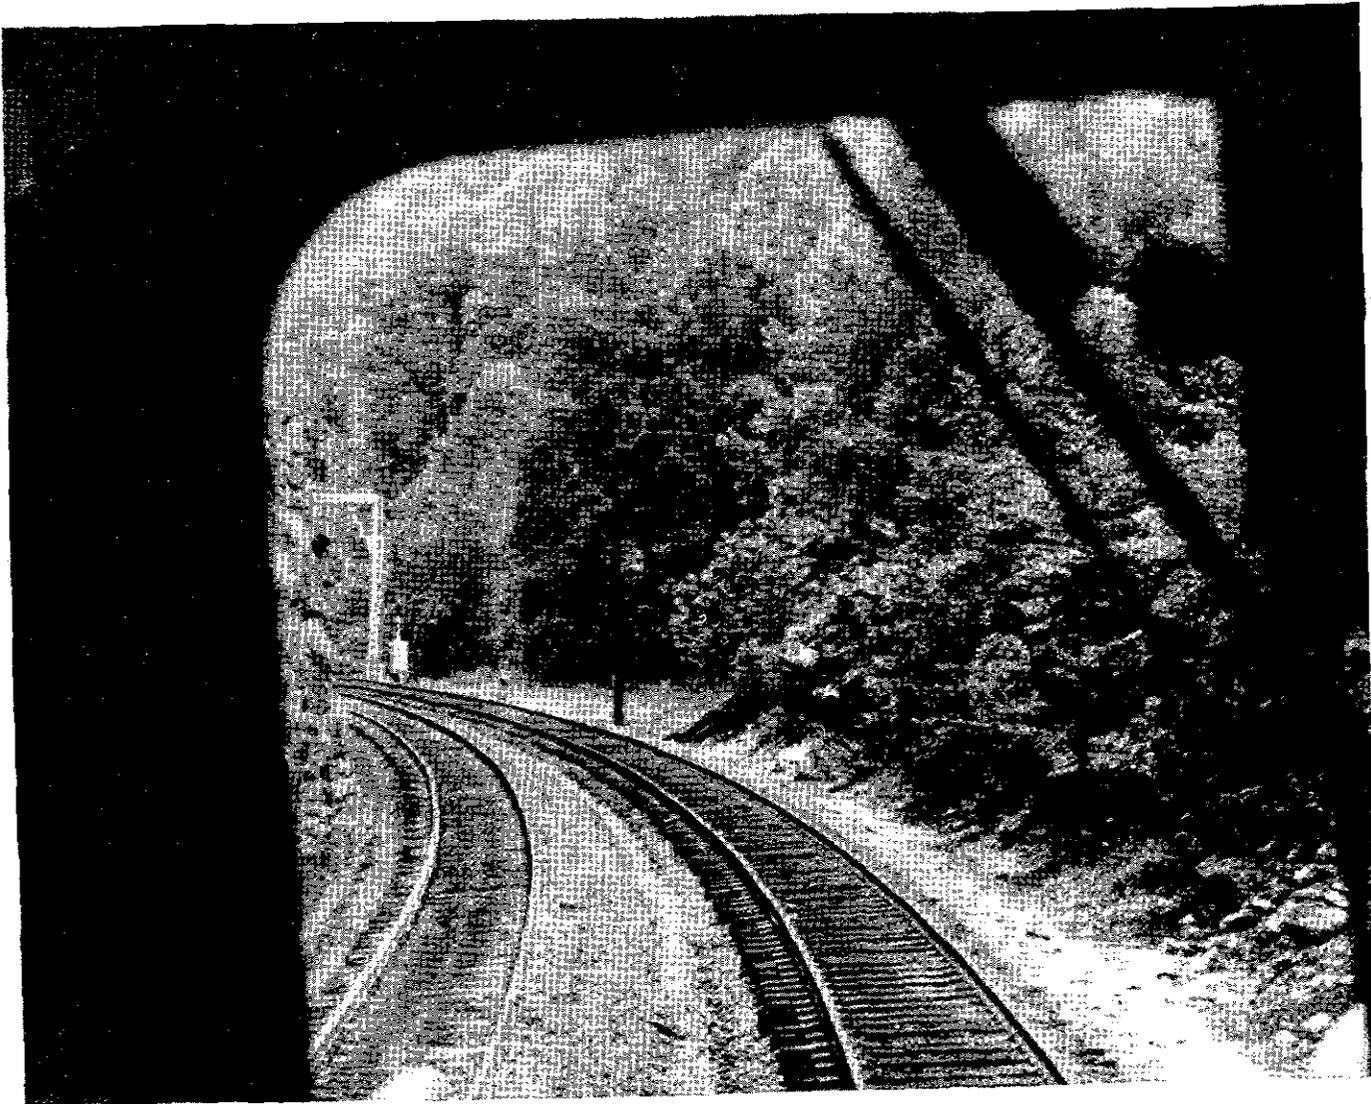
Figure 5.-- Eastbound operator's first available sighting of the "approach" signal at the west end of Farm.

The 414-foot maximum clear sight distance between the position of the operator's seat of train No. 86 and the approach signal at the west end of Farm

allowed a maximum viewing time of 8.5 seconds at a train speed of 35 mph. (See appendix D.) At this speed, the cab of the lead unit would have passed both the clear signal at Mohegan and the approach signal at the west end of Farm, a distance of 1,149 feet, in about 22 seconds. The transit time for these distances is considerably less than the total 60-second timing cycle of the crew alertness device.

Modify existing signals so that an "advance approach" aspect will be displayed for eastbound trains on both tracks at Mohegan when an "approach" aspect is displayed on either track at the west end of Farm. Where similar conditions exist at other locations, also provide an advance approach aspect. (Class II, Priority Action) (R-81-37)
