## INTERSTATE COMMERCE COMMISSION

REPORT OF THE DIRECTOR OF THE BUREAU OF SAFETY IN RE  
INVESTIGATION OF AN ACCIDENT WHICH OCCURRED ON THE  
NORFOLK AND WESTERN RAILWAY AT ALNWICK, W. VA., ON  
FEBRUARY 2, 1931.

March 11, 1931.

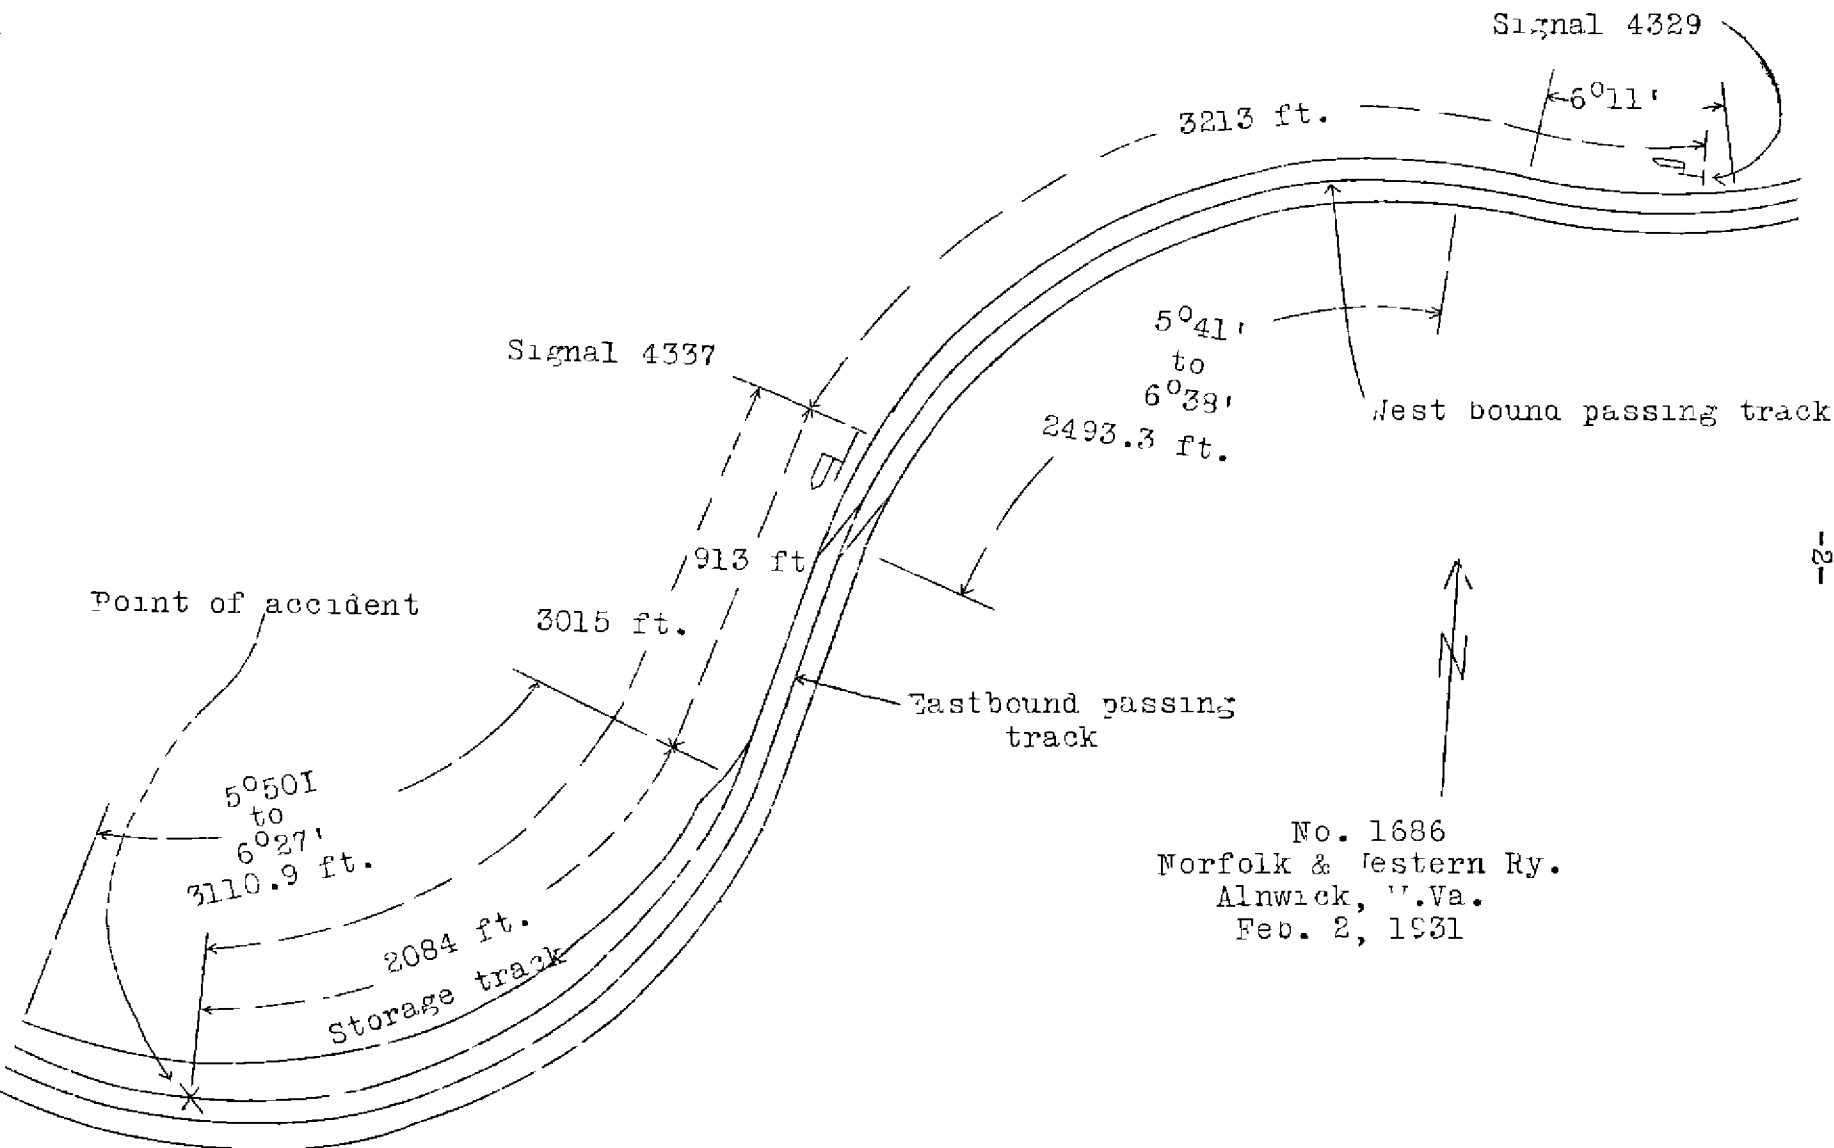
No. 1686  
Norfolk & Western Ry.  
Alnwick, Va.  
Feb. 2, 1931

The signals involved are signals 4337 and 4329, located 3,015 feet and 6,228 feet, respectively, east of the point of accident. These are approach-lighting

signals of the three-position, upper-quadrant, semaphore type, and at night they display green, yellow, and red indications. On account of the curvature of the track, signal 4337 can not be seen from the engineman's side of a westbound train until the engine is about 200 feet from it, but this signal is clearly visible from the fireman's side of a westbound train for a distance of more than 1,400 feet. The point of accident was visible from the engineman's side, a distance of 713 feet.
