# RAILROAD ACCIDENT REPORT.

HAZARDOUS MATERIALS ACCIDENT  
IN THE RAILROAD YARD OF THE  
NORFOLK AND WESTERN RAILWAY AT  
DECATUR, ILLINOIS  
JULY 19, 1974

U.S. NATIONAL TRANSPORTATION SAFETY BOARD.  
Washington, D.C. 20594  
REPORT NUMBER: NTSB-RAR-75-4.

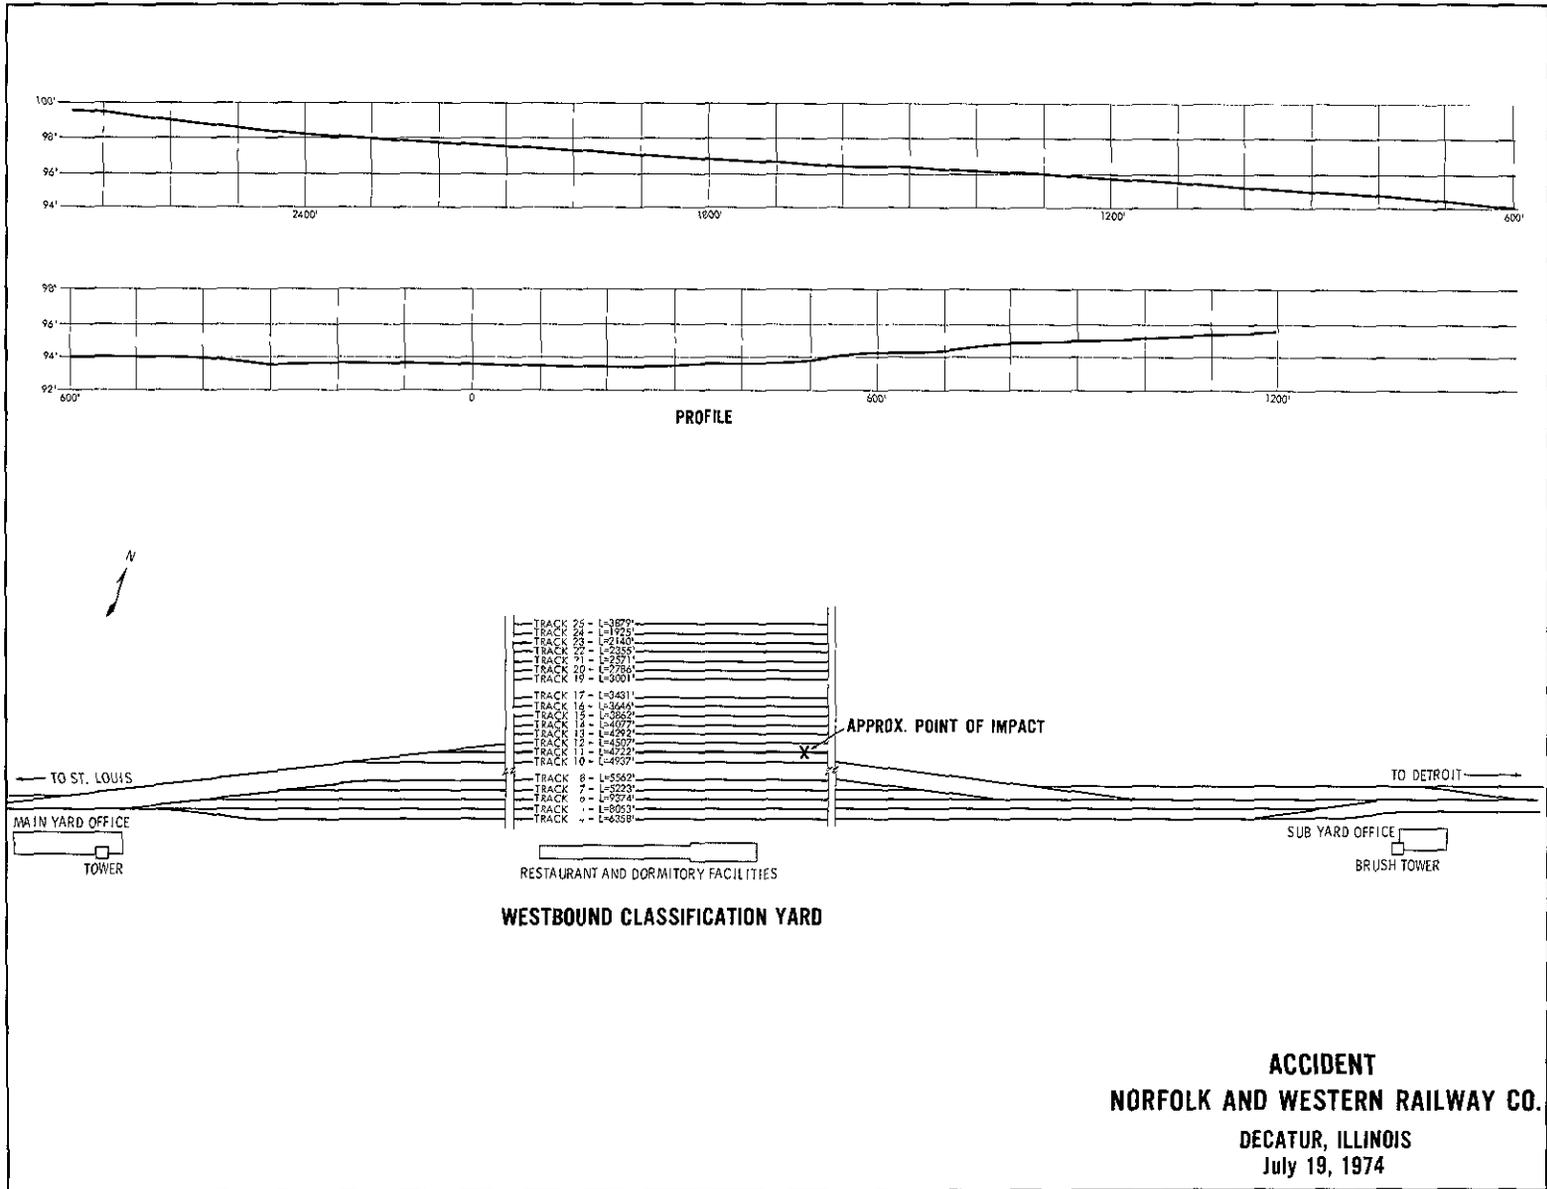
Figure 1. Plan view of portion of Westbound Yard.

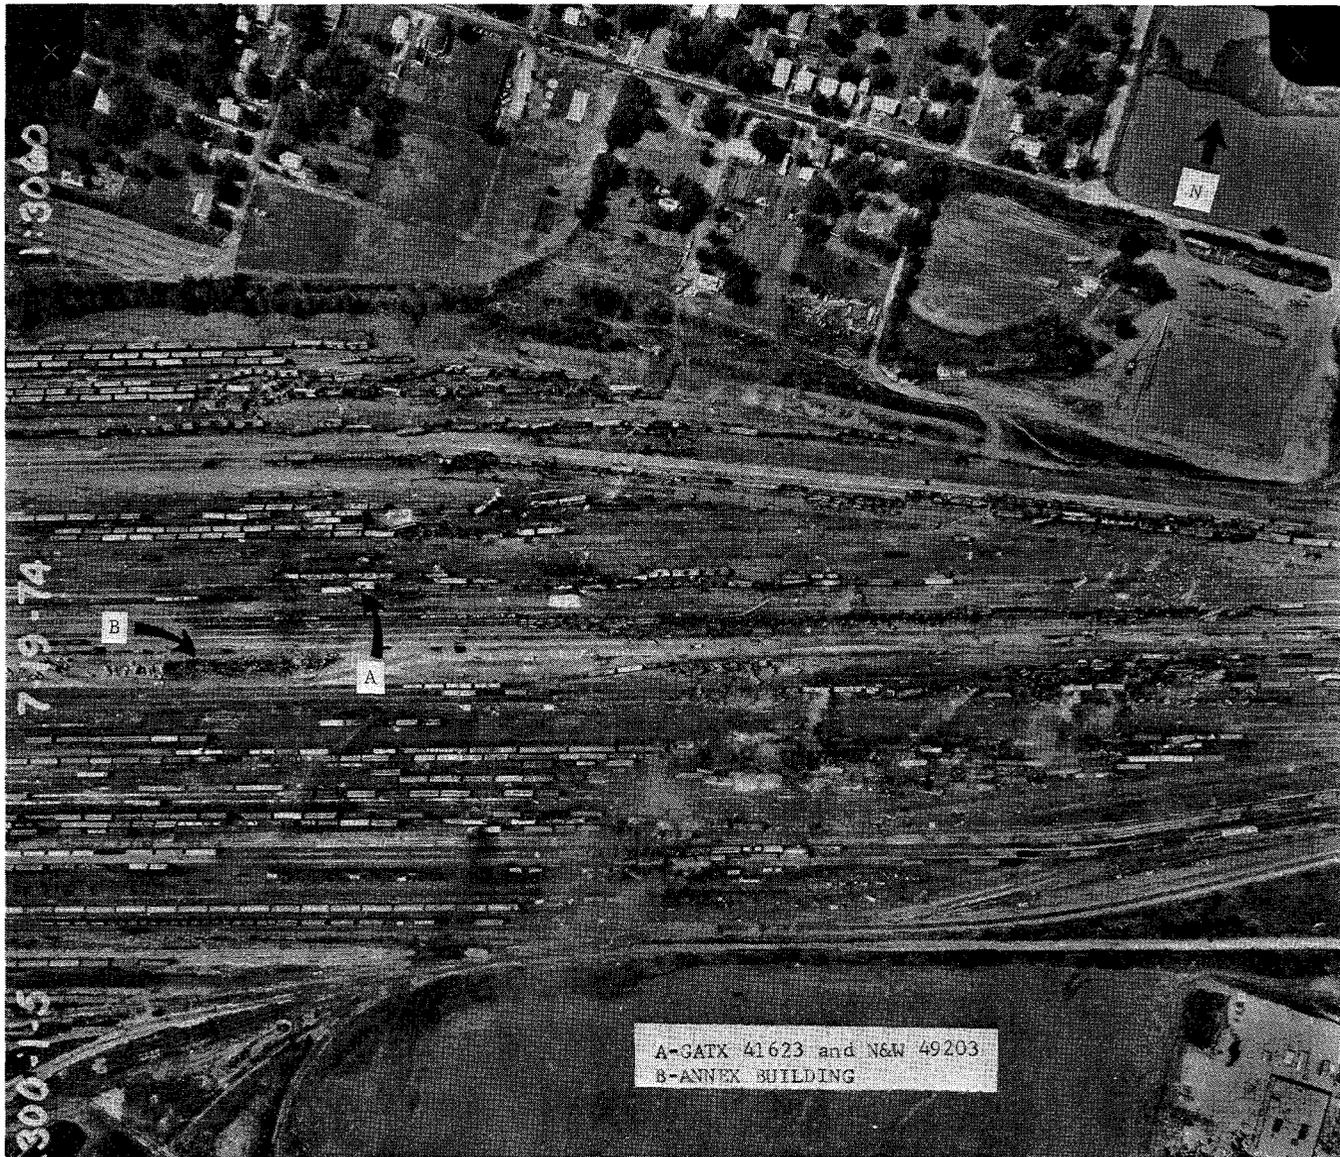
Liquid isobutane spilled from the 22-inch by 26-inch puncture at the rate of about 5,000 gallons per minute. The liquid vaporized, and a northwest wind spread the cloud southeastward for about 8 to 10 minutes. The cloud was then ignited by an unknown source and exploded violently. (See Figure 2.)

Figure 2. The explosion area in Decatur Yard.

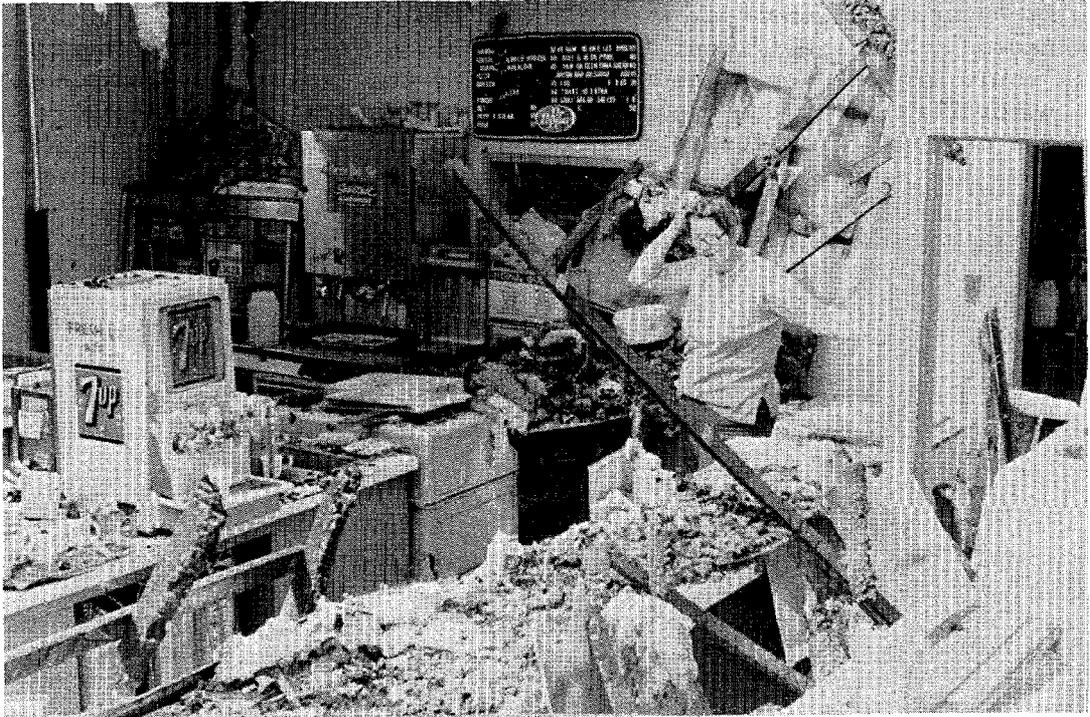
About 700 residences were damaged by concussion, 67 of which authorities declared uninhabitable; damage ranged from broken windows to collapsed roofs and walls. Many furnishings were damaged by flying glass and other debris. Lakeview High School, which was adjacent to the east-bound yard, was one of the most severely damaged buildings. An unfinished addition to the school was demolished. Ten other schools were also damaged. (See Figures 3 and 4.) Thirty-one commercial establishments reported damages to structures and contents.

Figure 3. Typical Damage, Residential Area  
Decatur, Illinois

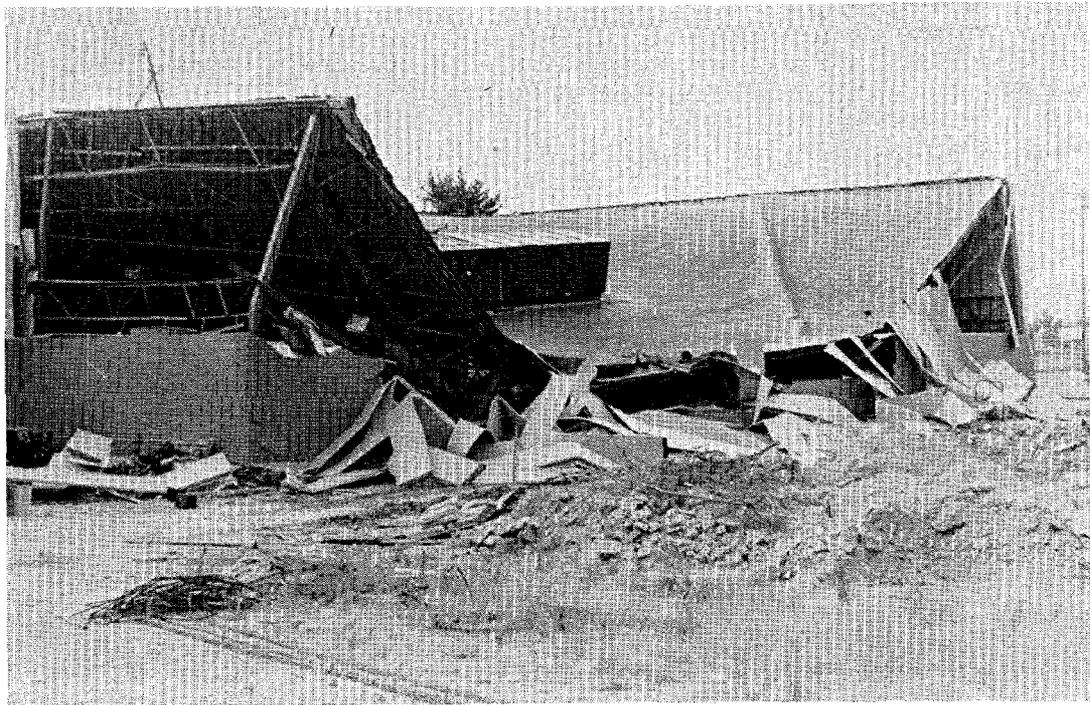
Figure 4. Damage to Lake View School, Decatur, Illinois.

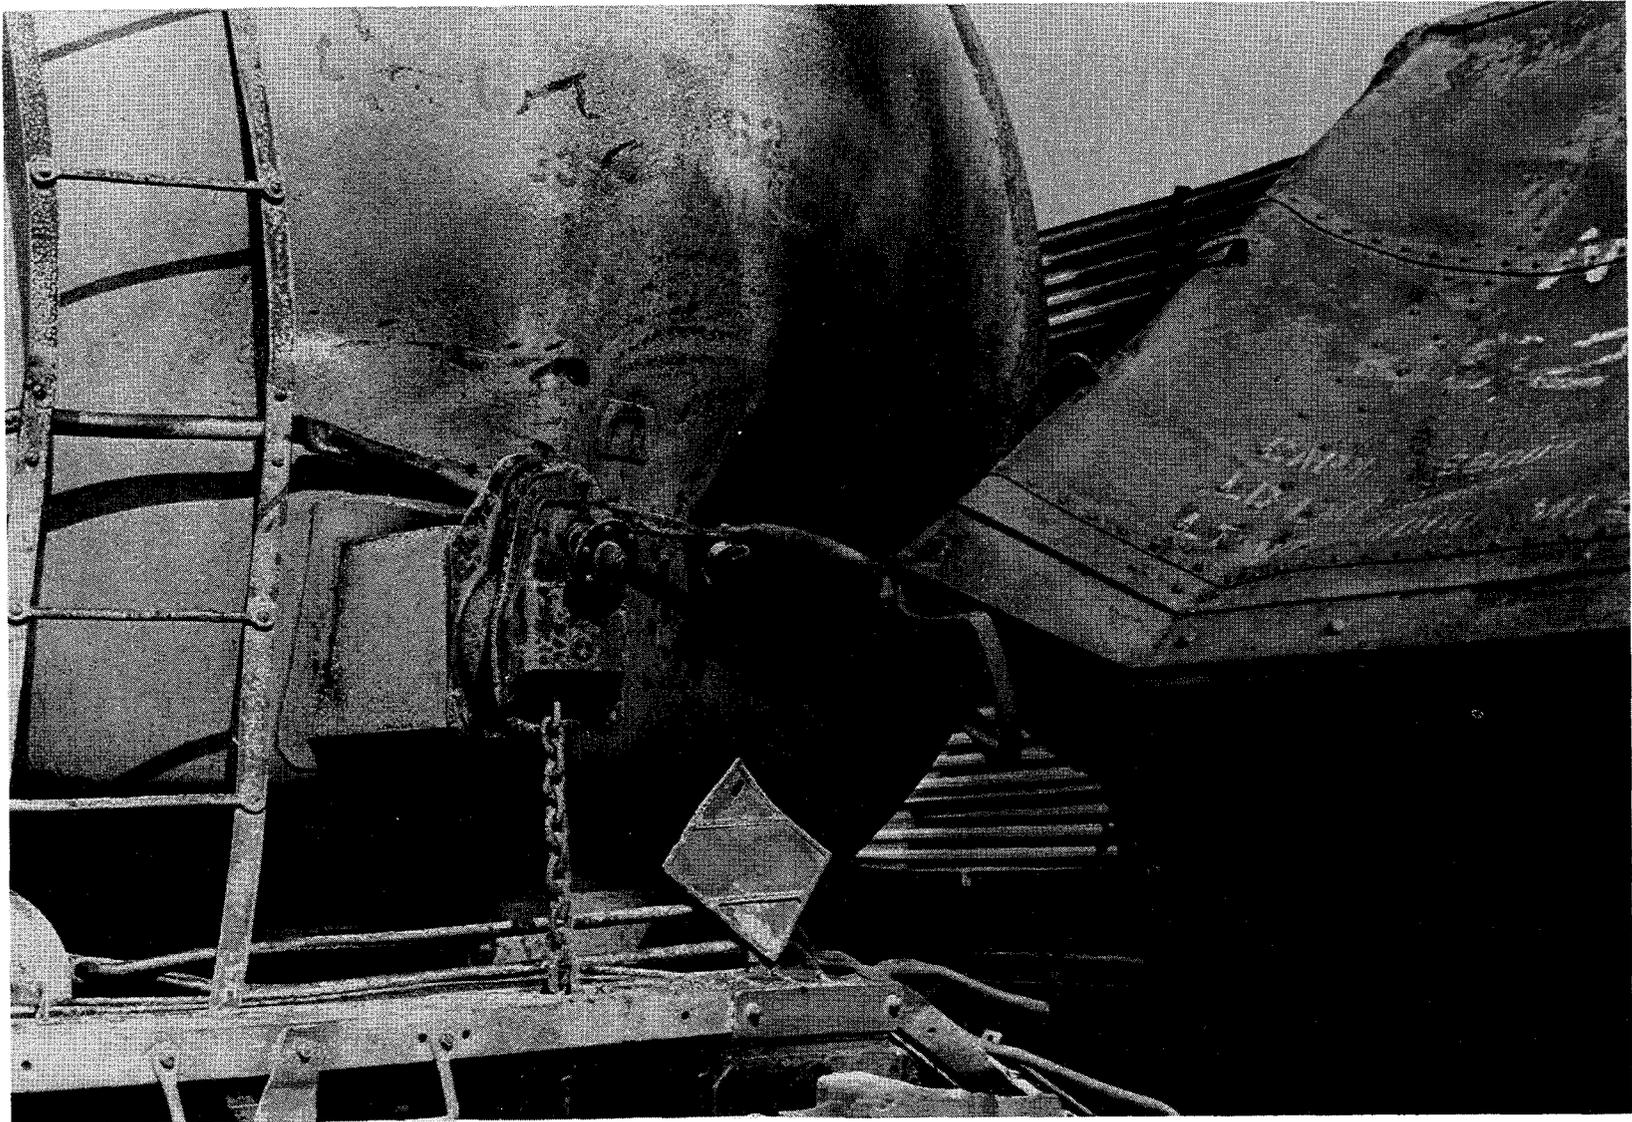
In addition to the 22-inch by 26-inch puncture, the running board, handrail, airbrake equipment, handbrake mechanism, and coupler on the east end of the car were damaged. The east end of the car was also burned. (See Figure 5.)

Figure 5. "B" end of GATX 41623.
