ACCIDENT ON THE
NORFOLK AND WESTERN RAILWAY

HULL, W. VA.

MARCH 3, 1938

INVESTIGATION NO. 2258

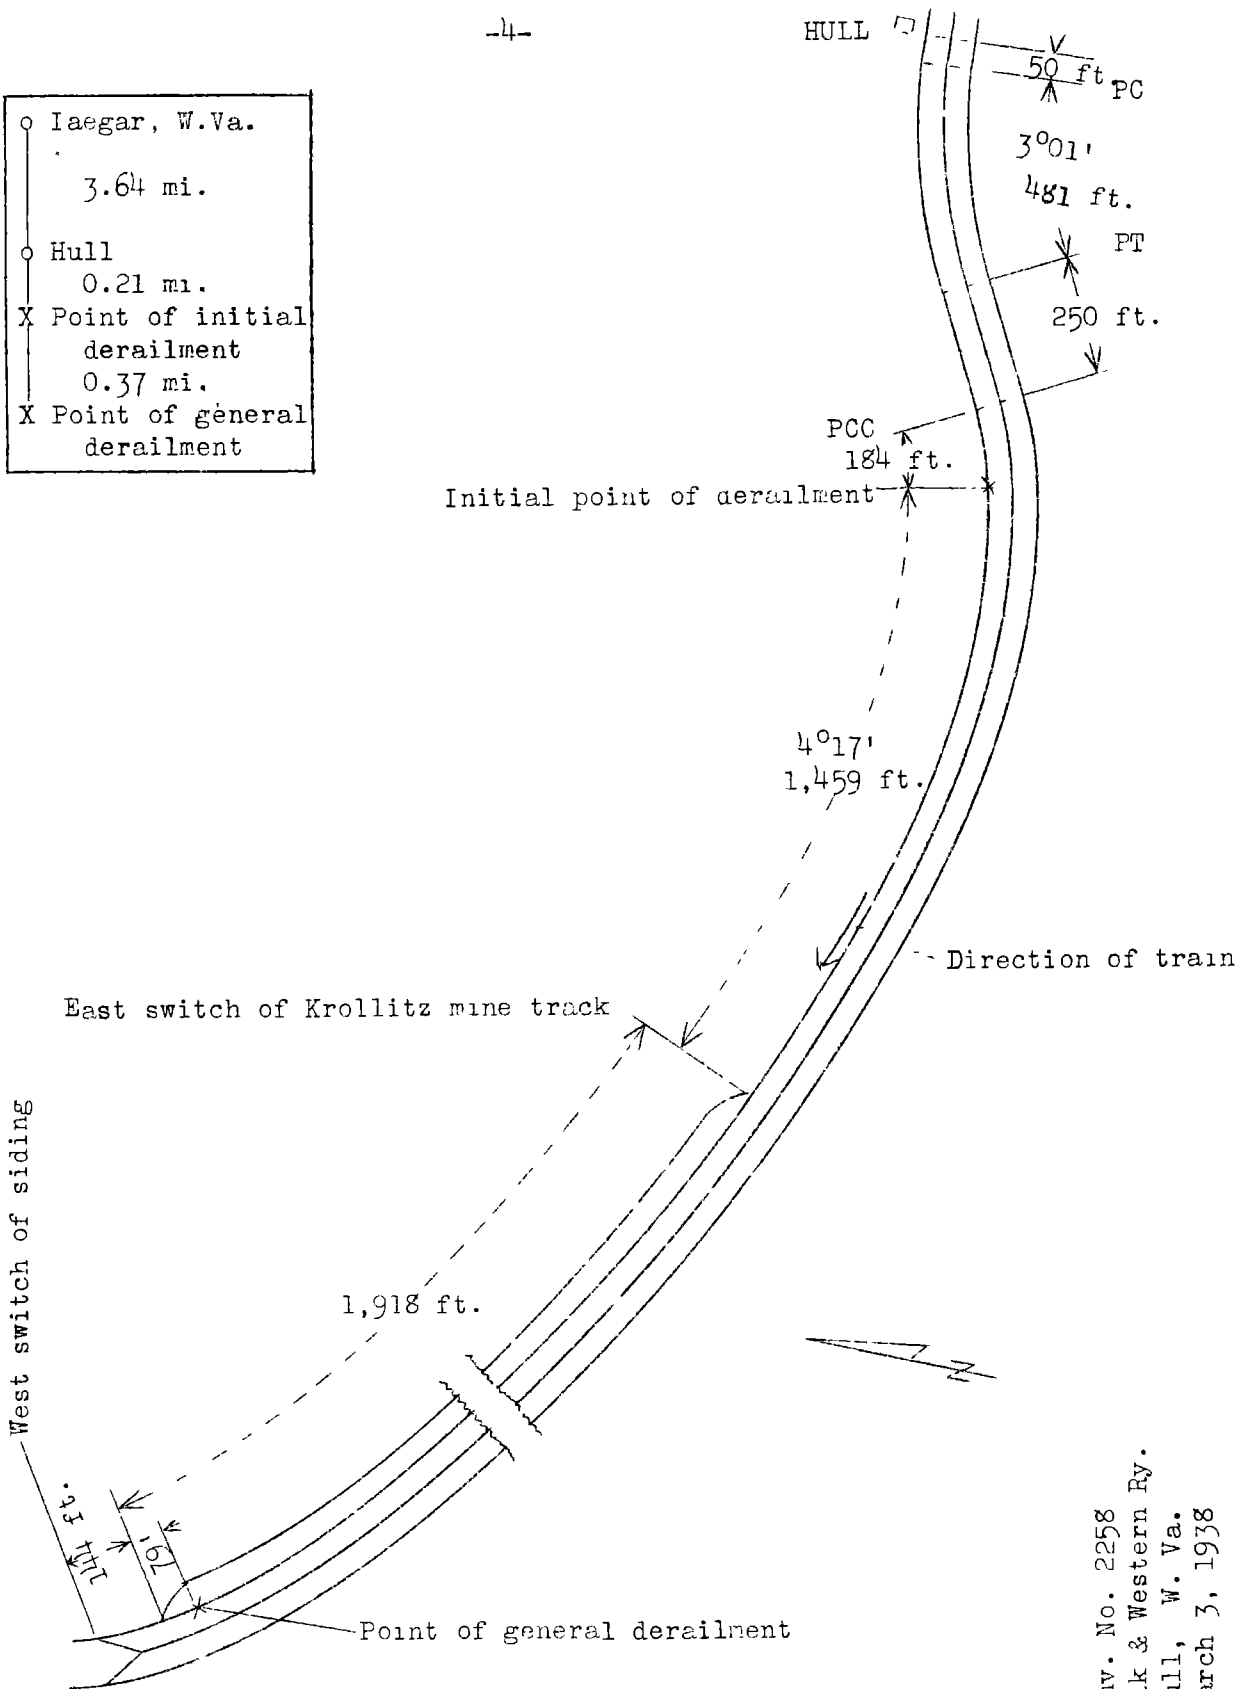
Inv. No. 2258
 Norfolk & Western Ry.
 Hull, W. Va.
 March 3, 1938

In the vicinity of the point of accident the tracks are laid on a hillside cut and parallel the north bank of the Tug River. At the initial point of derailment the embankment north of the westward main track rises at an angle of about 60 degrees to a height of approximately 60 feet; there is a space of about 10 feet between the toe of the slope and the north rail of the westward main track. A siding 8,924 feet in length is located between the main tracks at the point of accident, the west trailing-point switch of which is located about 4,485 feet west of Hull. The Krollitz Mine track, 1,918 feet in length, parallels the westward main track on the north and its east switch is located 2,425 feet west of Hull and its west switch 144 feet east of the west siding-switch. The general derailment occurred at the west switch of the Krollitz Mine track and the west switch of the siding.

Due to the curvature and the embankment to the north of the track approaching the scene of the accident, the view had by an engineman of a west-bound train is restricted to a distance of about 150 feet.
