ACCIDENT ON THE
NORFOLK AND WESTERN RAILWAY

PEMBROKE, VA.

MAY 26, 1939

INVESTIGATION NO. 2353

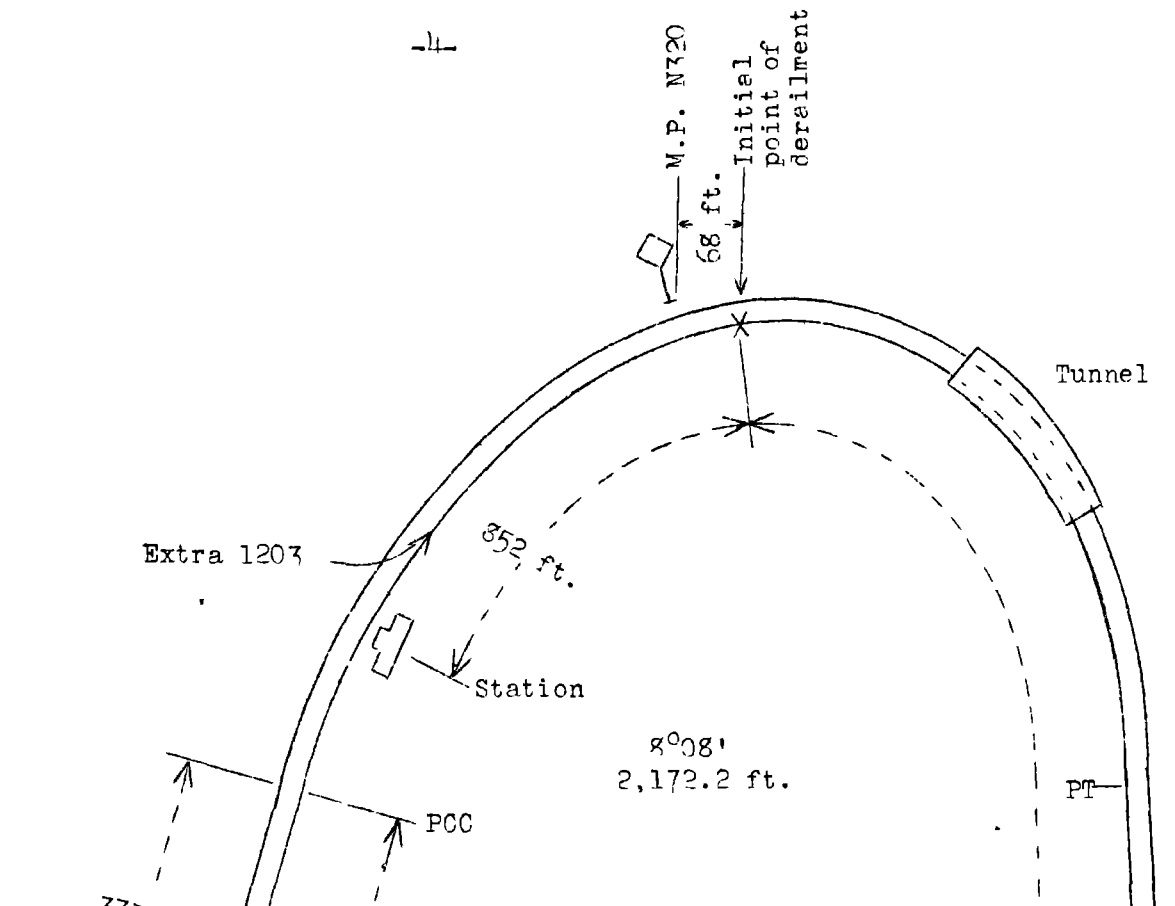
Inv. No. 2353
 Norfolk & Western Ry.
 Pembroke, Va.
 May 26, 1939

Final point of derailment
