INTERSTATE COMMERCE COMMISSION

REPORT OF THE DIRECTOR OF THE BUREAU OF SAFETY CONCERNING AN
ACCIDENT ON THE NORFOLK AND WESTERN RAILWAY AT ROANOKE,
VA., ON JUNE 1, 1933.

August 29, 1933.

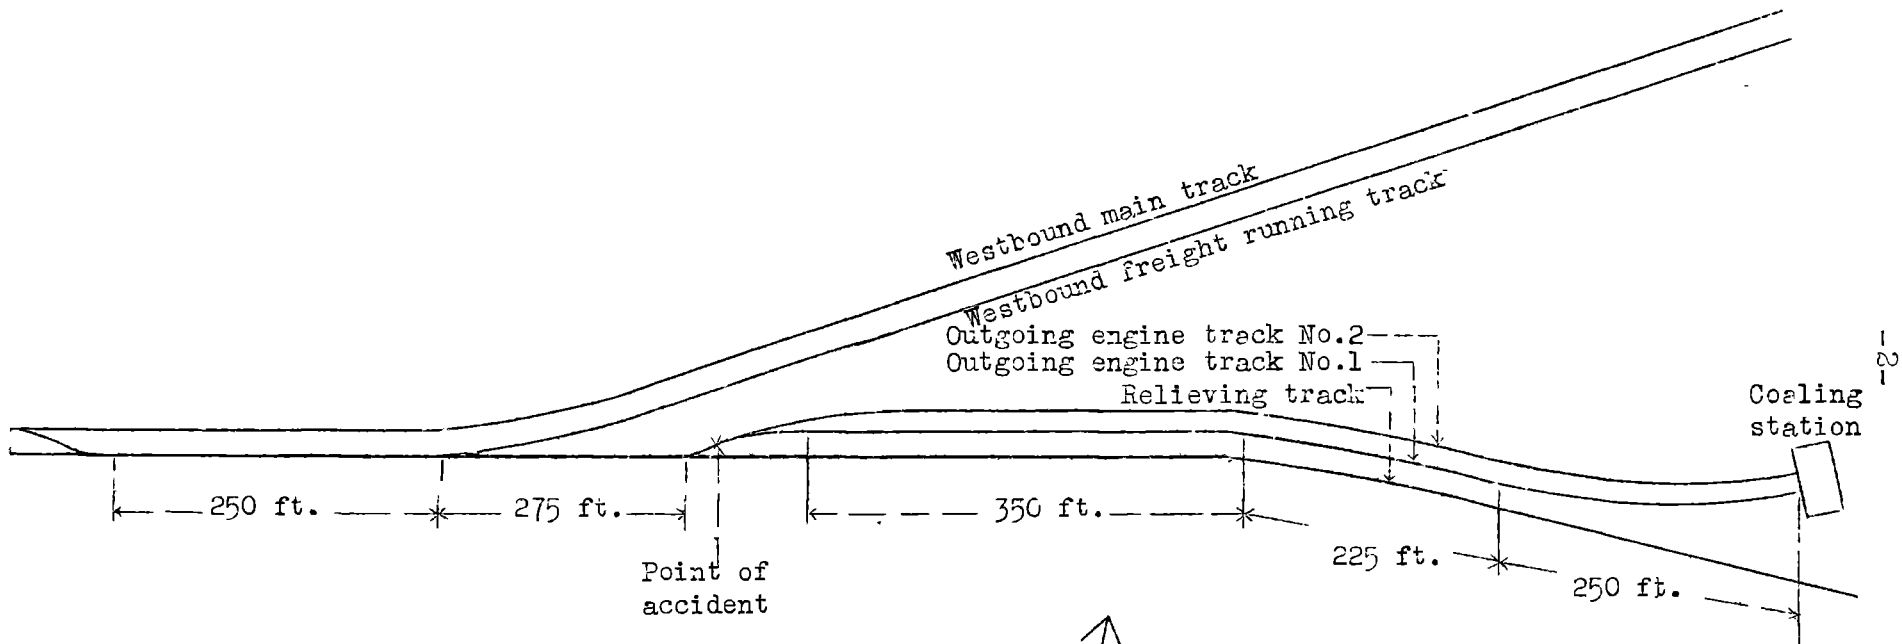
Inv. No. 1830
 Norfolk & Western Ry.,
 Roanoke, Va.
 June 1, 1933.

The accident occurred at the fouling point of a switch where the outgoing engine tracks and the relieving track converge, about 550 feet west of their connection with the west-bound main track. The relieving track is tangent for several hundred feet in both directions from the point of accident. Proceeding eastward on outgoing engine track no. 1 the track is tangent for a distance of 350 feet and then curves to the left toward the relieving-track switch. The grade at the point of accident is 0.94 percent ascending for west-bound trains. The view of the point of accident which could be had by an engineman of an engine backing west on engine track no. 1 is limited to a distance of 600 feet; the view from the engineman's side of an engine backing east on the running and relieving tracks is unobstructed the entire distance from the crossover connecting with the main track.
