RAILROAD ACCIDENT INVESTIGATION

Report No 3865

NORFOLK AND WESTERN RAILWAY COMPANY

DECEMBER 15, 1959

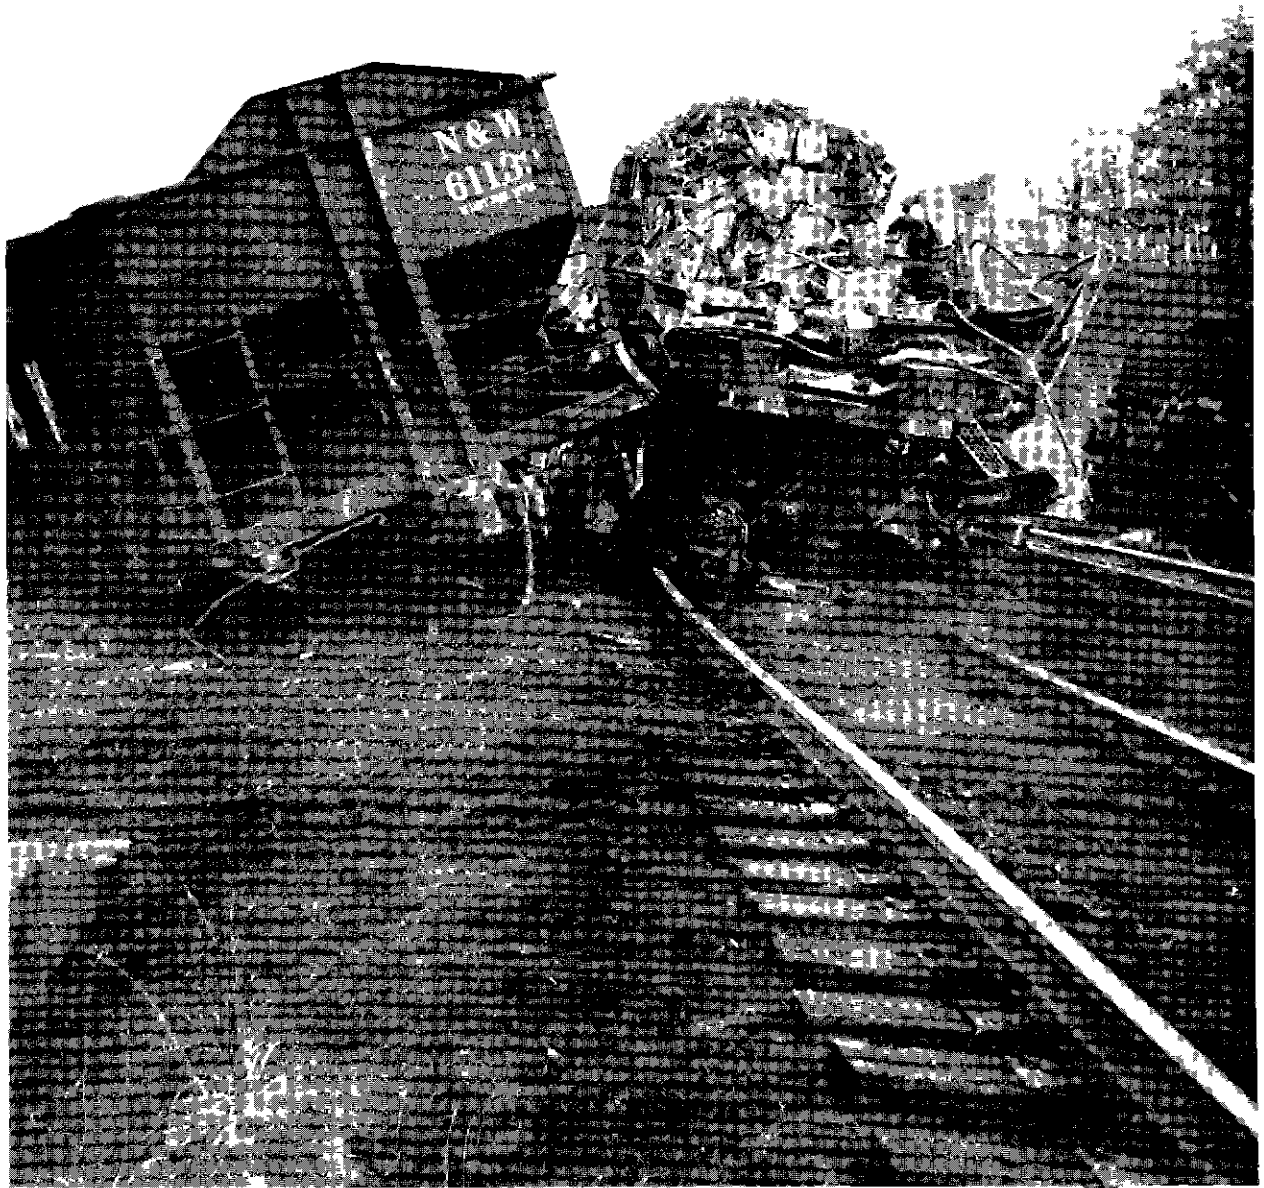
Front end of helper-locomotive 386 shown at right

The helper-locomotive with caboose stopped with the front end 192 feet east of the point of accident. The front truck of the first diesel-electric unit was derailed. The east end of this unit was telescoped throughout a distance of about 17 feet by one of the derailed cars, and the superstructure, including the control compartment at that end of the unit, was destroyed. The 1st diesel-electric unit was considerably damaged as shown in PLATE 1, and the 2nd unit was somewhat damaged.

It is recommended that the carrier immediately take such measures as may be necessary to insure that an emergency brake application initiated at any point or originating from any cause either on the locomotive or in the train-brake system of associated equipment will result in an emergency application of the pneumatic brakes of the locomotive.
