REPORT OF THE DIRECTOR OF THE BUREAU OF SAFETY CONCERNING
AN ACCIDENT WHICH OCCURRED ON THE NORFOLK AND WESTERN
RAILWAY AT UNION, OHIO, ON APRIL 21, 1932.

June 14, 1932.

Inv. No. 1762
Norfolk and Western Ry.,
Union, Ohio
April 21, 1932

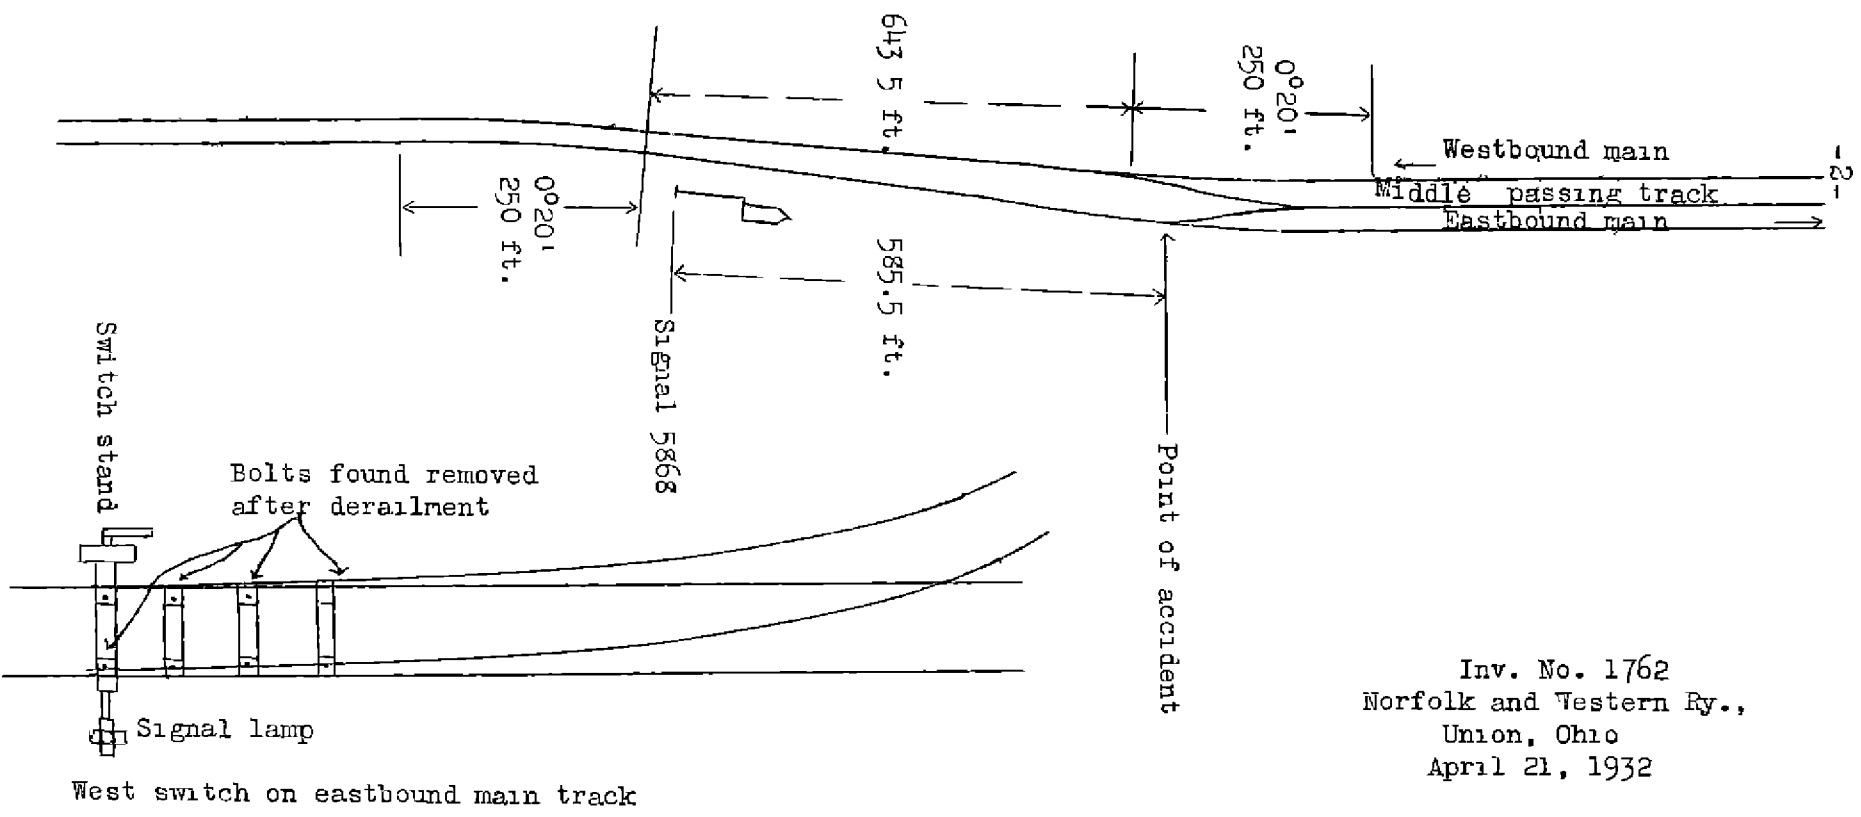
The switch involved is a facing-point switch for eastbound trains and leads off the main track through a No. 12 turnout to the left or north to the middle passing track, which is situated between the westbound and eastbound main tracks. The switch stand is of the Ramapo No. 20 type,

the lever being located on the north side of the track while the stand, approximately 24 inches in height and equipped with an electric lamp, is located on the south side of the eastbound main track, normal night indications are green when the switch is closed and red when the switch is open. The last eastbound automatic signal - 5868 - is located 585.5 feet west of the switch.

The switch was found with the bolt at the south end of the No. 1 switch rod, and the bolts at the north end of Nos. 2, 3, and 4 switch rods removed and lying between the ties, with the nuts and cotter keys on the ties. The manner in which the switch rods had been disconnected permitted the south switch point to be moved over against the

south rail, and a spike was found near the south switch point which appeared to have been used to hold the point against the rail. Apparently this switch had been tampered with by some one who was familiar with track work and the operation of automatic signals, and was careful not to disturb the north switch point; had that point been moved more than 3/16 inch from the stock rail it would have broken the track circuit and caused the automatic block signal, located approximately 585 feet west of the switch, to display a red or stop indication.
