RAILROAD ACCIDENT INVESTIGATION

Report No 3806

NORFOLK AND WESTERN RAILWAY COMPANY

APRIL 6, 1958

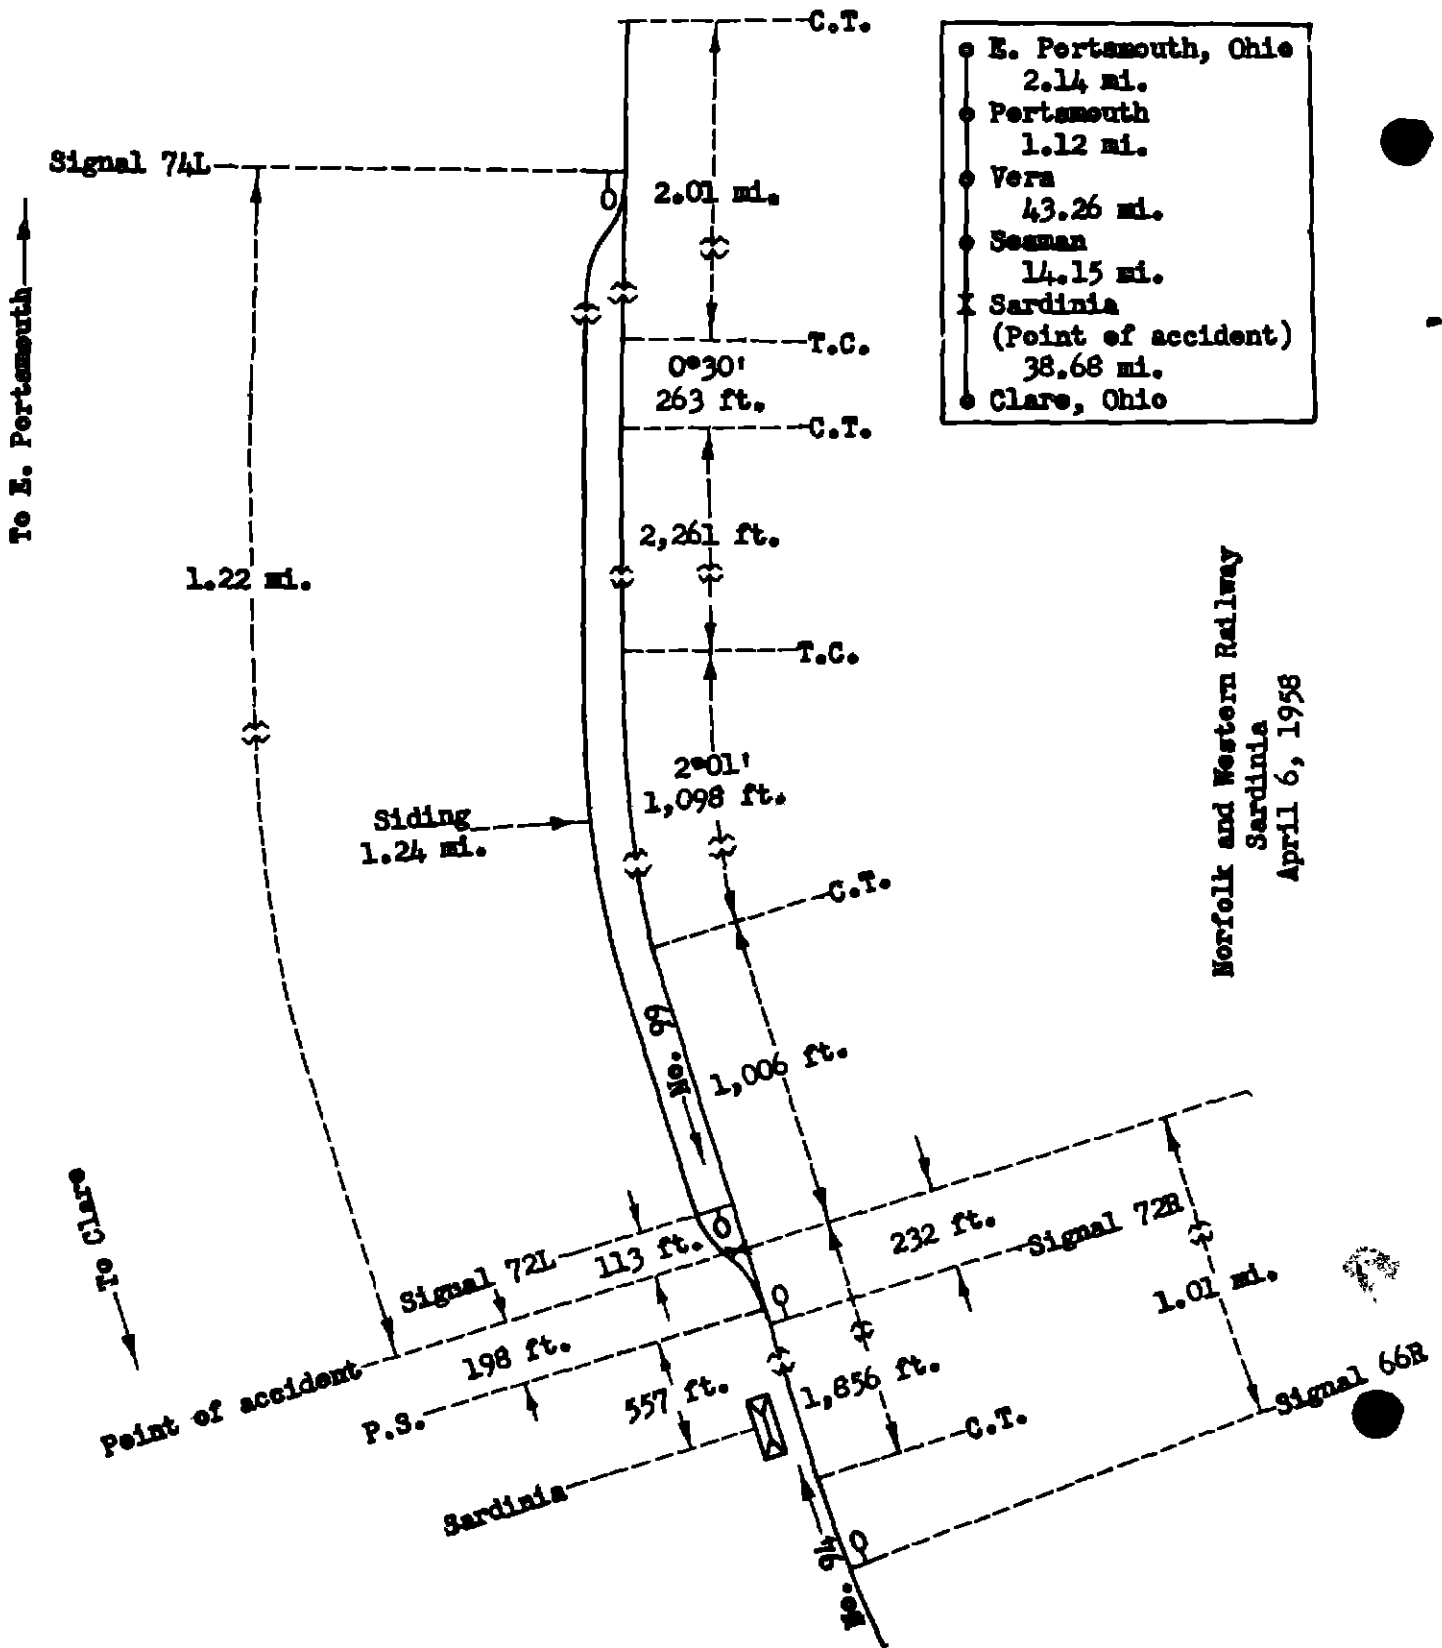
Norfolk and Western Railway
Sardinia
April 6, 1958

Point of accident

Location of Accident and Method of Operation

Controlled signals 66R and 72R governing eastbound movements are located, respectively, 1.01 miles and 232 feet west of the point of accident. Controlled signals 74L and 72L governing westbound movements are located, respectively, 1.22 miles and 113 feet east of the point of accident. These signals are of the position-light type and are continuously lighted. The aspects applicable to this investigation, and the corresponding indications and names are as follows:
