REPORT NO. 3553
NORFOLK AND WESTERN RAILWAY COMPANY
IN RE ACCIDENT
NEAR WHITE, W. VA., ON
JANUARY 12, 1954

Accident near White, W. Va., on January 12, 1954, caused
by failure to provide adequate protection for the
movement of a track motor-car.

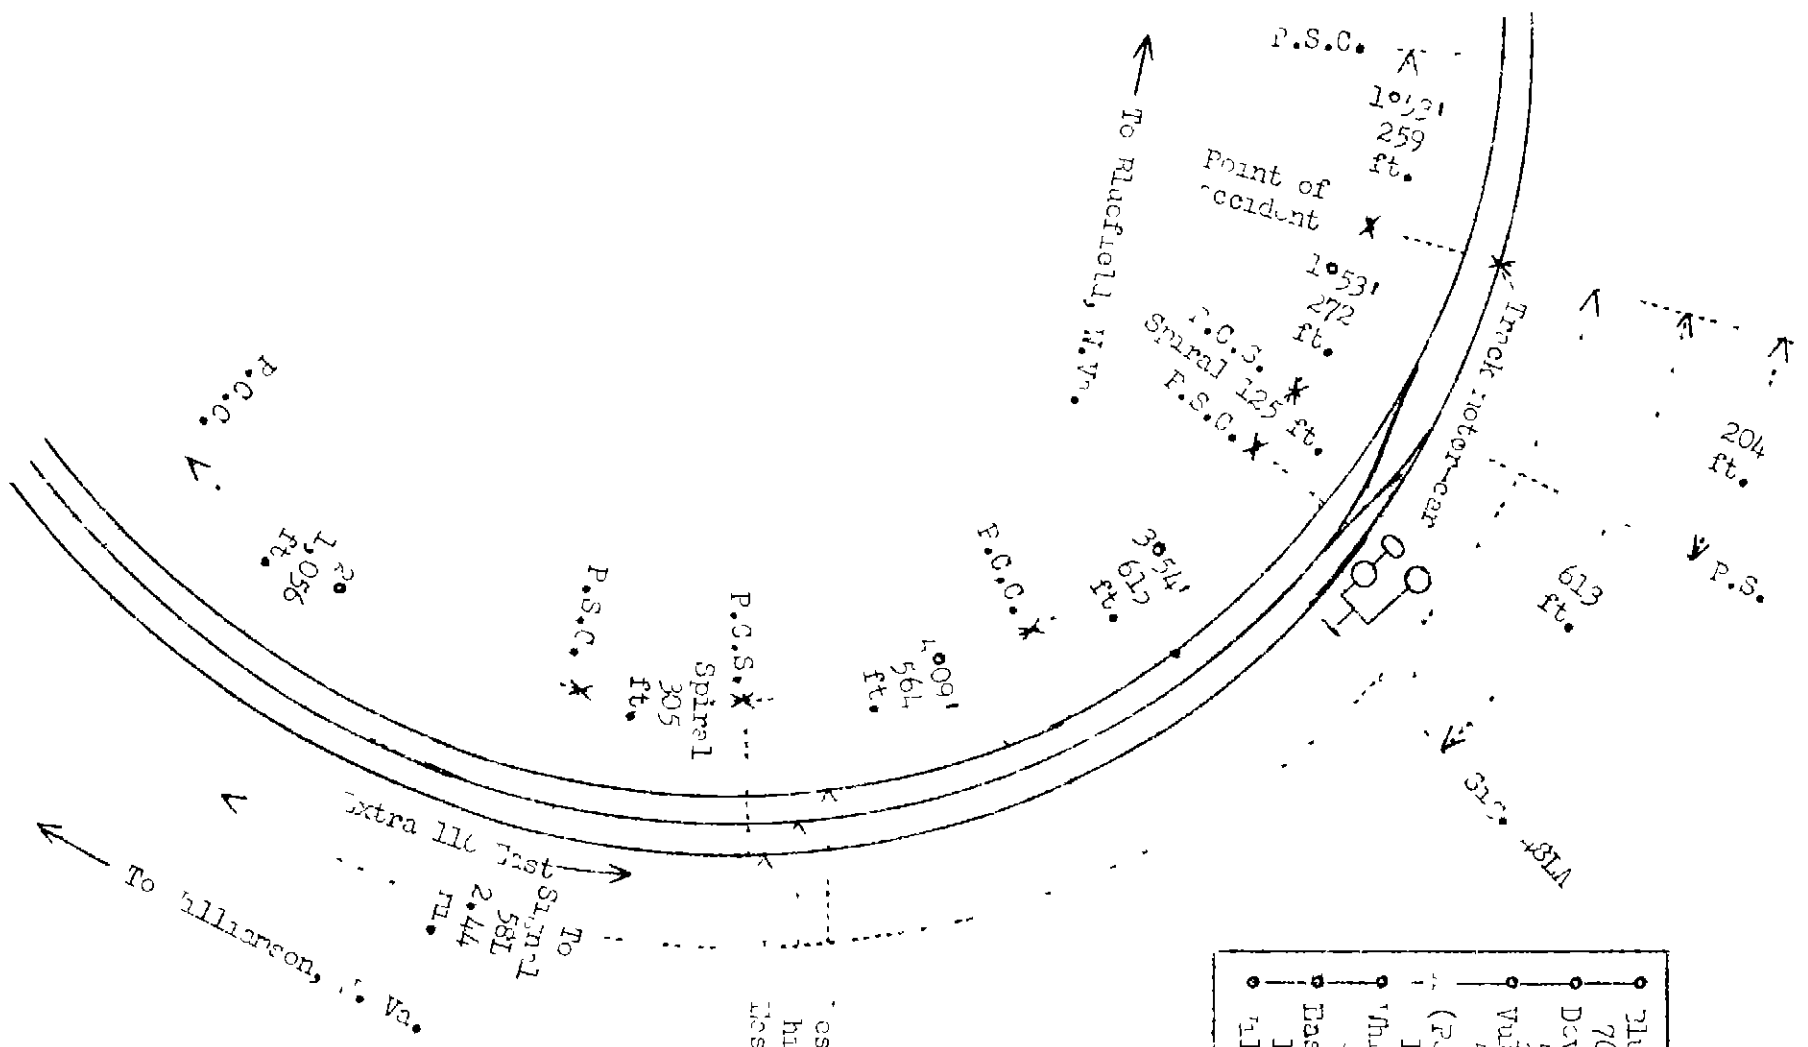
Report No. 3553
 Norfolk and Western Railway
 White, Va.
 January 12, 1954

Eastern Main Track
 into Station 2.4 mi.
 Western Main Track
