NATIONAL TRANSPORTATION SAFETY BOARD

RAILROAD ACCIDENT/INCIDENT SUMMARY REPORT

KNOX, INDIANA - SEPTEMBER 17, 1991

Accident Number:	DCA-91-MR-010
Location:	Knox, Indiana
Date and Time:	September 17, 1991, 8 a m central daylight time (CDT)
Railroad:	Norfolk Southern (NS)
Type of Trains:	Train 277, container-on-flat-car, train 629, molten sulphur tank cars
Persons on Board:	Train 277 and train 629 had three crewmembers each
Injuries:	One death, one serious injury, and four minor injuries
Damage:	\$3 5 million
Type of Occurrence:	Head-on collision, derailment, and hazardous- materials release
Phase of Operation:	Train 277--en route west on single main track, train 629--en route east

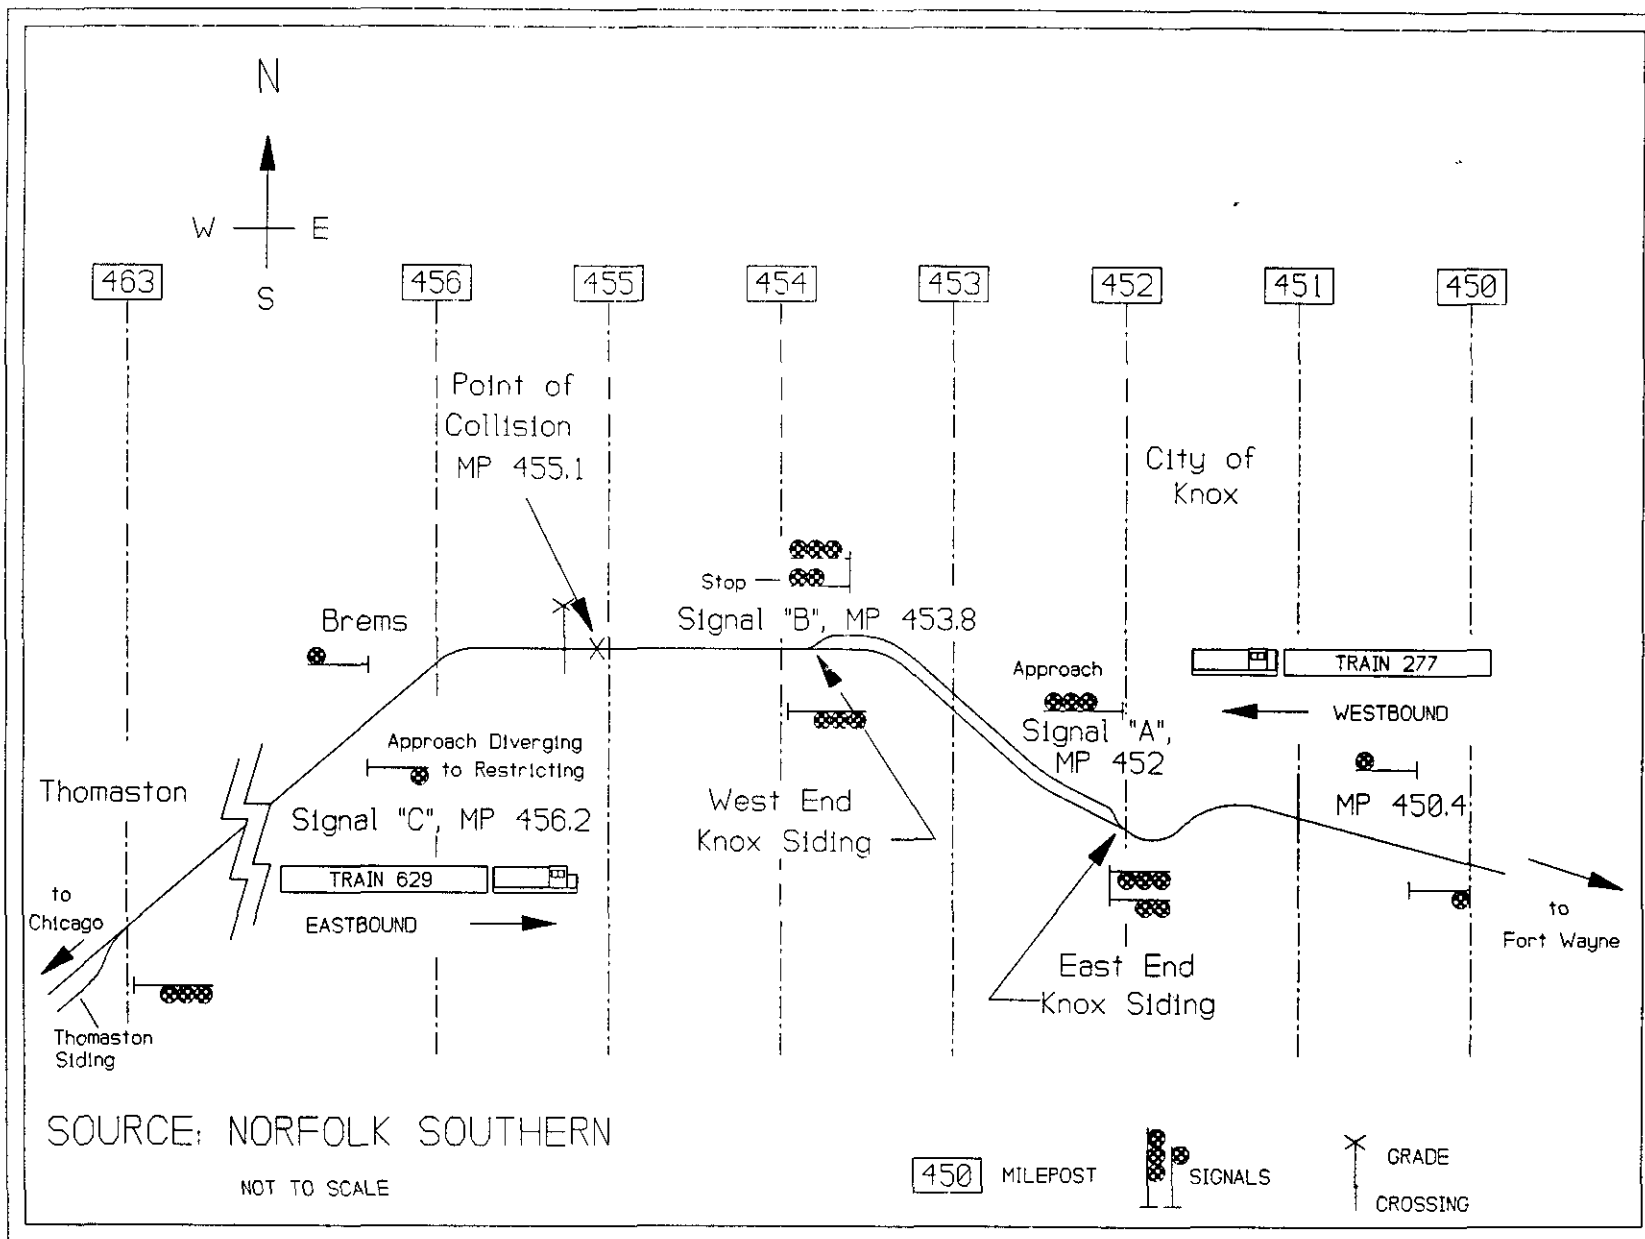
Figure 1 -- Knox siding

As train 629 neared signal C (MP 456.2), the "approach signal" for the west end of the Knox siding (see figure 1), the signal changed unexpectedly from "approach diverging" (the traincrew should be prepared to enter the siding at 25 mph) to "restricting" (the train should not exceed 15 mph and the traincrew should be prepared to stop the train short of an obstruction or another train). The unexpected signal change indicated that there was a problem, such as a broken rail or another train, between the signal and the west end of the siding. The engineer stated that the train was traveling about 46 mph when he first saw the "approach diverging" signal and applied the dynamic brake. To comply with the "restricting" signal, he increased the dynamic brake and later applied the automatic brake.

The student engineer said that he saw signal A (MP 452; see figure 1), the "approach" signal for the east end of the Knox siding, and thought it was clear, he did not describe the combination of colors that the signal showed. He also said he assumed the engineer saw the signal because the engineer was standing behind him. According to the student engineer, neither he nor the engineer called out the signal as required by operating rule 34. The student engineer stated that "as far as I know" (but he was not sure), the conductor called the signal clear.

Signal B (MP 453.8), the signal for the west end of the Knox siding, was clear, according to the student engineer. The investigation showed, however, that signal B, which is a "remote control" signal controlled by the dispatcher, displayed a "stop" signal. Train 277 should have stopped at signal B, which governs movement of trains on the main track at the west end of the siding. The student engineer stated that he observed "green over red" (the color combination that signifies clear) on the left column of signal lights. He said that neither he nor the engineer, who was in the middle of the cab at the time, called the signal. The conductor had moved from the rear seat to the front seat on the left side, and he called "clear," according to the student engineer, who said the signal was clear as the train passed it. The student engineer reported that he did not notice which way the switch was lined (whether it was set to allow train 277 to proceed on the main track or to allow train 629 to enter the siding). He estimated the train's speed at 35 mph and increasing when the locomotive passed the signal and switch.

proceeded to Brems, MP 456 2, where signal C showed "approach diverging," indicating that the train was to enter the siding (See figure 1)

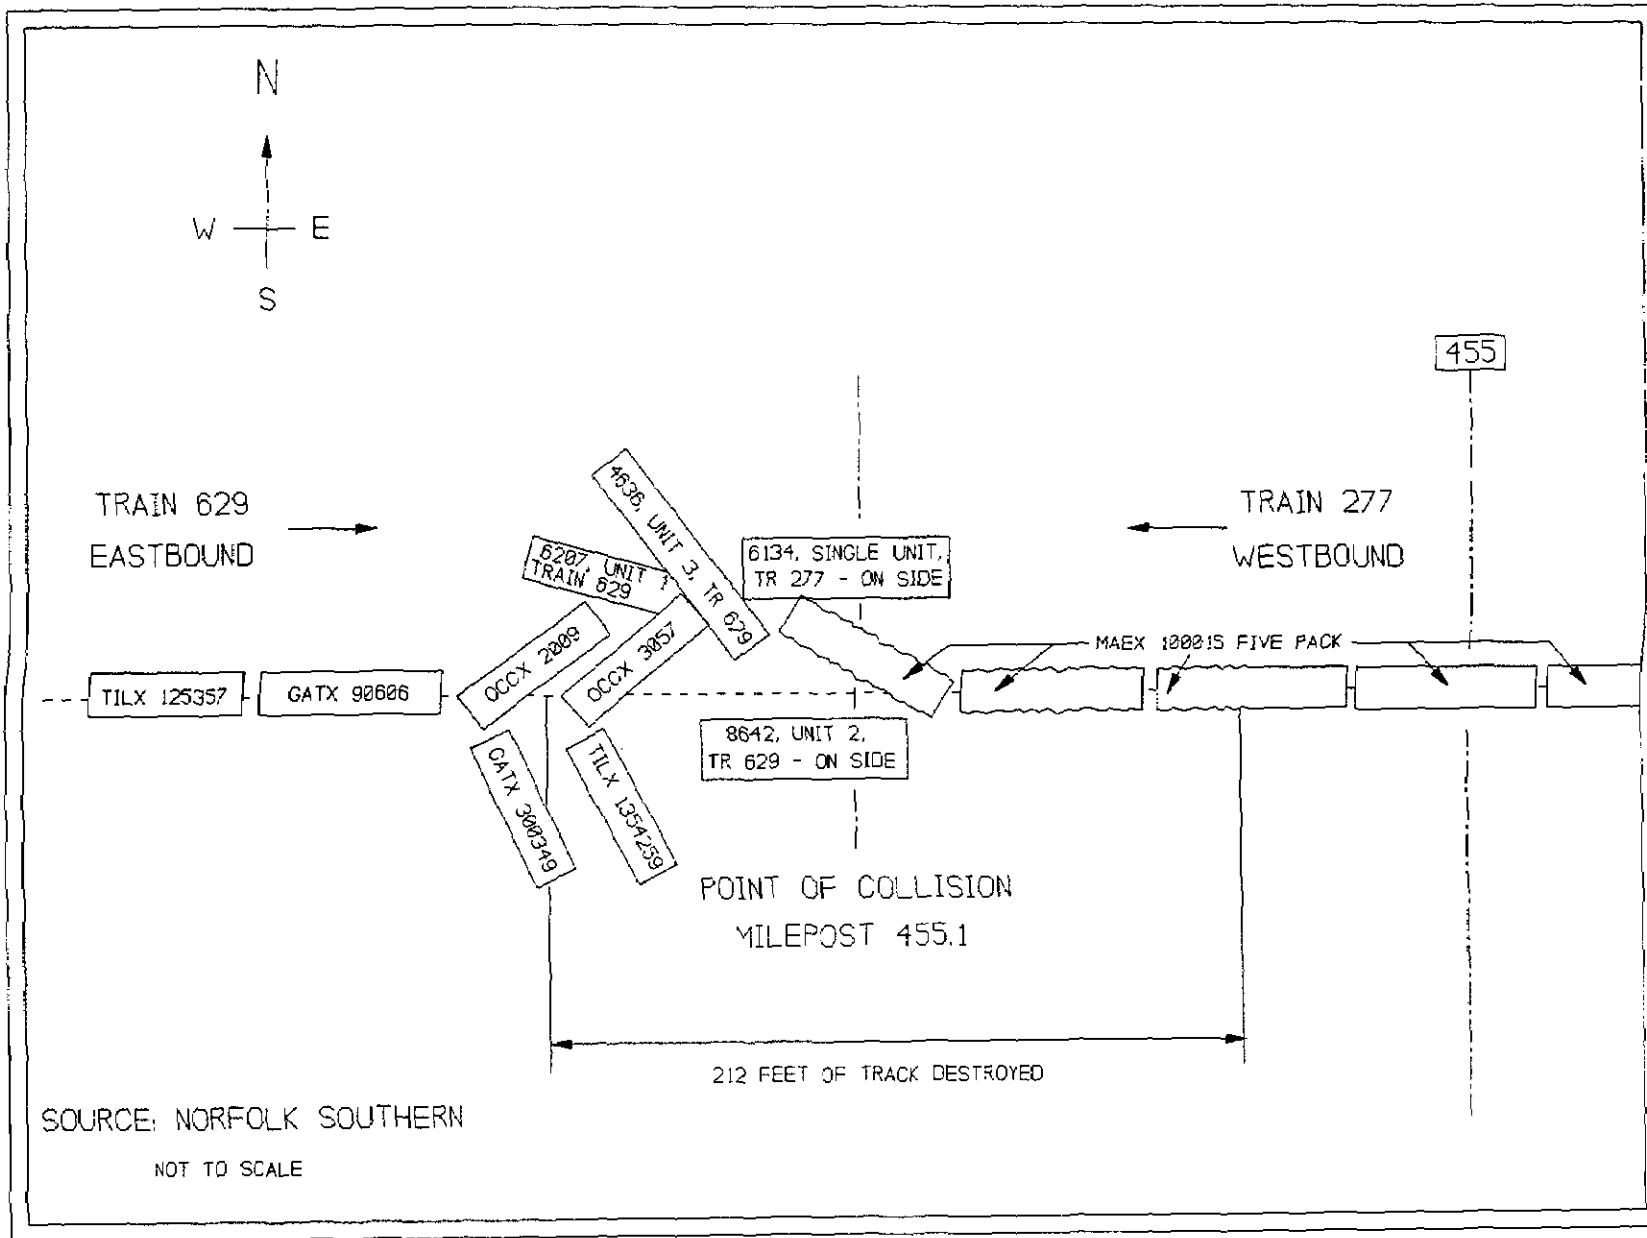
Figure 3.-- Collision Site

fuel ignited and burned the wreckage. The switch at the west end of the Knox siding and 212 feet of track at the point of the collision were destroyed (See figure 3)

The Safety Board's investigation team determined that the switch had been destroyed when train 277 passed through it while it was lined to allow train 629 to enter the siding. Train 277 bent the points and throw rods on the switch assembly.
