INVESTIGATION NO. 2530
THE NORFOLK SOUTHERN RAILROAD COMPANY
REPORT IN RE ACCIDENT
NEAR OAKBORO, N. C., ON
SEPTEMBER 24, 1941

Railroad: Norfolk Southern
Date: September 24, 1941
Location: Oakboro, N. C.
Kind of accident: Derailment
Train involved: Freight
Train number: 62
Engine number: 601
Consist: 20 cars, caboose
Estimated speed: 25 m.p.h.
Operation: Timetable and train orders
Track: Single; 4° curve to right; 1.1
percent ascending grade northward
Weather: Clear, hot
Time: About 1:25 p.m.
Casualties: 3 killed; 1 injured
Cause: Kinked track

Accident near Oakboro, N. C., on September 24, 1941, caused by
kinked track.

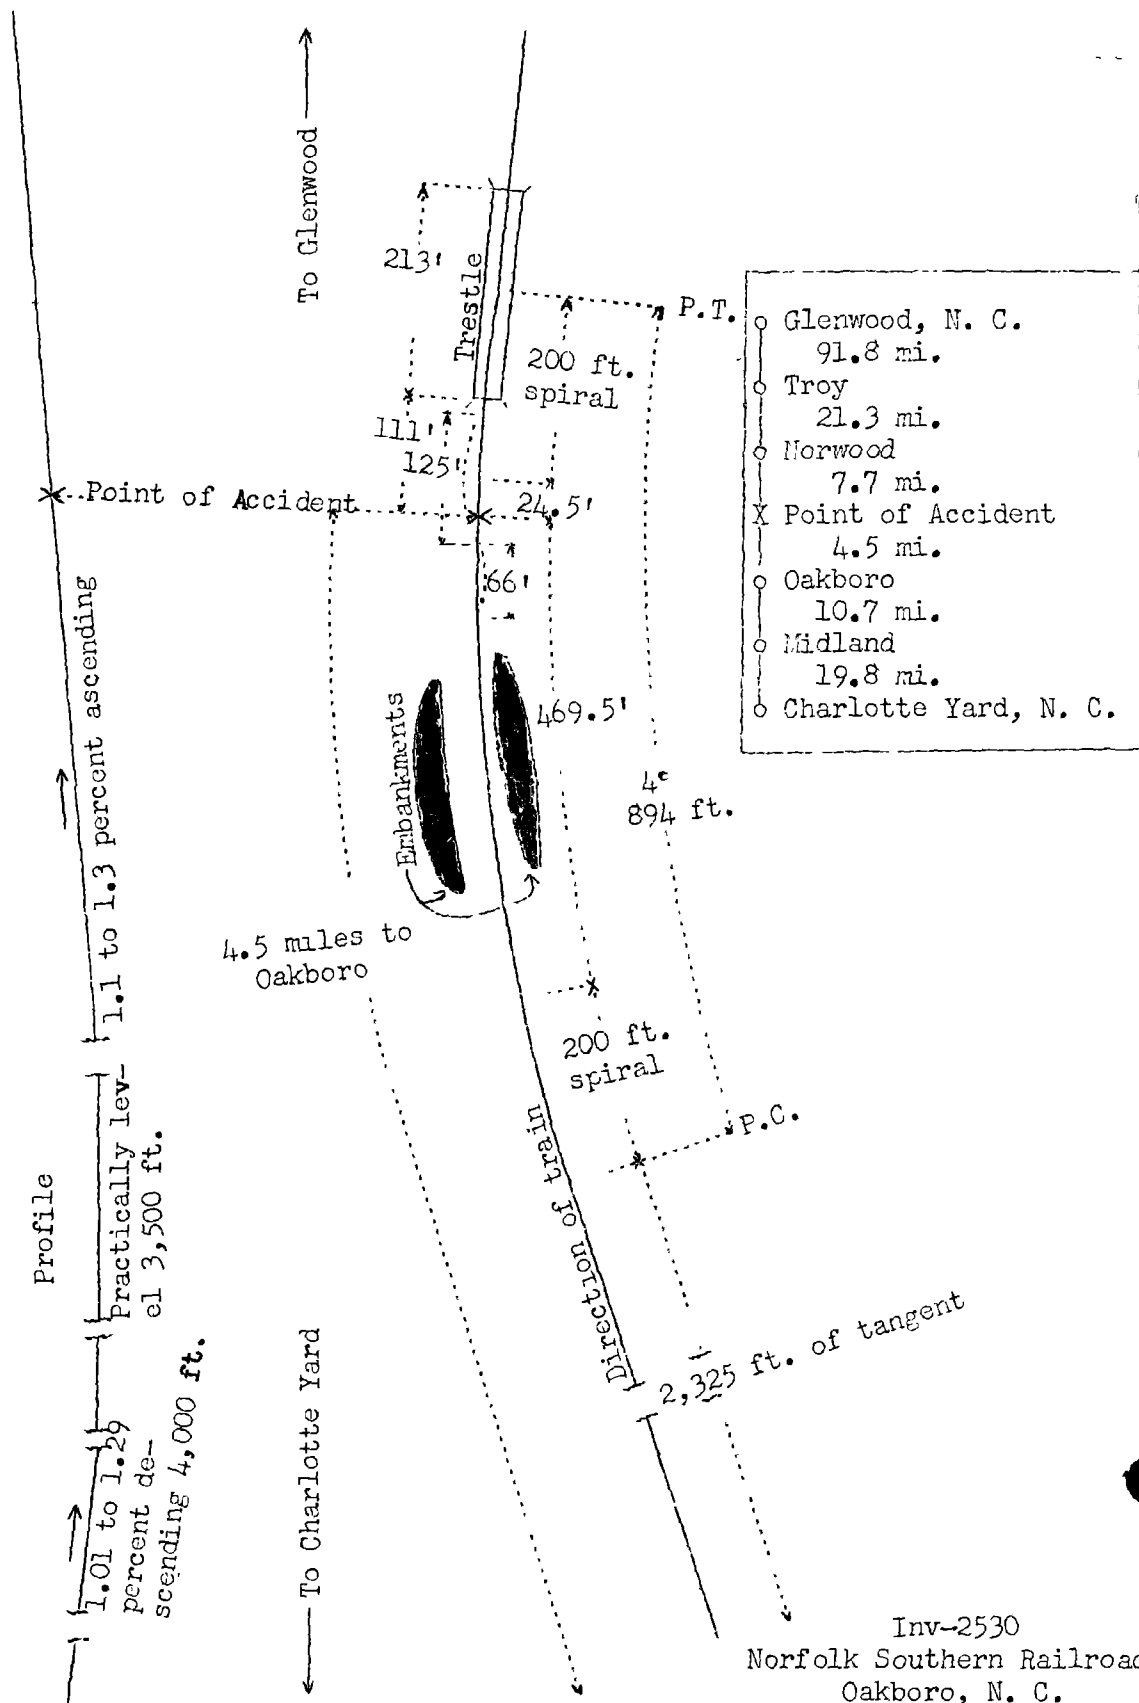
Inv-2530
 Norfolk Southern Railroad
 Oakboro, N. C.
 September 24, 1941

Prior to the time of accident, a section of track 191 feet long within the curve involved was displaced. Northward from a point 585.5 feet north of the south end of the curve, the track was displaced throughout a distance of 66 feet. The maximum displacement was 17 inches to the east of the normal center-line. Immediately north of this section, the track was displaced to the west of the normal center-line throughout a distance of 125 feet. The maximum displacement was 32 inches. The maximum curvature of the first section was about $12^{\circ}00'$ to the right and of the second section about $12^{\circ}00'$ to the left. The derailment occurred at a point 18 feet north of the south end of the second section, at which point the displacement was 9 inches to the west of the normal center-line.

After the accident it was found that a section of track 66 feet long on the 4-degree curve to the right was deflected to the east and formed a 12-degree curve to the left. Immediately north of this section, a section of track 125 feet long was deflected to the west and formed a 12-degree curve to the right. At a point 18 feet north of the south end of the second section of displaced track, a wheel-tread mark appeared on the

The displacement of the track occurred on a 1.1 to 1.3 percent ascending grade northward and on a 4-degree curve. The foot of this grade was 1,685 feet south of the point where the displacement occurred. South of the foot of this grade the track was level a distance of about 3,500 feet, and south of this there was a 1.1 to 1.29 percent ascending grade southward. Since rail anchors were not used and since it was necessary a year prior to the accident to shorten the rail sufficiently to permit the track to be realigned properly, it appears probable that the rail gradually crept down the grade during the past year and caused the rail joints on the lower end of the grade to be compressed. This condition, combined with high temperature, ballast that offered little resistance to lateral movement of the track, and track curvature, resulted in the track being kinked.
