PB91-916302
NTSB/RAR-91/02

RAILROAD ACCIDENT REPORT

COLLISION AND DERAILMENT
OF NORFOLK SOUTHERN TRAIN 188
WITH NORFOLK SOUTHERN TRAIN G-38
AT SUGAR VALLEY, GEORGIA
AUGUST 9, 1990

**ADOPTED: JULY 9, 1991
NOTATION 5367A**

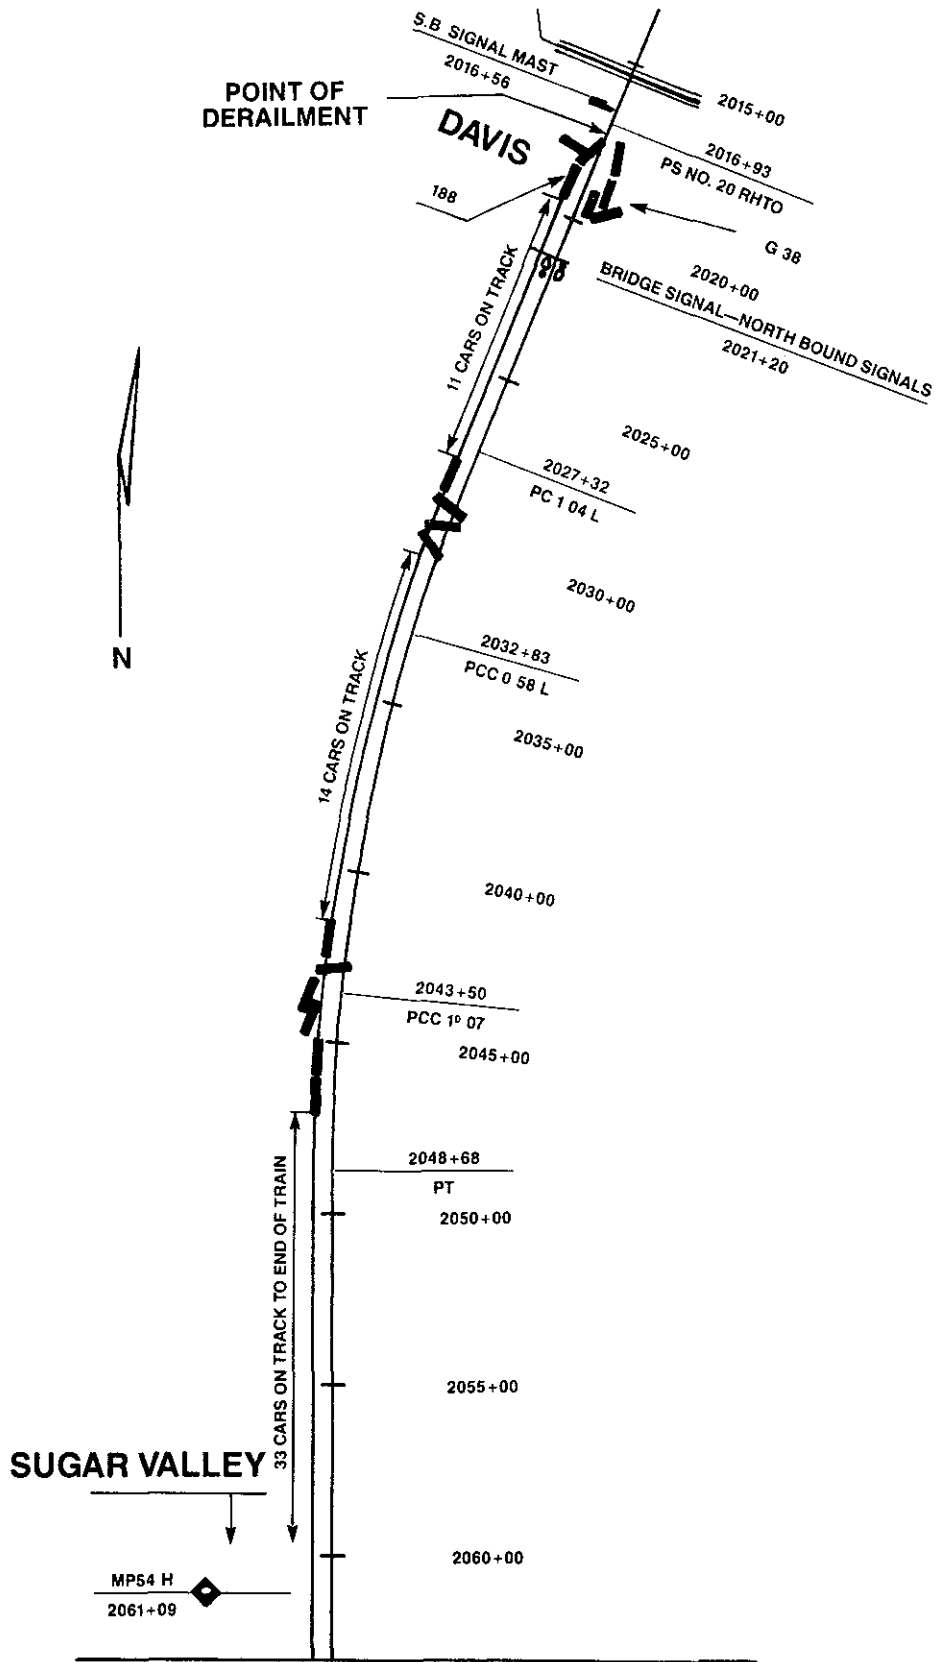
Figure 2.--Accident site CP SUGAR Valley to CP DAVIS.

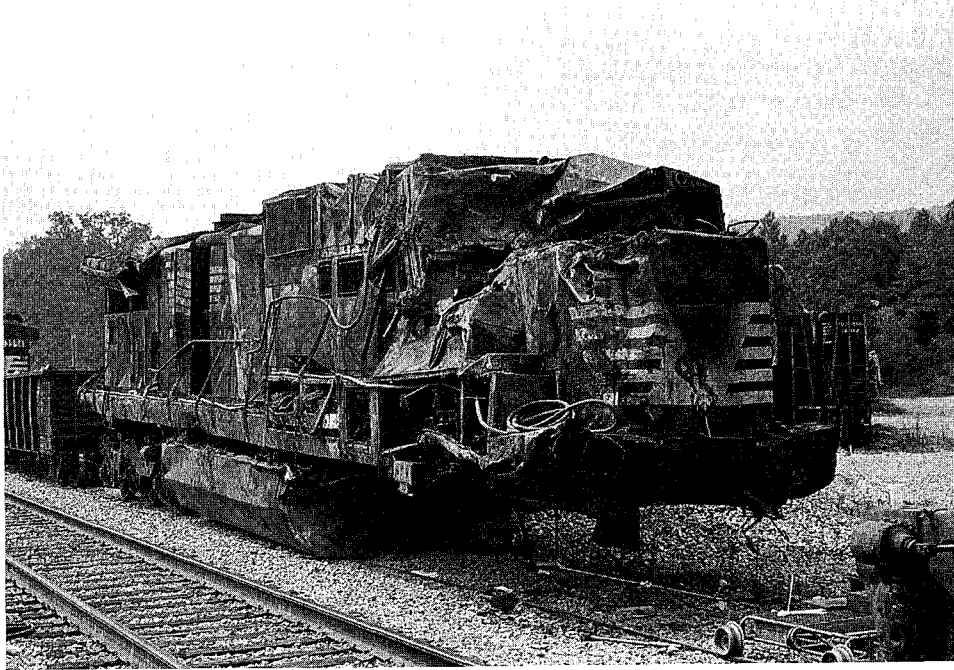
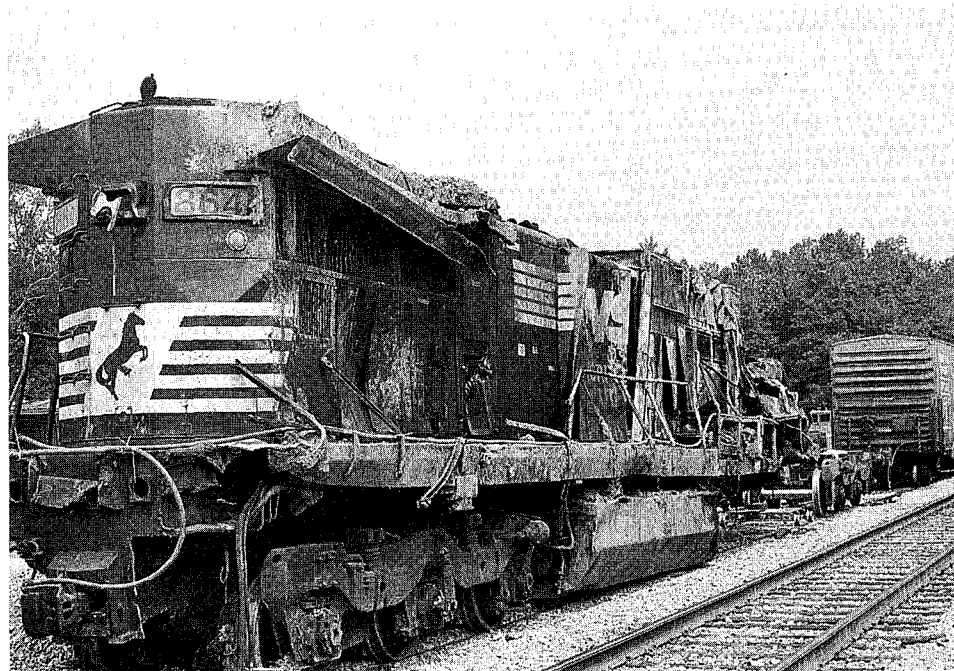
Train 188 --The lead locomotive unit derailed and came to rest about 90 feet to the west of and at a 90-degree angle to the track. It lay on its right side with the short hood pointed toward the west. Both trucks were separated from the unit, and its fuel tank was dented and ruptured. Fire had damaged the short hood and the part of the long hood that was over the fuel tank. The right side of the control cab was severely crushed inward, and no survivable space remained between the conductor's console and the right exterior wall. The interior of the cab was extensively damaged by heat (see figure 3). The grab rails along the exterior right side had collapsed inward. The power switch was on, and the dynamic braking switch was off.

Figure 3.--Two photos of damage to the lead unit, NS 8641, of train 188.

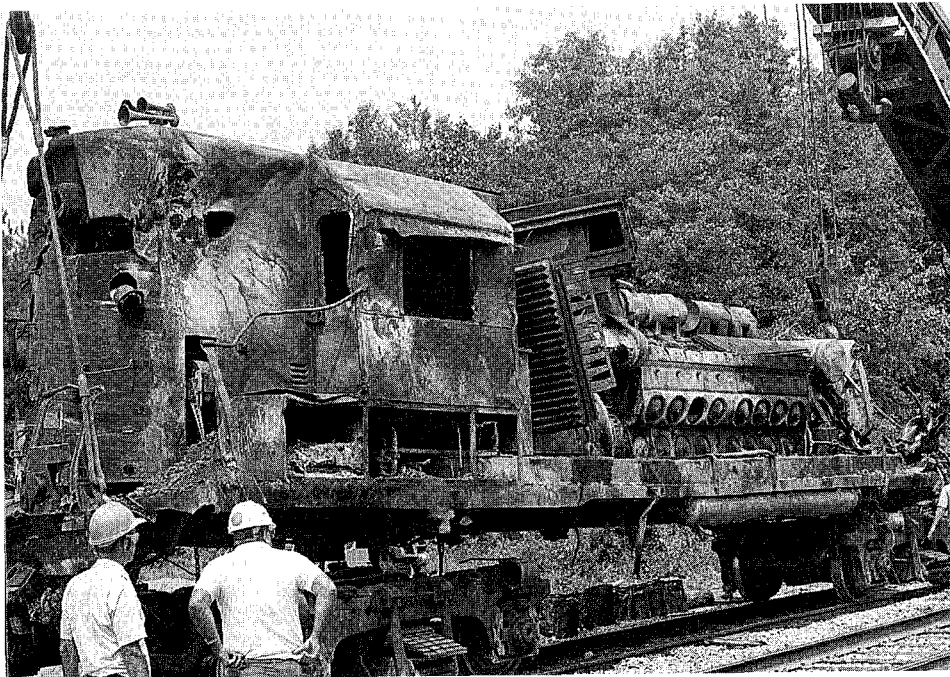
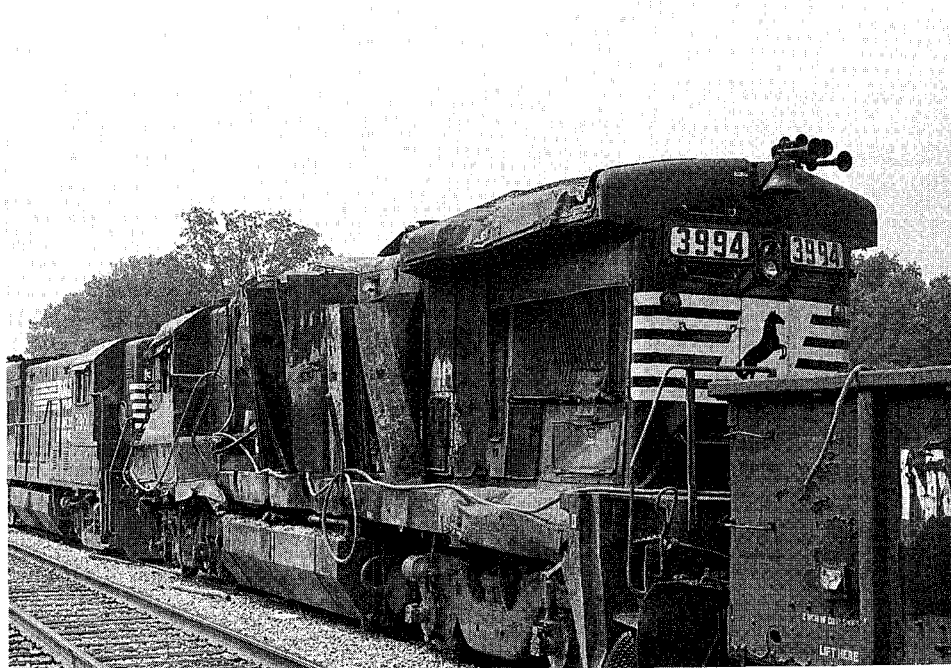
Train G-38--The lead locomotive unit derailed to the east of the main track; it lay on its right side with the long hood pointed south. All the sheet metal that had surrounded the engine was torn away. The locomotive was off its trucks, and its fuel

tank was torn off. The cab interior was intact and had no apparent structural damage, but thermal damage was extensive. (See figure 4.)

The sheet metal and grab rails of the right front of the second locomotive unit were damaged thermally and structurally. (See figure 4.) The fuel tanks were punctured, and the locomotive was on its right side. The interior of the cab was not visibly damaged.

Figure 4.--Two photos of damage to the locomotive of train G-38.
