REPORT NO. 3763
NORFOLK SOUTHERN RAILWAY COMPANY
IN RE ACCIDENT
NEAR EDENTON, N. C., ON
JULY 5, 1957

Accident near Edenton, N. C., on July 5, 1957, caused by
failure of a trestle.

Report No. 3763
Norfolk Southern Railway
Edenton, N. C.
July 5, 1957

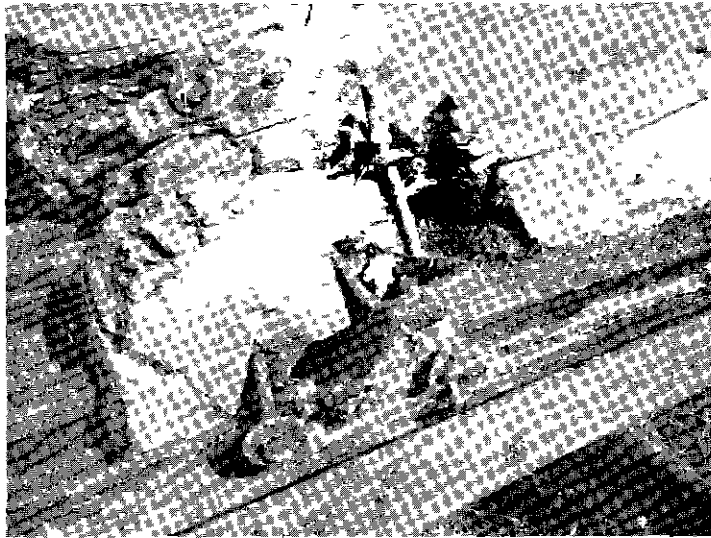
In the vicinity of the point of accident the trestle consisted of frame-type bents. The penetration of the piles was approximately 40 feet. At low tide the depth of the water is about 20 feet. The water level varies approximately 2 feet. There was no indication that equipment had been derailed before the trestle failed. The frames of 11 bents were destroyed when the accident occurred. Twenty-one piles of these bents remained in place. Since only about 20 percent of the trestle members involved in the accident were recovered, the sequence of events that led to the failure of the trestle could not definitely be determined. There was no indication of damage to the piles by marine borers. One batter post of a frame involved in the accident was decayed near the bottom end to the extent that only approximately 30 percent of the original cross-sectional area was effective in bearing the load applied to the post. (See Plate 1.)

Plate 1. Showing the extent of decay found at the bottom end of a batter post of one of the frame-type bents involved in the accident.

2. That any member of the structure disclosed by this inspection to have deteriorated to such an extent that it can no longer be relied upon to perform its intended function, as well as those portions of the trestle found during the investigation of this accident, some of which are illustrated in this report, to be in such an advanced state of deterioration as obviously to necessitate their renewal, be replaced immediately, in order to preclude the possibility of recurrence of the type of failure that resulted in collapse of the structure.

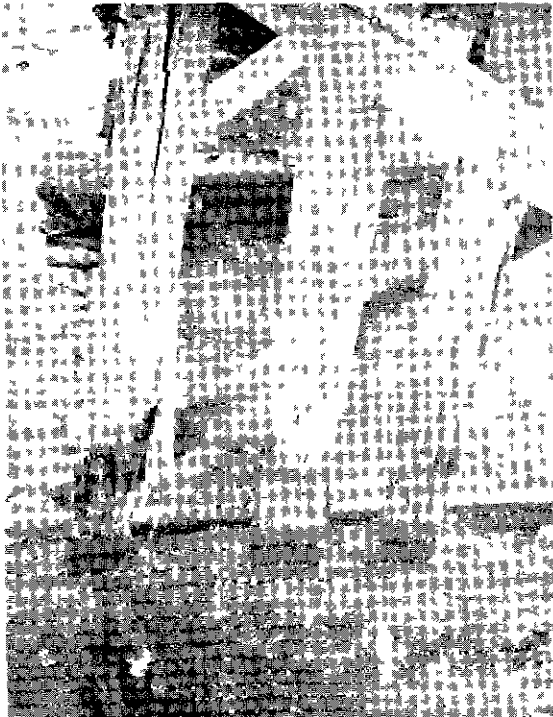
Plate 2. Showing failure of the east outside batter pile of an original full-pile bent because of decay; also shows longitudinal split.

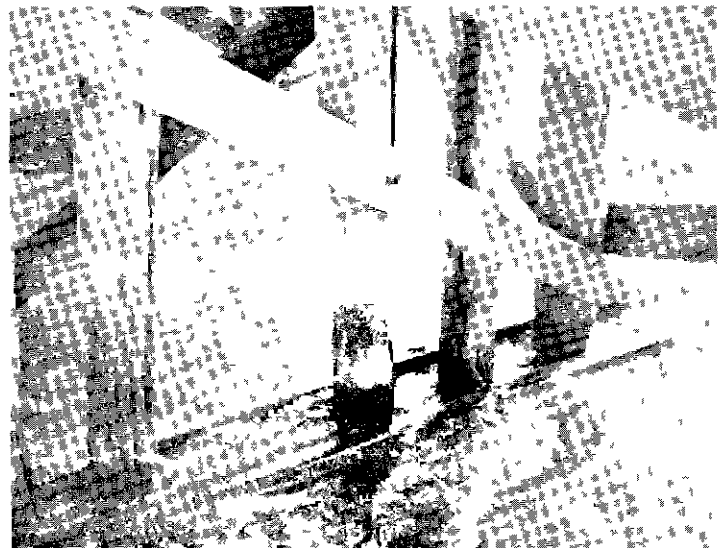
Plate 3. Showing extent of decay in other piles of the original full-pile bent shown in Plate 2.

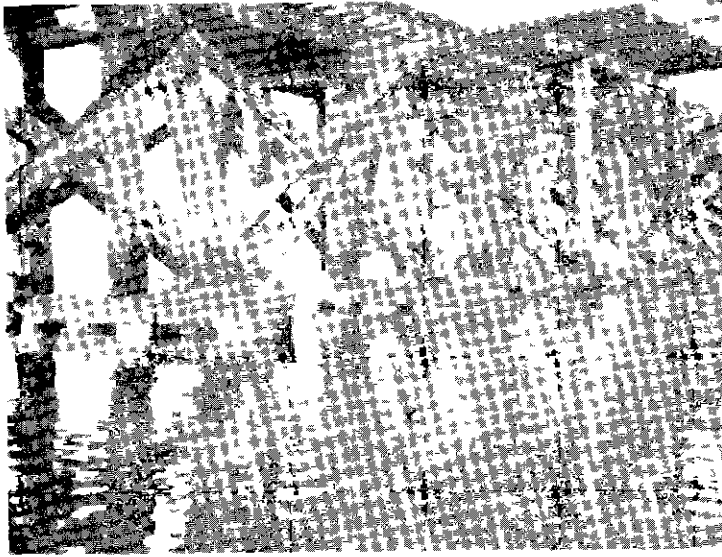
have been distributed over six piles. A considerable number of frame-type bents were found in which the sill was not bearing on the outside batter pile. In some cases the pile was missing or had moved from its proper location, and in other cases the pile was in its proper location but the top of the pile had deteriorated to the extent that it was not in contact with the sill. (See Plates 4 and 5.) Under that condition the unsupported end of the sill was required to withstand the force transmitted by the batter post and high bending stresses were produced in the sill where it was supported by the inside batter post. Two bents were found in which the sills had failed because the top of the outside batter pile was not in contact with the sill. (See Plates 6 and 7.) In each case the outside batter pile was in its proper location and prevented the sill from breaking off completely. It is probable in each of these cases that if the outside batter pile had moved from its proper location or had been missing the bent would have failed.

Plate 4. Showing outside batter piles of frame-type bents which have moved from proper location or are missing.

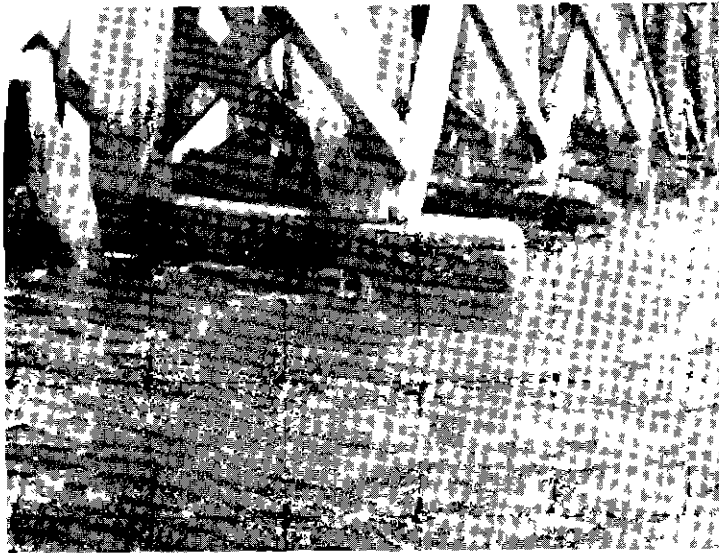
Plate 5. The top of the outside batter pile in the foreground had deteriorated to the extent that the base sill is not bearing on it. Note that the nearest point of support on the base sill is provided by the pile under the plum post.

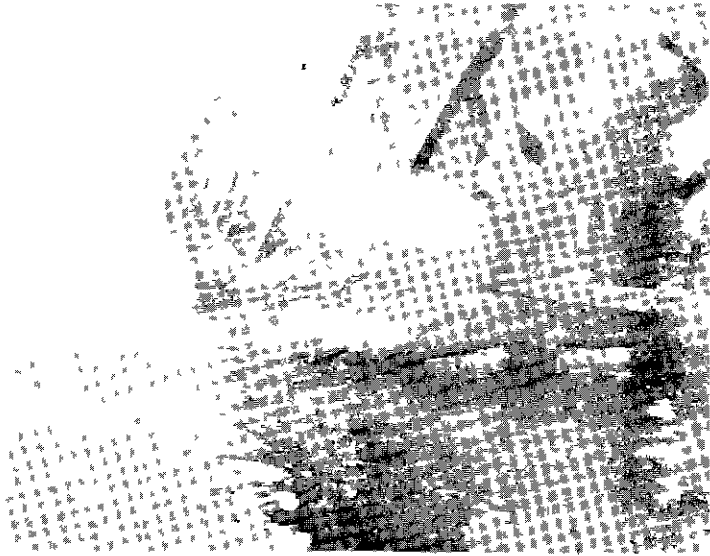
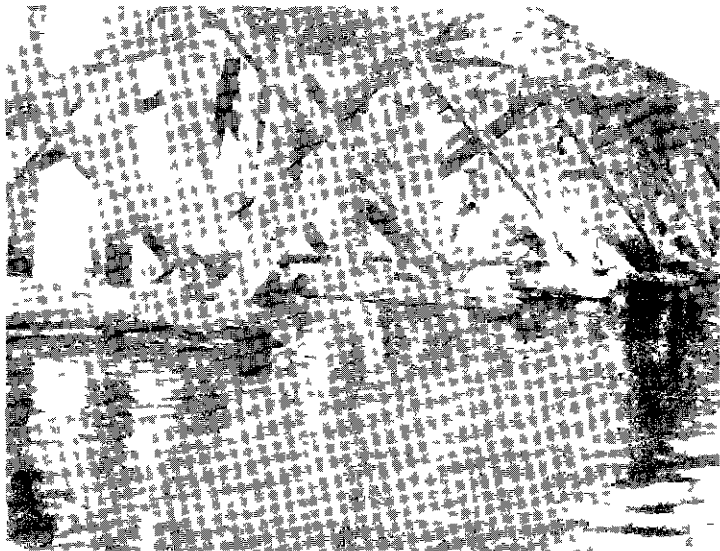
Examination of the remaining portion of the trestle from the deck after the accident occurred disclosed that a large number of ties were in various states of decay. None of the decayed ties were adjacent to each other. A number of stringers were decayed but not more than one decayed stringer was found in any group of three stringers on either side of the trestle. Examination from the water level disclosed that a number of piles of the bents containing the original full piles were in various states of decay. The outside batter pile of one of these bents had split longitudinally and had decayed near the water line to the extent that it had failed. Two other piles in this bent were considerably decayed. (See Plate 2 and 3.) The tops of the piles supporting the frames of a considerable number of frame-type bents had deteriorated to the extent that the sills were not bearing on them. Some of these bents had as many as three piles in that condition with the result that the sill was subjected to high bending stresses and three piles were bearing a load which should

Showing failure of base sills of frame-type bents because of deterioration of the tops of the outside batter piles.
