RAILROAD ACCIDENT REPORT

COLLISION BETWEEN NORTHERN INDIANA
COMMUTER TRANSPORTATION DISTRICT
EASTBOUND TRAIN 7 AND WESTBOUND TRAIN 12
NEAR GARY, INDIANA, ON JANUARY 18, 1993

Abstract: On January 18, 1993, Northern Indiana Commuter Transportation District (NICTD) eastbound commuter train 7, traveling from Chicago, Illinois, to South Bend, Indiana, and NICTD westbound commuter train 12, traveling from South Bend to Chicago, collided at milepost 61.1 in Gary, Indiana. Seven passengers died and 95 people sustained injuries.

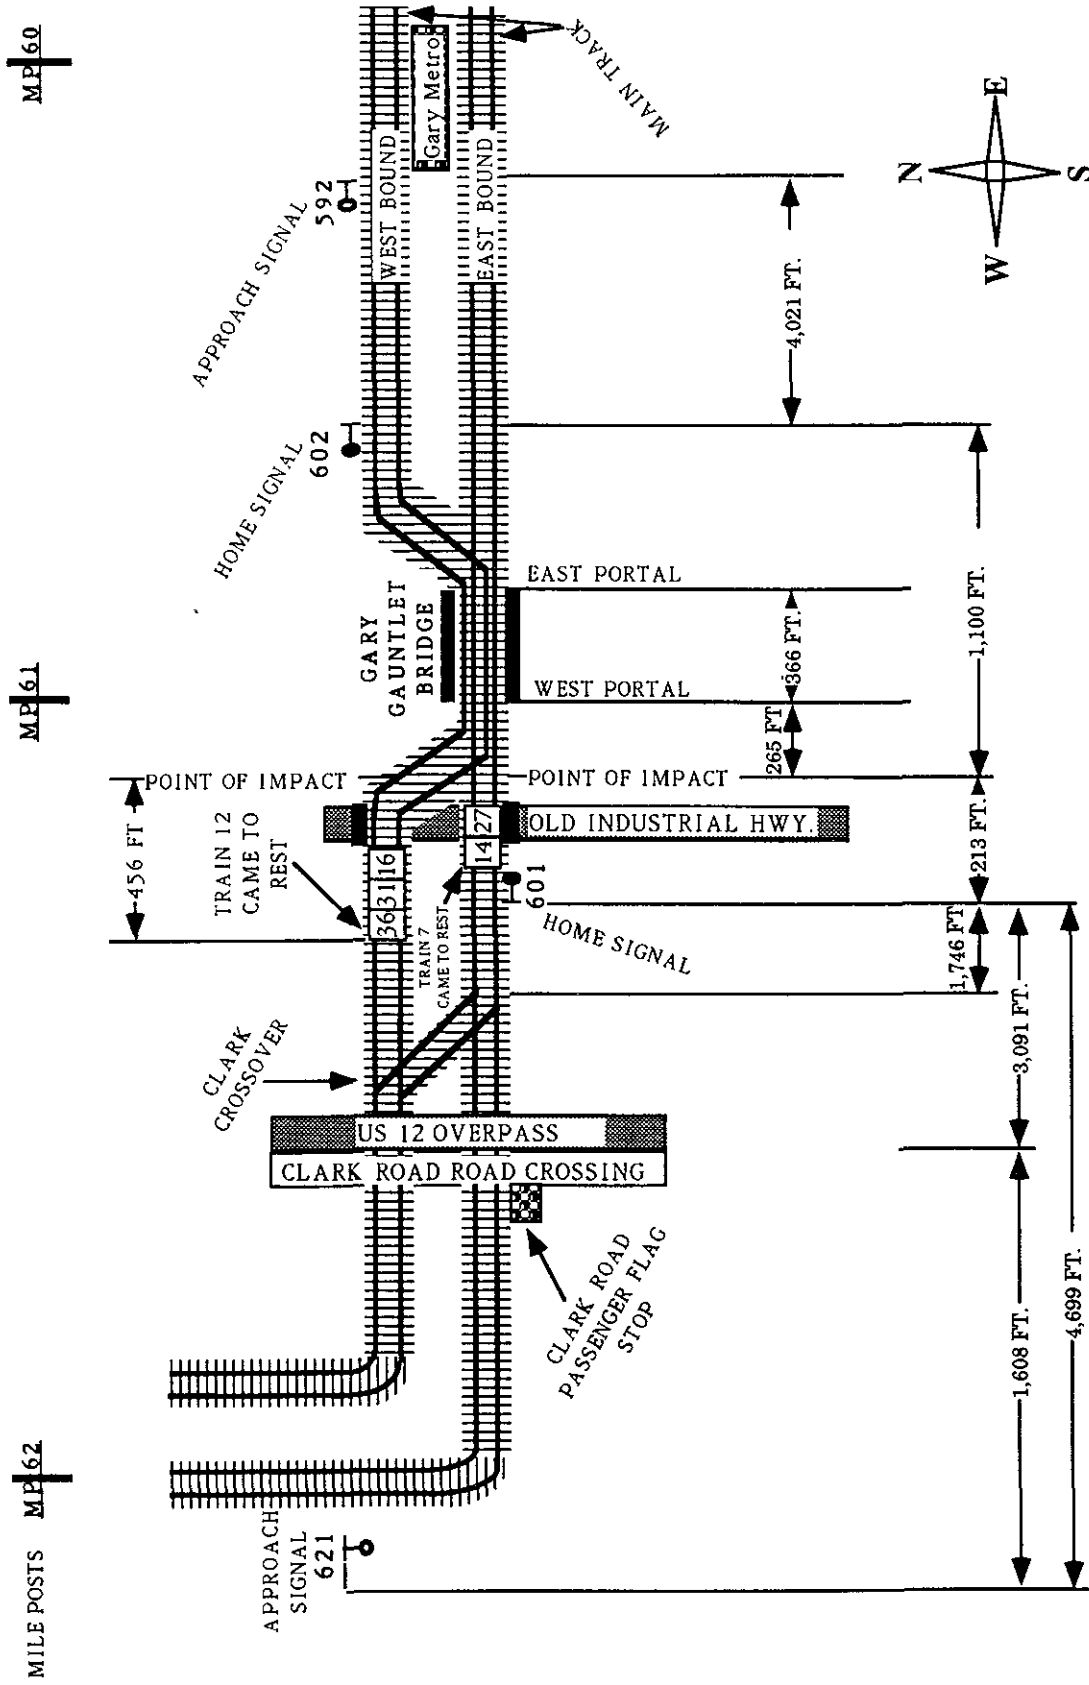
Figure 2.--Postaccident track diagram.

The engineer of train 7 continued by saying that he recalled when the signal looked "dark," he then stood up to have a better view and saw the signal was "red." He added that the train was about 212 feet west of the signal when he saw it as "red" and that he immediately placed the train brakes in emergency application. Train 7 came to rest about 213 feet east of signal 601 and encroached the westbound track by 1 foot. (See figure 2.) The engineer said that once train 7 came to "rest," he could see train 12 on the bridge. This train collided with train 7, which pushed train 7 westward about 12 feet from the point of impact.

At Ogden Dunes, Indiana, a deadheading⁶ collector/brakeman, who was also qualified as an engineer, boarded train 12 and entered the control compartment (The normal NICTD practice is for the engineer to be alone in the control compartment while operating the train) Both he and the engineer said that they called signals en route as prescribed by the NICTD rules⁷ and noted that before the Gary Gauntlet Bridge, both signals 592 and 602, which governed the train over the bridge, displayed a proceed indication They saw train 7 approaching, as train 12 was then on the bridge, from the west. As train 12 crossed and exited the bridge, the engineer and collector/brakeman saw that train 7 had passed signal 601. When the collector/brakeman saw train 7 was in the path of train 12, he left the control compartment, entered the passenger compartment, and dove onto a row of seats The engineer stated that he put train 12 into emergency braking as the collector/brakeman left the control compartment The engineer control stand is in the right corner of the control compartment The left front corner of the train 12 lead car struck the left front corner of the train 7 lead car Train 12 came to rest 456 feet west of its point of impact with train 7

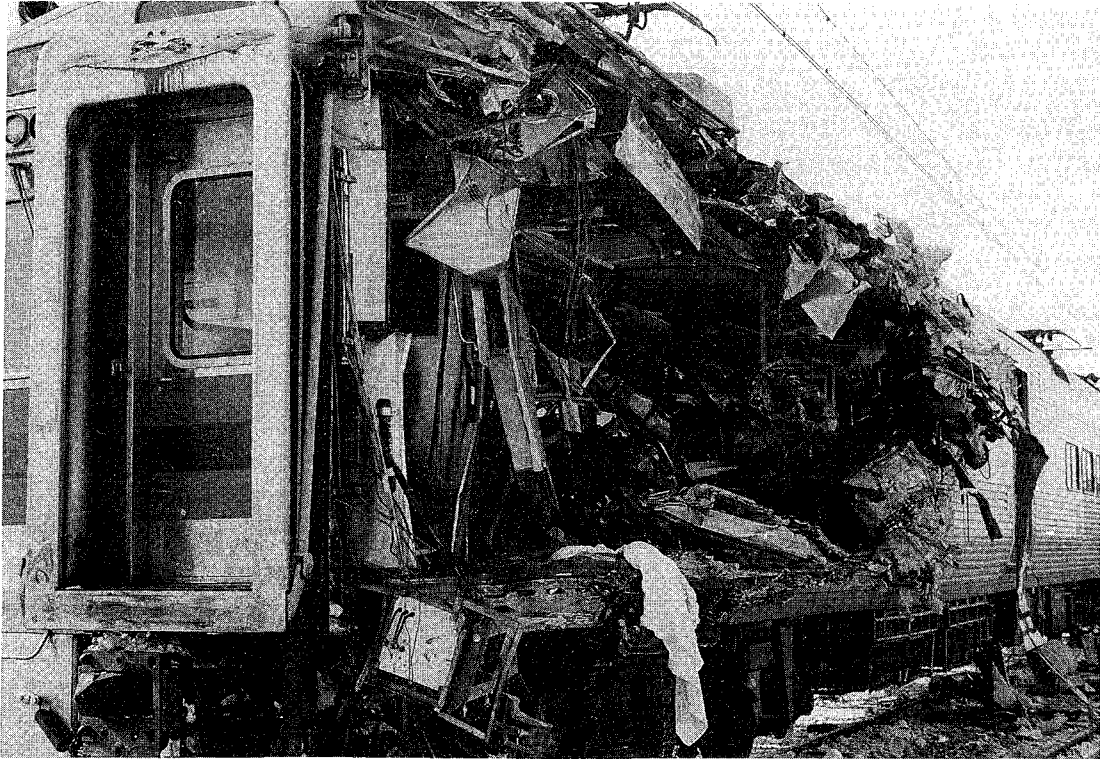
a.--Car 27 on train 7.

Train 7 Collision Damage -- Impact damage was concentrated to the left front corner on lead car 27 of train 7 (See figure 4a.) The entire left front corner post structure, which included the door structure and the front of the car, was missing from floor to roof. The car body sidewall separation extended about 27 feet.

An interior inspection of car 27 revealed a wall of impact debris near the sidewall separation, however, virtually no damage or debris was at the opposite end of the car. A single, large segment of car body wall had intruded and rotated into the car, and it was wedged at 90 degrees to its initial orientation across the compartment against the opposite wall. Jagged pieces of sheet metal, broken seats, and related impact debris were strewn about the area. Inspection of several damaged seats revealed that their seatbacks and legs were bent in the opposite direction to their normal mounted position and were torn from their floor mountings.

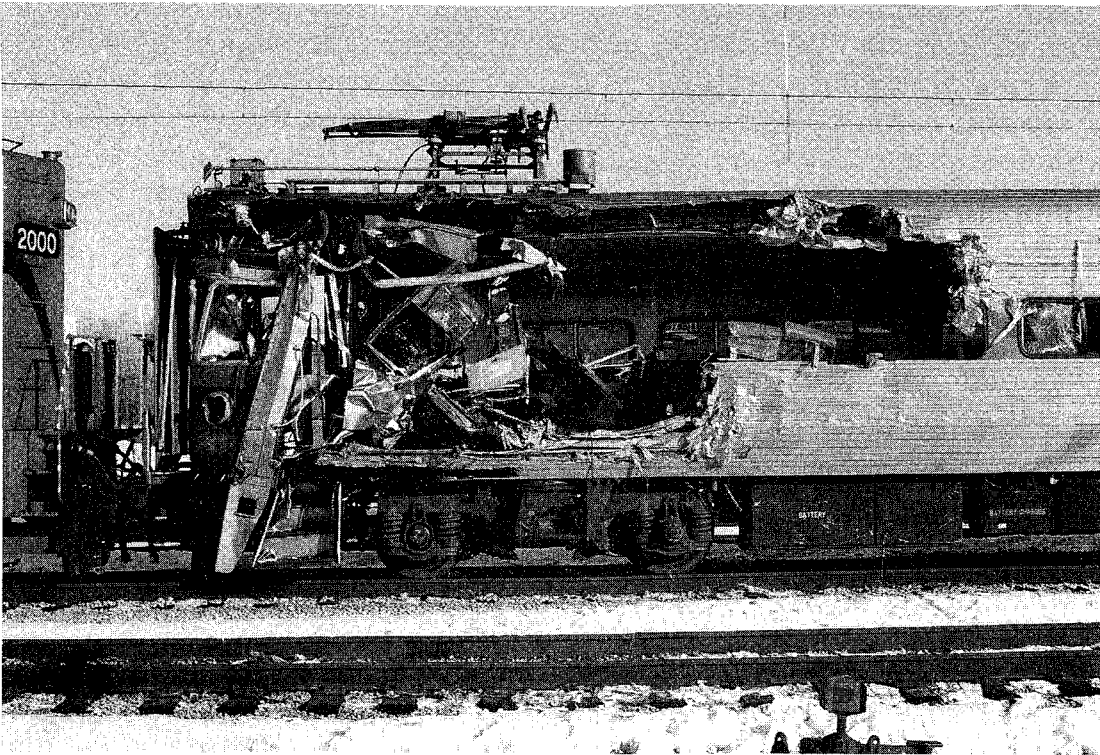
b.--Car 36 on train 12.

Train 12 Collision Damage -- Impact damage was concentrated to the left front corner on lead car 36 on train 12. (See figure 4b.) An external inspection of the car body side structure revealed a major separation from the left corner of the front end, extending along the left side, to and including the third window, this separation extended about 27 feet. The front left corner post structure was displaced about 1 foot inward and about 2 feet rearward from floor to roof. The door frame structure adjacent to the left front corner post appeared structurally unaffected by the impact. Significant dents, gouges, and gashes were visible in the sheet metal panel structure. A vertical indentation was on the left front panel of the car, outboard of the headlight. This indentation was about a foot from the extreme corner edge and extended from the lower frame of the left front window down to the car floor.

The car body sidewall structure from the floor to the roof, including the left front door and door pocket, was missing. The car body sidewall had separated at this point, and a jagged edge was visible along the floorline and the roofline of the separation. Inspection of several damaged seats revealed that their seatbacks and legs were bent in the opposite direction to their normal mounted position and were torn from their floor mountings. Seats, bent almost flat to a fully collapsed condition, were stacked upon the adjacent seats in a fallen-domino configuration. Impact scratches and gouges were visible on the ceiling and interior car body wall opposite the separation.

A single segment of sidewall that consisted of an intact, although visibly damaged, window and related window/sidewall framing intruded into the car. Attached to the car body wall, it was suspended about 5 feet from the floor in a horizontal orientation, pointing in a rear direction. The tube frame of the luggage rack was dented at a point opposite its attachment to the car body wall.
