INTERSTATE COMMERCE COMMISSION
WASHINGTON

INVESTIGATION NO. 3056

NORTHERN PACIFIC RAILWAY COMPANY
AND
CHICAGO, SAINT PAUL, MINNEAPOLIS AND OMAHA
RAILWAY COMPANY

REPORT IN RE ACCIDENT
AT ASHLAND JCT., WIS., ON
DECEMBER 31, 1946

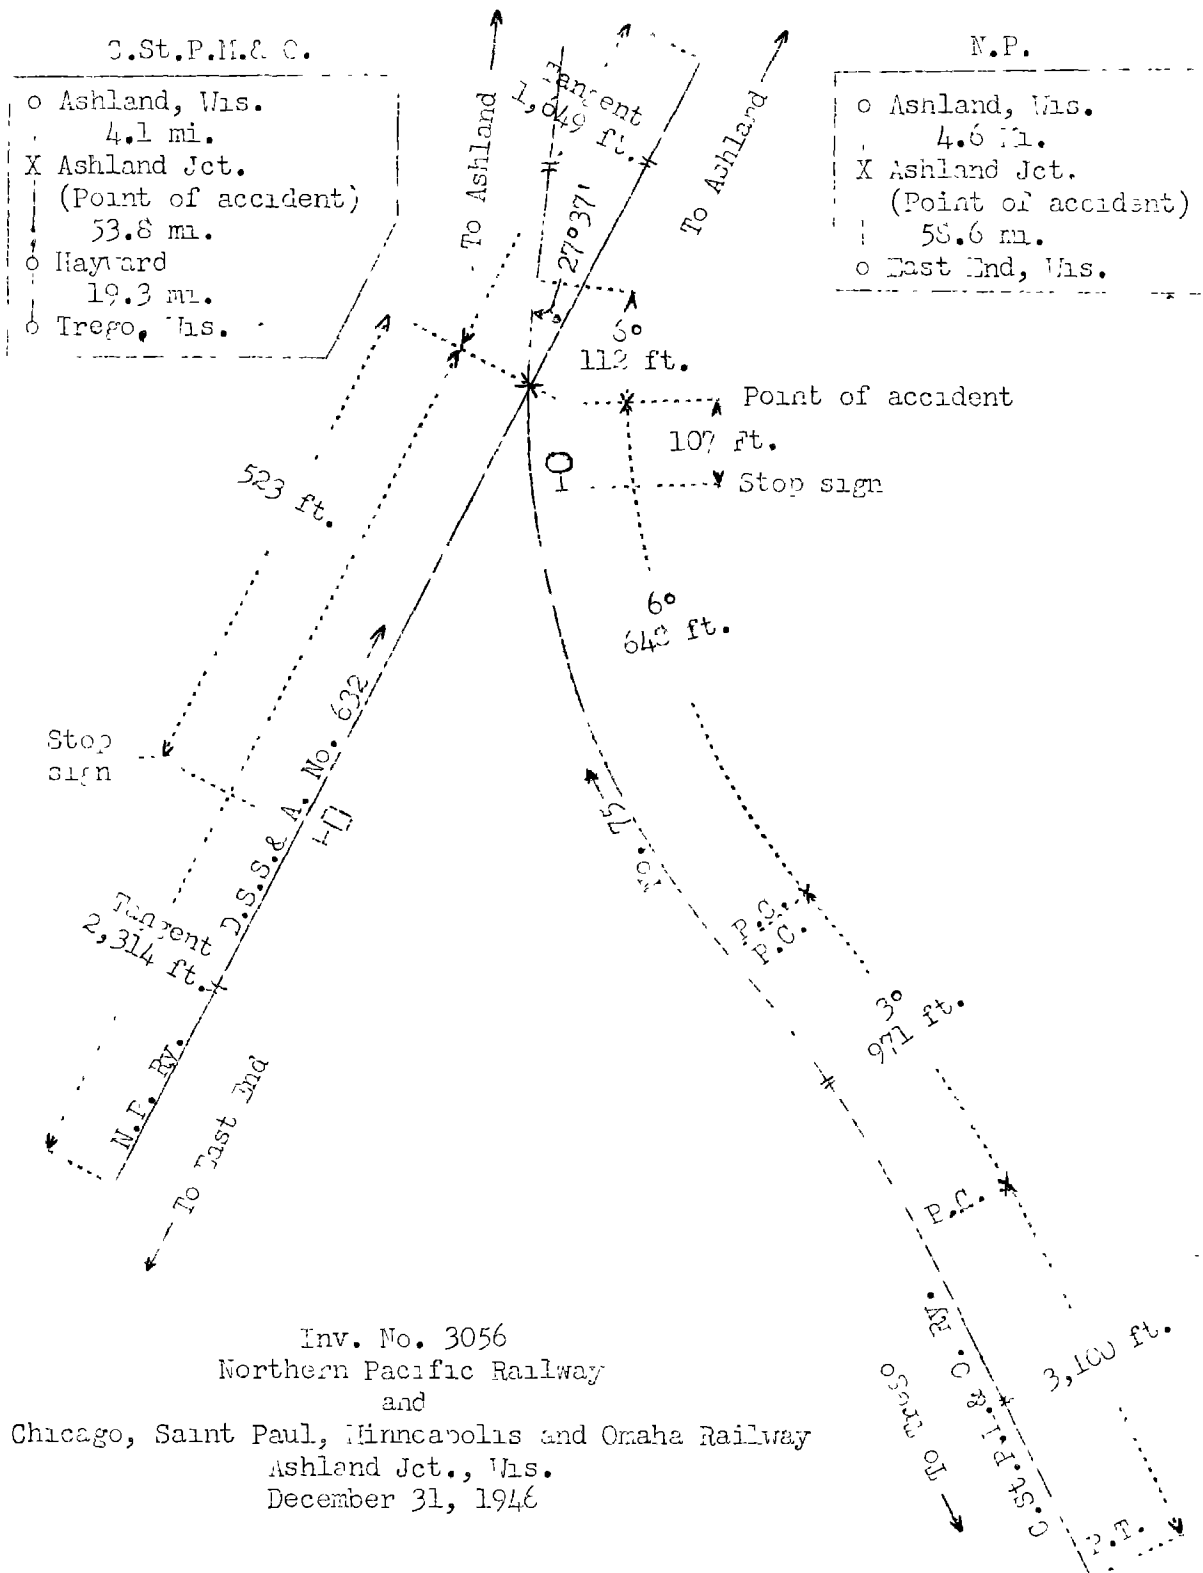
Inv. No. 3056
 Northern Pacific Railway
 and
 Chicago, Saint Paul, Minneapolis and Omaha Railway
 Ashland Jct., Wis.
 December 31, 1946

The accident occurred at the intersection of a line of the Northern Pacific Railway and a line of the Chicago, Saint Paul, Minneapolis and Omaha Railway at Ashland Jct., Wis. The crossing is located on that part of the Lake Superior Division of the N.P. extending between East End and Ashland, Wis., 63.2 miles, and on that part of the Eastern Division of the C.St.P.M. & O. extending between Trego and Ashland, Wis., 77.2 miles. According to the timetables, Ashland Jct. is 58.6 miles east of East End and 73.1 miles west of Trego. In the vicinity of Ashland Jct. both are single-track lines, over which trains are operated by timetable and train orders. There is no block system in use on either line. Trains of the Duluth, South Shore & Atlantic Railway are regularly operated over the N.P. line. At the crossing the main track of the N.P. intersects the main track of the C.St.P.M. & O. at an angle of 27°37'. The N.P. main track extends northwest and southeast, and the C.St.P.M. & O. main track extends southwest and northeast. Timetable directions are hereinafter used in this report. The N.P. main track is tangent throughout a distance of 2,314 feet immediately west of the crossing and 1,649 feet eastward. The grade is practically level. From the east on the C.St.P.M. & O. there are, in succession, a tangent 3,100 feet in length, a 3° curve to the left 971 feet and a 6° curve to the right 648 feet to the crossing and 112 feet westward. The grade for west-bound trains varies between 0.51 percent and 0.95 percent descending throughout a distance of about 1 mile immediately east of the crossing, where it is 0.51 percent descending.

Stop signs governing movement of east-bound trains on the N.P. and west-bound trains on the C.St.P.M. & O. are, respectively, 523 feet west and 107 feet east of the crossing.
