RAILROAD ACCIDENT INVESTIGATION

REPORT NO. 4126

NORTHERN PACIFIC RAILWAY COMPANY

PLATEAU, MONT.

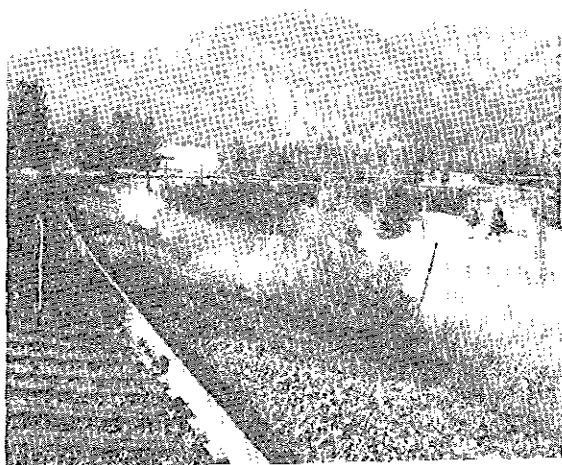
A highway bridge spans the main track 1,959 feet west of the collision point. Because of this bridge, track curvature, and trees on the north side of the railroad, the view between an eastbound track motorcar and a westbound train approaching the collision point is materially restricted. However, when the track motorcar passes the highway bridge, its occupants may look across the curve and between trees, and see portions of any westbound train approaching within a distance of about $1\frac{1}{2}$ miles. The maximum unobstructed range of vision between an eastbound track motorcar and the locomotive of a westbound train nearing the collision point is 975 feet.

View westward from collision point.

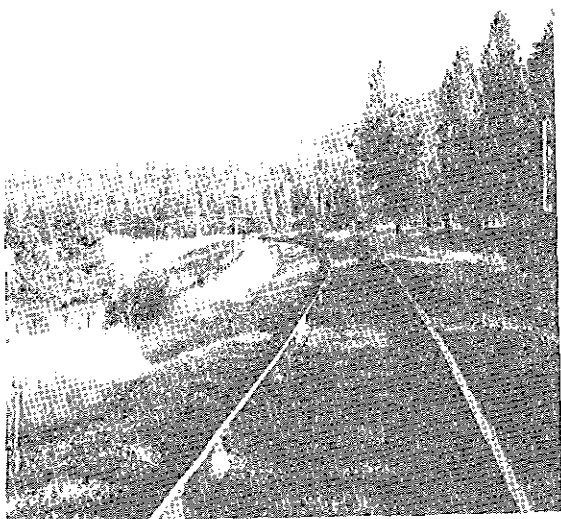
View eastward from collision point.
