REPORT OF THE DIRECTOR OF THE BUREAU OF SAFETY IN RE
INVESTIGATION OF AN ACCIDENT WHICH OCCURRED ON
THE NORTHERN PACIFIC RAILWAY AT DIXON, MONT.,
ON APRIL 4, 1931.

INV. NO. 1699
NORTHERN PACIFIC RAILWAY
DIXON, MONT.
APRIL 4, 1931.

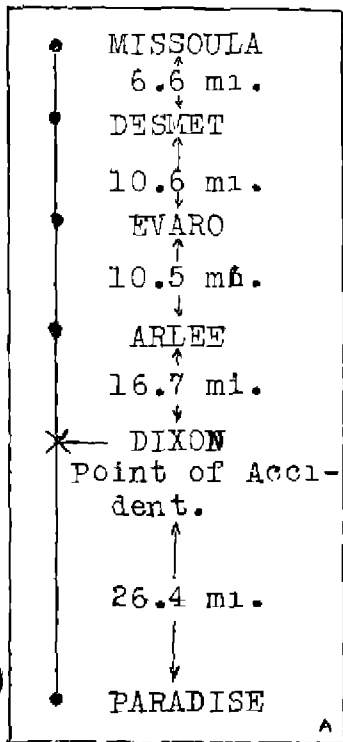
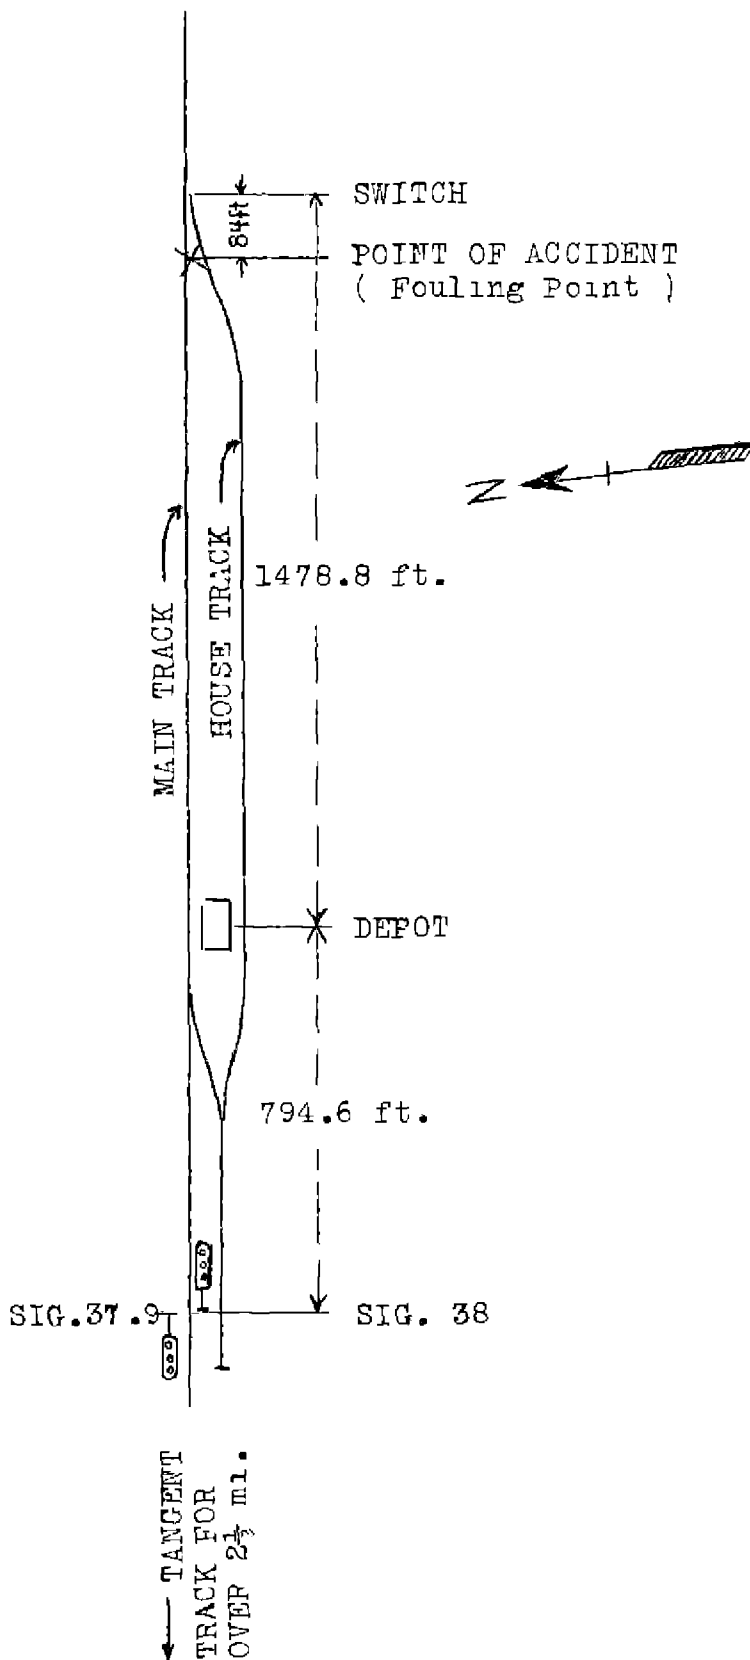
While the view of the east switch of the house track is unobstructed from the engineman's side of an eastbound engine, yet on account of the depot being located between the house track and the main track, a helper engine on the east end of the house track would be obscured from the view of an eastbound engineman until his engine passed the depot.
