INTERSTATE COMMERCE COMMISSION

REPORT OF THE DIRECTOR OF THE BUREAU OF SAFETY CONCERNING
AN ACCIDENT WHICH OCCURRED ON THE NORTHERN PACIFIC
RAILWAY NEAR EDDY, MONT., ON MARCH 18, 1932.

May 19, 1932.

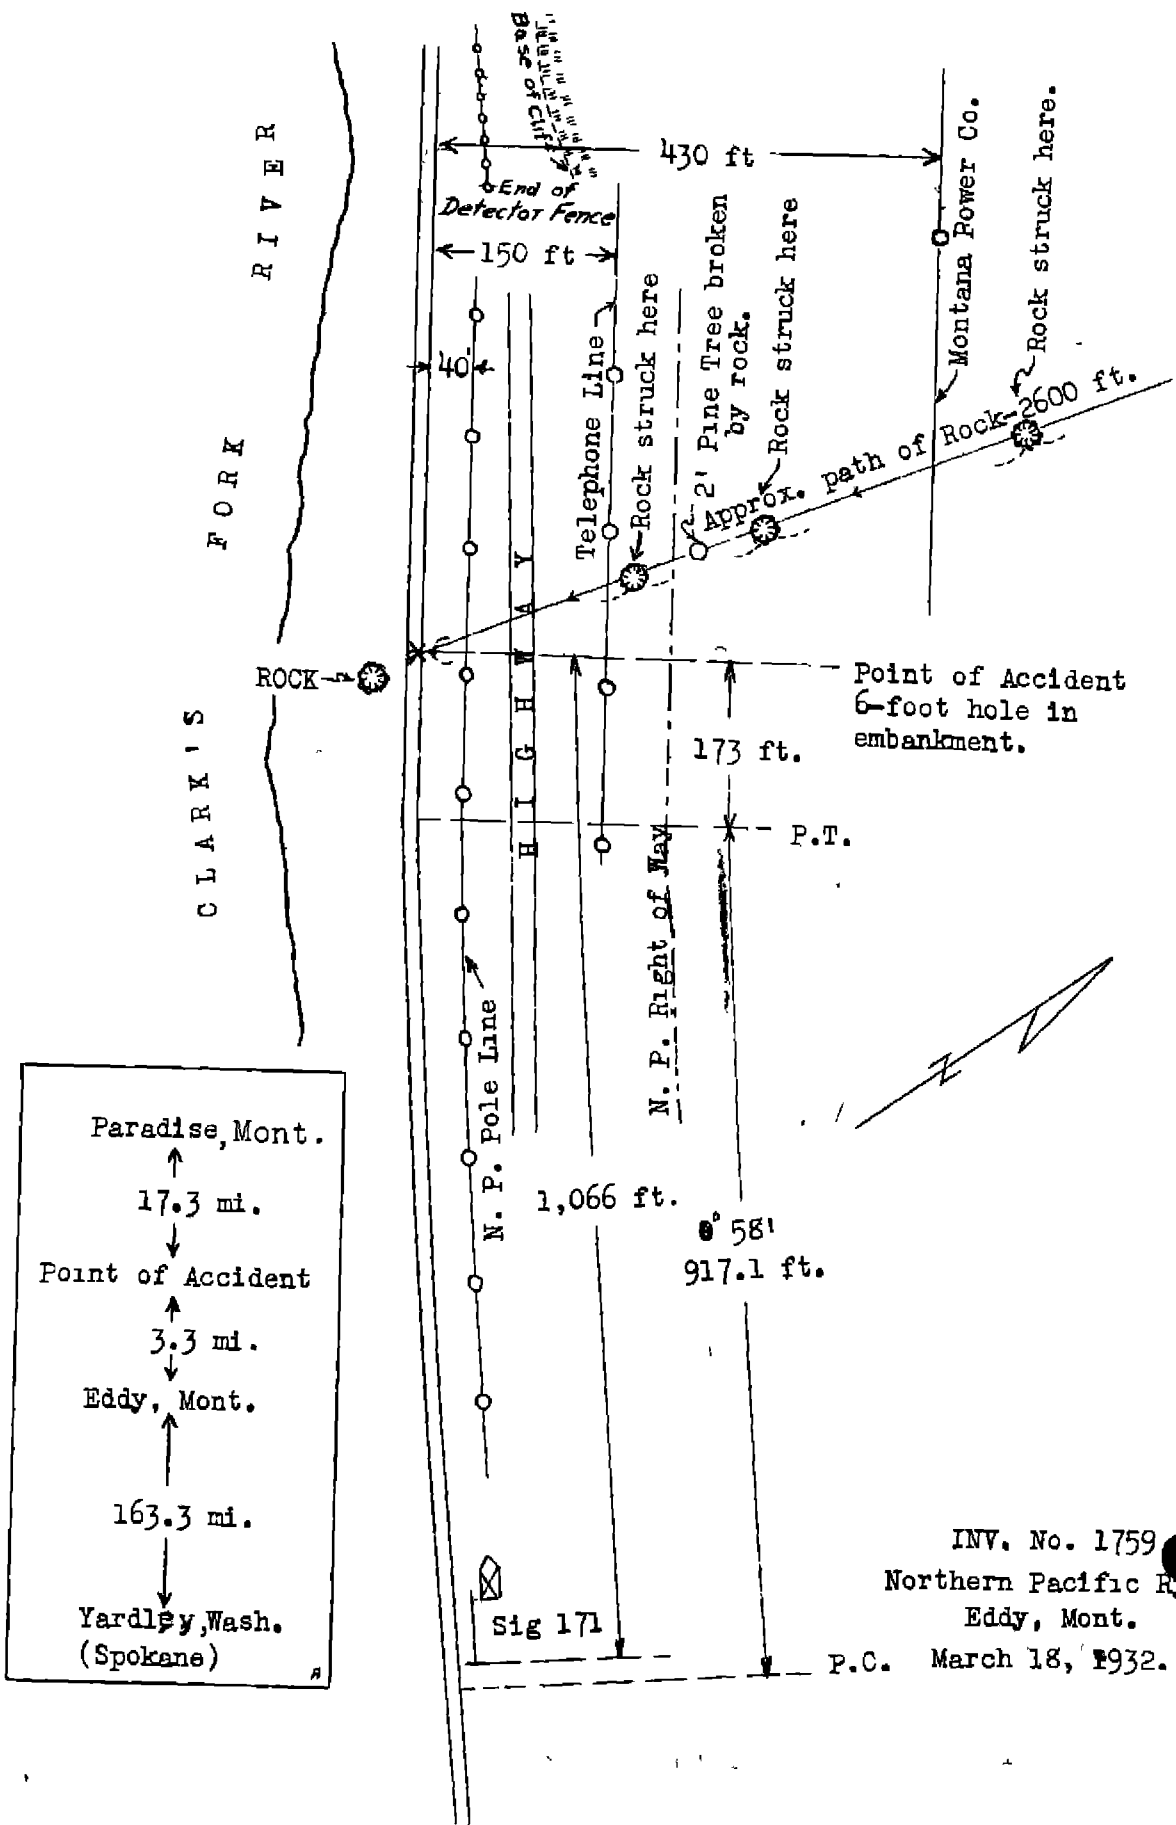
INV. No. 1759
 Northern Pacific Ry.
 Eddy, Mont.

Paradise, Mont.
 ↑
 17.3 mi.
 ↓
 Point of Accident
 ↑
 3.3 mi.
 ↓
 Eddy, Mont.
 ↑
 163.3 mi.
 ↓
 Yardley, Wash.
 (Spokane)
