INVESTIGATION NO. 2680  
THE NORTHERN PACIFIC RAILWAY COMPANY  
REPORT IN RE ACCIDENT  
NEAR HUNTLEY, MONT., ON  
SEPTEMBER 26, 1942

Accident near Huntley, Mont., on September 26, 1942, caused  
by a misunderstanding of flagging instructions.

Inv-2630  
Northern Pacific Railway  
Huntley, Mont.  
September 26, 1942

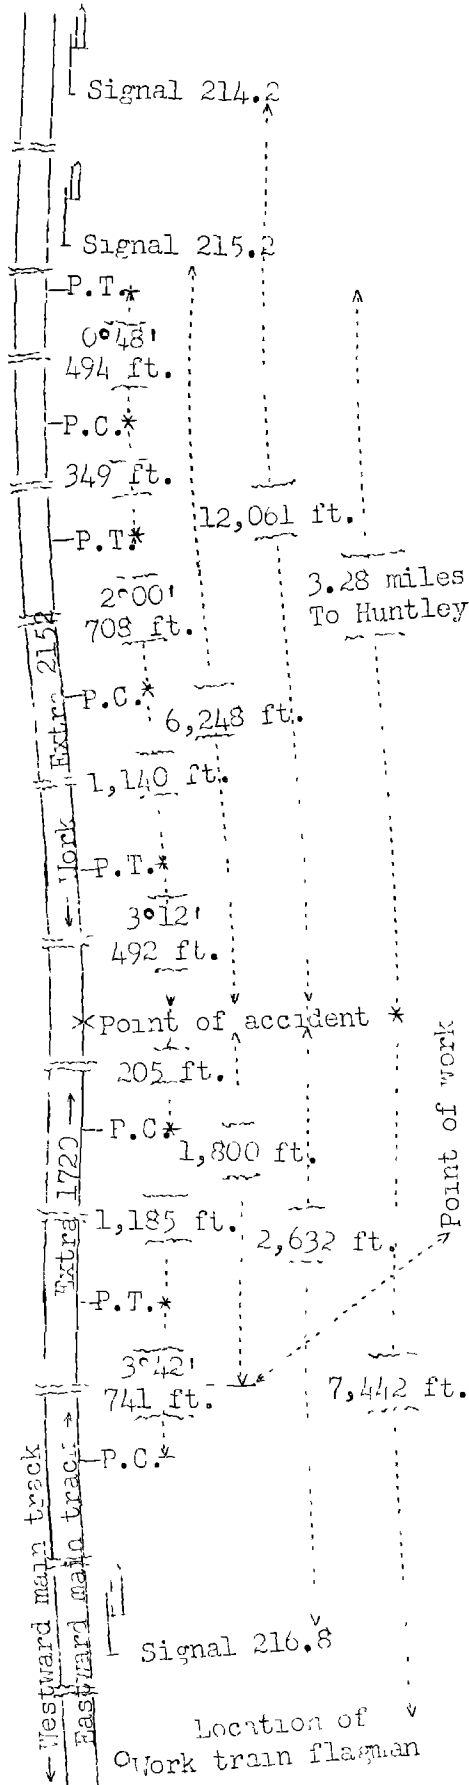
- o Forsyth, Mont.  
89.30 mi.
- o Huntley  
3.28 mi.
- X Point of accident  
9.02 mi.
- o Billings, Mont.

From an engine moving in either direction, in the vicinity of the point of accident, the view of a train approaching from the opposite direction is restricted to a distance of approximately 1,000 feet, because of the rock bluff and track curvature.
