INVESTIGATION NO. 2934
NORTHERN PACIFIC RAILWAY COMPANY
REPORT IN RE ACCIDENT
AT PROSSER, WASH., ON
SEPTEMBER 23, 1945

SUMMARY

Accident at Prosser, Wash., on September 23, 1945, caused
by a switch being opened immediately in front of an
approaching train.

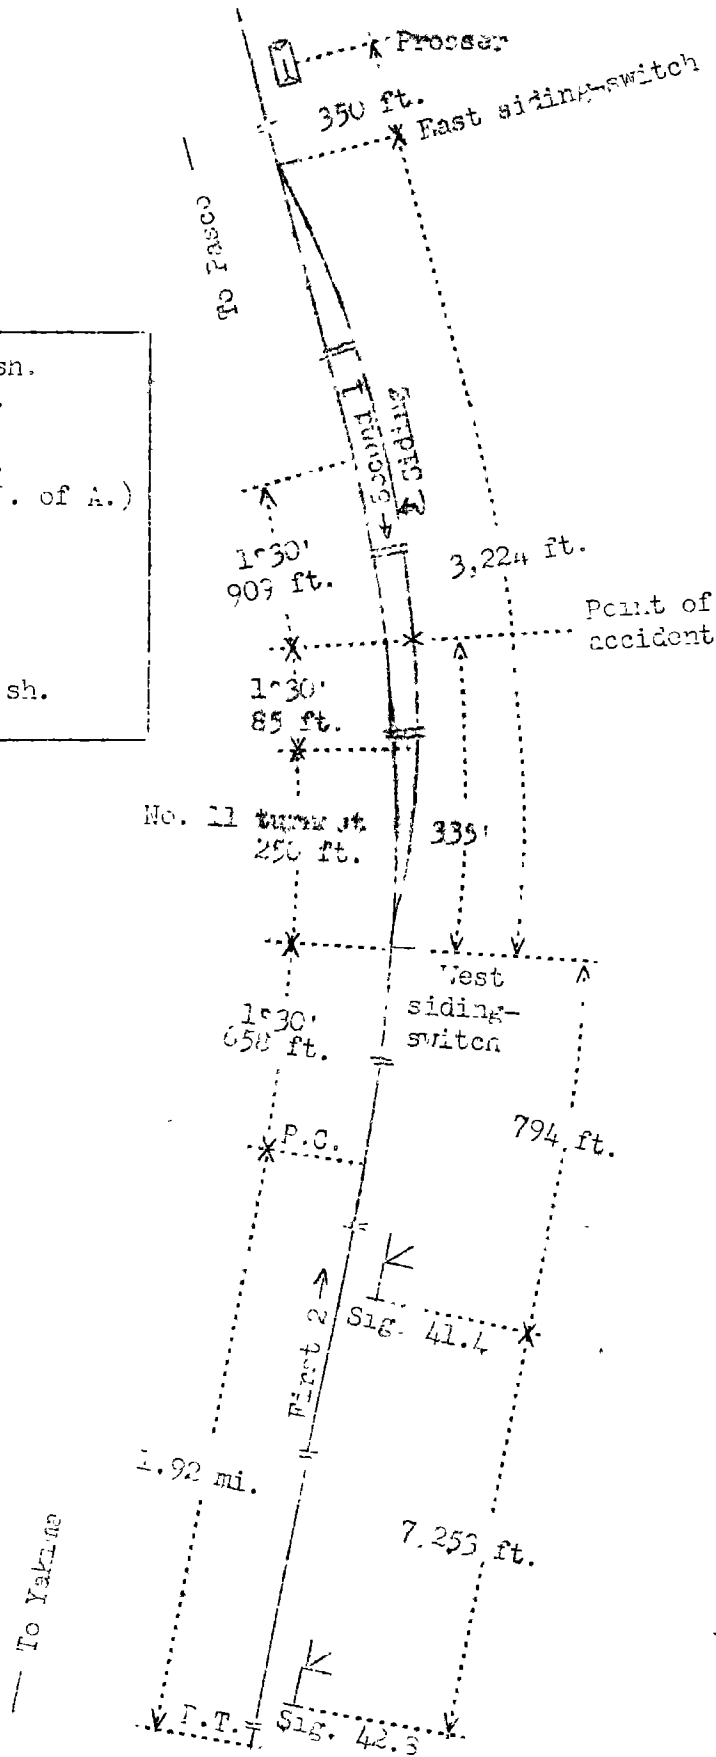
Inv. No. 2934
 Northern Pacific Railroad
 Prosser, Wash.
 September 23, 1945

Location of Accident and Method of Operation

This accident occurred on that part of the Idaho Division which extends between Pasco and Yakima, Wash., 89.5 miles, a single-track line in the vicinity of the point of accident, over which trains are operated by timetable, train orders and an automatic block-signal system. At Prosser, 39.9 miles west of Pasco, a siding 3,224 feet in length parallels the main track on the south. The east switch and the west switch of this siding are, respectively, 350 feet and 3,574 feet west of the station. The accident occurred on the siding at a point 335 feet east of the west switch. From the west there are, in succession, a tangent 1.92 miles in length, a 1°30' curve to the left 658 feet to the west siding-switch, a No. 11 turnout to the right 250 feet and a 1°30' curve to the left 85 feet to the point of accident and 909 feet eastward. At this point the grade is 0.25 percent ascending eastward.

The force of the impact moved Second 1 eastward about 15 feet. The engine and the front truck of the first car of Second 1, and the engine, the first car and the front wheels of the rear truck of the second car of First 2 were derailed. The superstructure of the first car of First 2 was practically demolished. The remainder of the derailed equipment was considerably damaged.

It is recommended that the Northern Pacific Railway Company install electric switch-locking at main-track hand-operated switches in high-speed automatic block-signal territory.
