REPORT NO. 3294

THE NORTHERN PACIFIC TERMINAL COMPANY
OF OREGON

IN RE ACCIDENT

OCTOBER 10, 1949

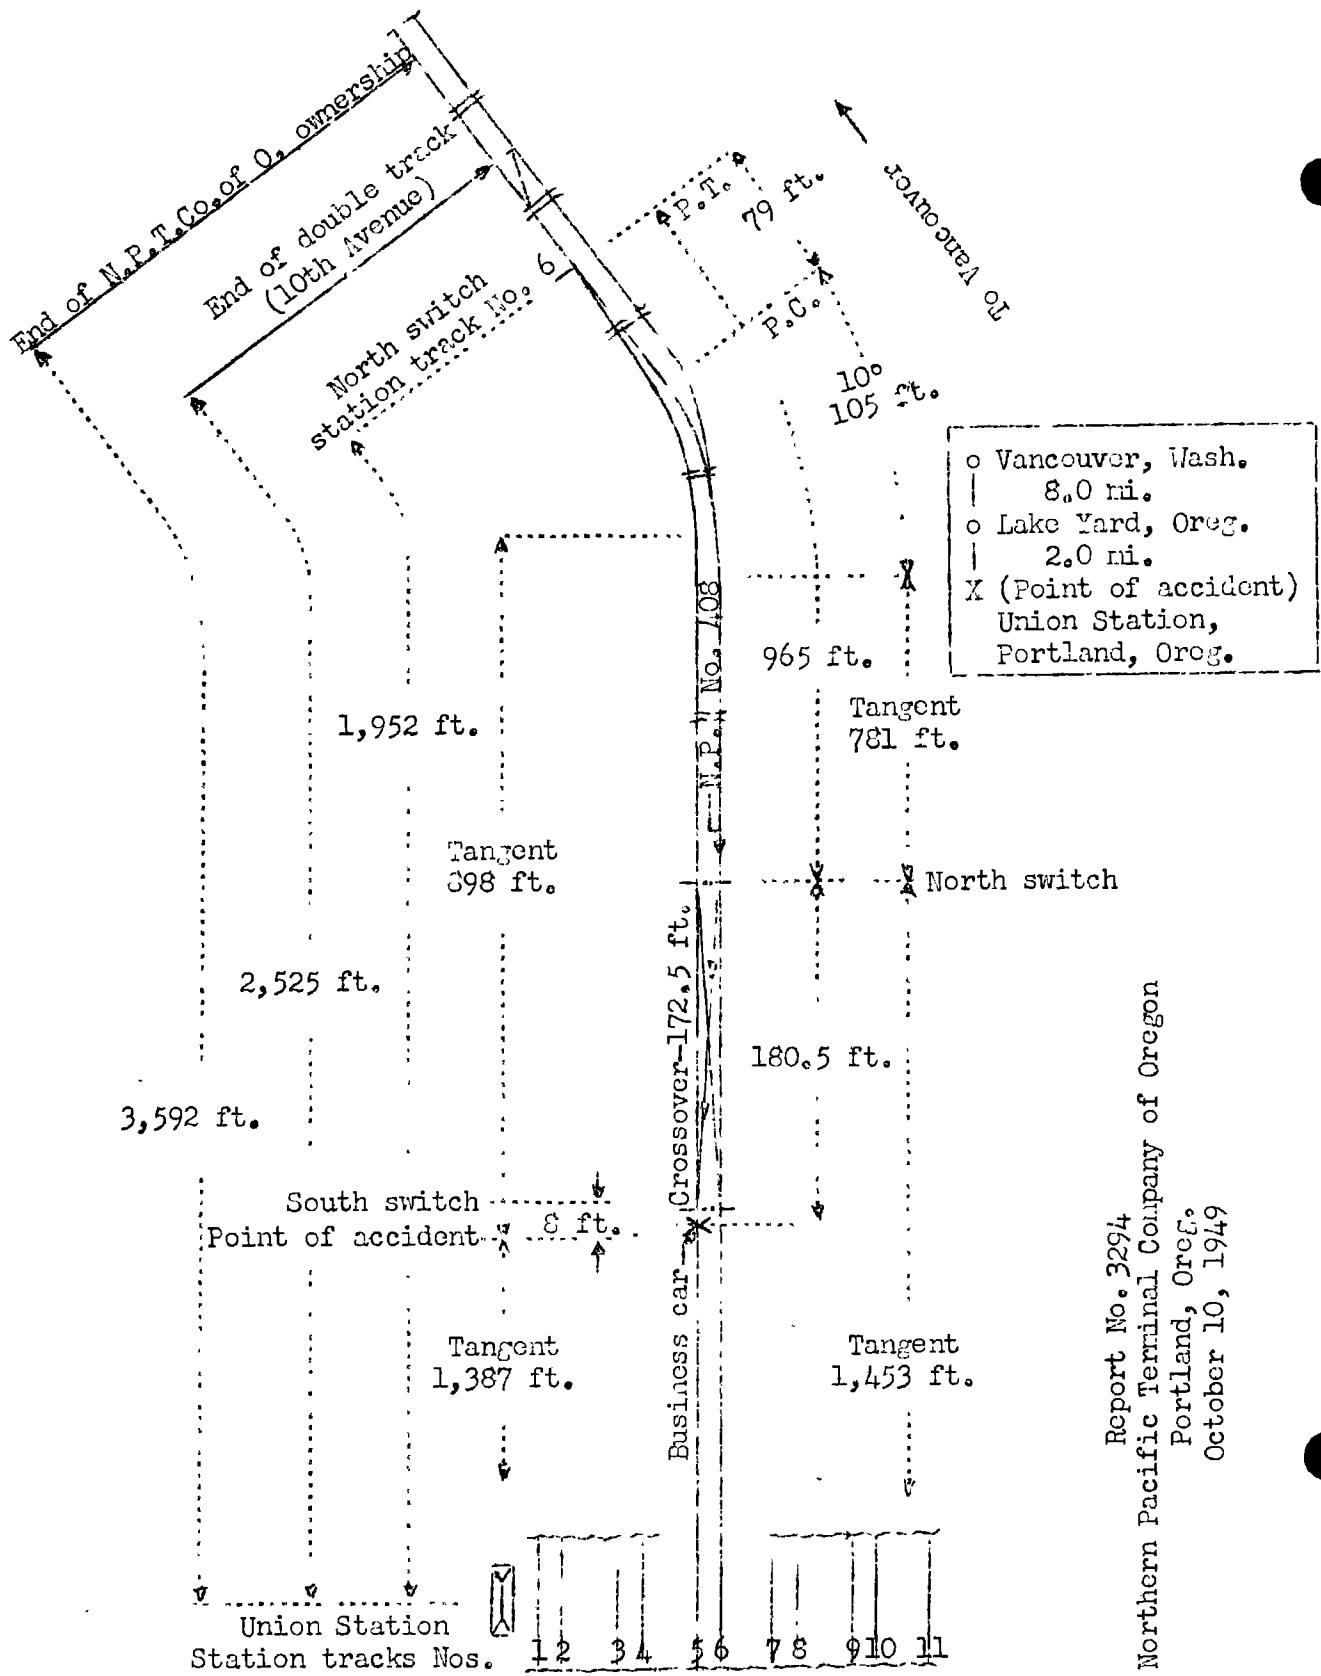
Report No. 3294
 Northern Pacific Terminal Company of Oregon
 Portland, Ore.
 October 10, 1949

This accident occurred on a station track at Union Station, Portland, Oreg., over which trains are operated by special instructions. At Union Station, Portland, there are 11 station tracks, designated from west to east, successively, as tracks Nos. 1 to 11. Tracks Nos. 5 and 6 are, respectively, 2,580 feet and 2,918 feet in length. The north switch of track No. 6 is 1,952 feet north of the station. The north switch of a crossover which connects tracks Nos. 5 and 6 is located 965 feet south of the north switch of track No. 6. This crossover is facing-point for south-bound movements on track No. 6 and is 172.5 feet in length. The accident occurred on track No. 5 at a point 180.5 feet south of the north crossover-switch. Track No. 5 is tangent throughout a distance of 898 feet immediately north and 1,387 feet immediately south of the point of accident. From the north on track No. 6 there are, in succession, a tangent 79 feet in length, a 10° curve to the right 105 feet, and a tangent 781 feet to the north crossover-switch and 1,453 feet southward. The grade for south-bound movements is 0.06 percent descending a distance of 452 feet, then 0.03 percent descending 604 feet to the point of accident.

The distance between the center-lines of tracks Nos. 5 and 6 is 12 feet 2-1/2 inches. The crossover between these tracks is provided with a No. 9 turnout at each end. The switch stand at the north switch is of the ground-throw type and is located 4 feet 2 inches east of the center-line of the track. The switch is equipped with an oil-burning lamp located 5 feet 8 inches west of the center-line of the track. This lamp is mounted on a turning base which is operated by a bar connected to the operating rod of the switch. It displays a green aspect when the switch is lined in normal position, and displays a red aspect when the switch is lined for entry to the crossover. The lenses of the lamp are 4-1/4 inches in diameter, and the centers of the lenses are 1-7/8 inches above the level of the tops of the rails. A switch target is not provided.

passed Lake Yard, the last open office, 2 miles north of Union Station, Portland, at 4:25 p. m., on time. As it approached 10th Avenue, 2,525 feet north of Union Station, Portland, the switchtender at that point gave a hand signal to proceed. The train passed 10th Avenue, entered track No. 6 at the north switch, entered track No. 5 at the crossover, and, while moving at a speed of about 3 miles per hour, it struck a business car which was standing on track No. 5 at a point 8 feet south of the south crossover-switch.
