ACCIDENT ON THE
NORTHWESTERN PACIFIC RAILROAD

CAMP NINE, CALIF.

AUGUST 6, 1937.

INVESTIGATION NO. 2193

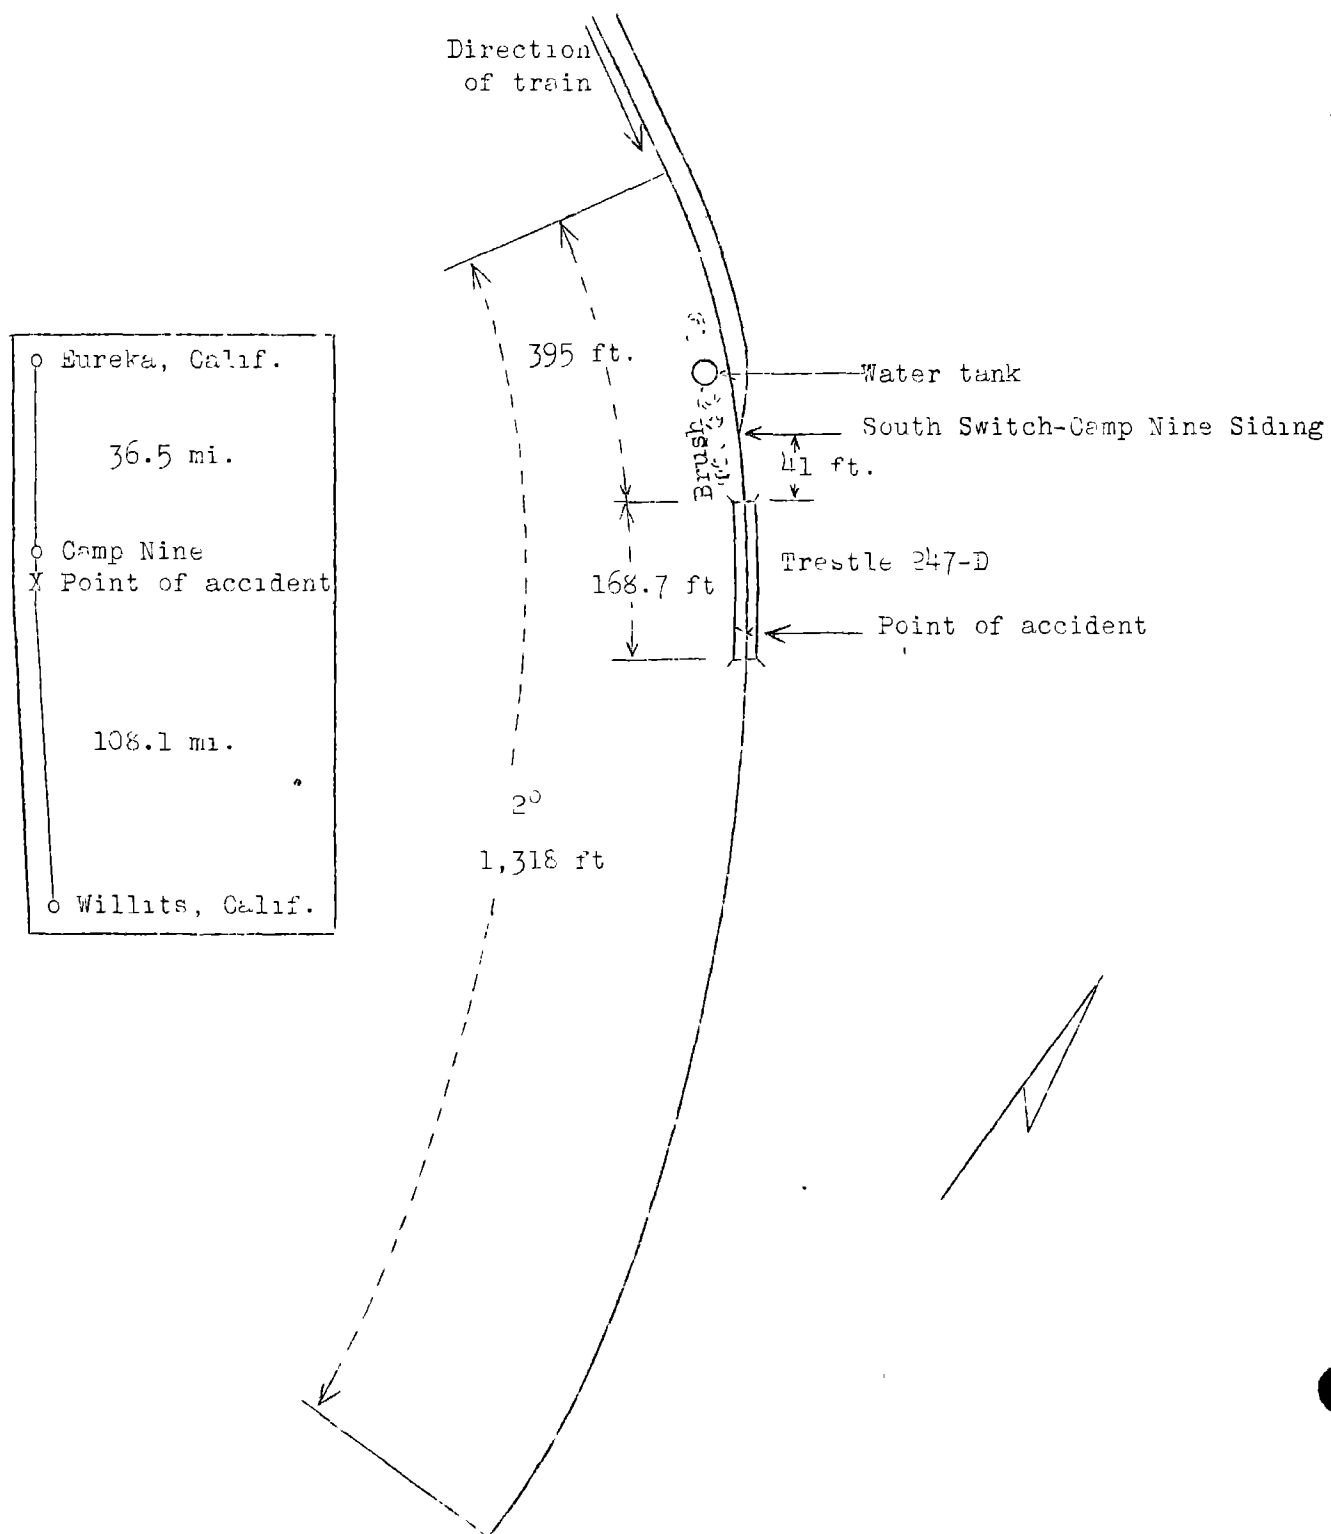
Inv. No. 2193
Northwestern Pacific R.R.
Camp Nine, Calif.
August 6, 1937

at a speed estimated to have been about 20 miles per hour, and became derailed on Trestle 247-D which had been weakened by a fire that was still in progress.

The engine rolled off the right side of the trestle and stopped bottom side up on the south embankment parallel with the track; the tender was on its right side at the rear of the engine, and the first car stopped bottom side up near the foot of the embankment. None of the remaining equipment was damaged. The employees killed were the engineman, fireman and head brakeman.
