INTERSTATE COMMERCE COMMISSION

REPORT OF THE DIRECTOR OF THE BUREAU OF SAFETY CONCERNING AN
ACCIDENT ON THE LINE OF THE OREGON-WASHINGTON RAILROAD
& NAVIGATION COMPANY, UNION PACIFIC SYSTEM, AT ATTALIA,
WASH., ON AUGUST 14, 1933.

December 18, 1933.

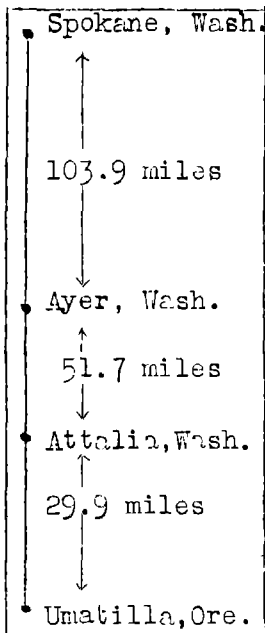
Point of accident

The first mark of disturbance was a piece of brass found on the end of a tie 5,200 feet east of the frog of the spur track; 176 feet farther west another piece was found; 336 feet beyond this point was the first mark on top of a rail; the wedge was 56 feet farther west and the end of the journal was found 843 feet beyond the wedge, 50 feet from the center line and on the south side of the track. The first indication of the wheel being derailed was 1,343 feet west of where the journal was found, or at a point 2,377.5 feet east of the spur-track frog. The journal which burned off was the left no. 2 journal, and the marks indicated that the truck side dropped to the ties and was dragged along in that position, with the wheel derailed, until it encountered the frog at the spur-track switch.
