INVESTIGATION NO. 2940
PACIFIC ELECTRIC RAILWAY COMPANY
REPORT IN RE ACCIDENT
NEAR ATHENS, CALIF., ON
OCTOBER 19, 1945

PACIFIC ELECTRIC RAILWAY COMPANY

Accident near Athens, Calif., on October 19, 1945, caused
by an inferior train occupying the main track on the
time of an opposing superior train.

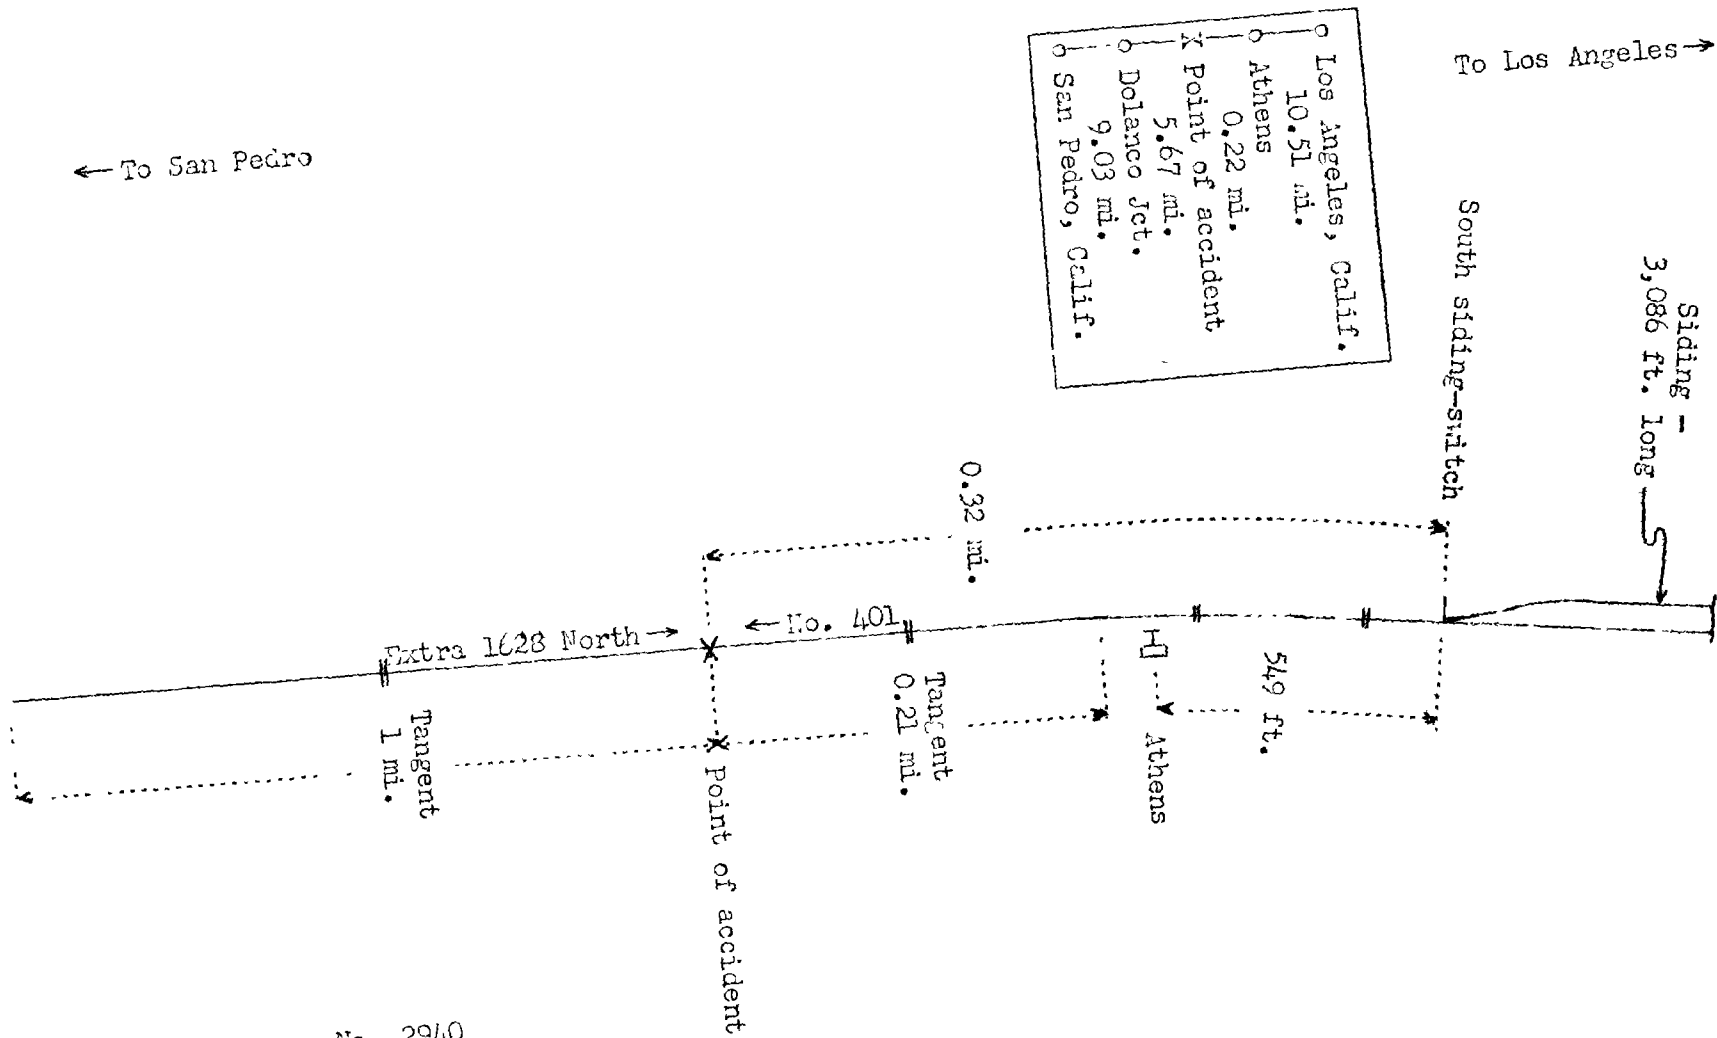
Inv. No. 2940
Pacific Electric Railway
Athens, Calif.
October 19, 1945

Location of Accident and Method of Operation

This accident occurred on that part of the Southern District extending between Los Angeles and San Pedro, Calif., 25.43 miles, a single-track line in the vicinity of the point of accident, equipped with an overhead trolley system for the electric propulsion of trains, over which trains are operated by timetable and train orders. There is no block system in use. At Athens, 10.81 miles south of Los Angeles, a siding 3,086 feet in length parallels the main track on the west. The south switch of this siding is 549 feet north of the station. The accident occurred on the main track 0.32 mile south of the south siding-switch. The main track is tangent throughout a distance of about 1 mile south of this point and 0.21 mile northward. The grade is 1.419 percent ascending northward.
